2017 ASPECT Preliminary Report
Rapids Needs Assessment &
Arkema Plant Response, Crosby, TX

September 2, 2017
0700 hrs to 2200 hrs

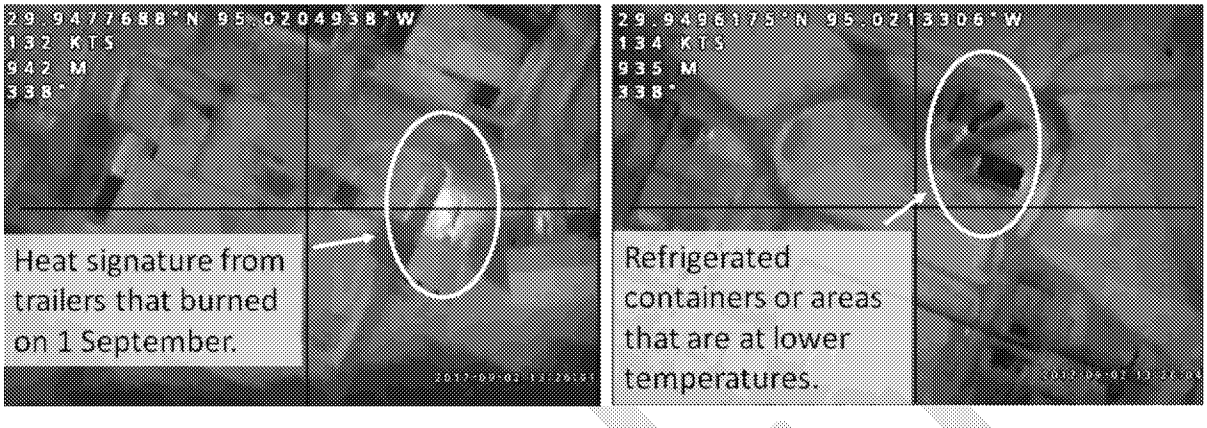
0740 hrs: ASPECT completes a pass over the Arkema facility and reports no significant chemical detections. Figure 3 contains two images taken from the IR video showing a heat signature from the remnants of the trailers that burned on 1 September and the remaining refrigerated trailers.

Figure 3: Infrared images taken from the video (0813 hrs CST) showing the heat signature from the trailers that burned on 1 September (left) and the refrigerated trailers (right).

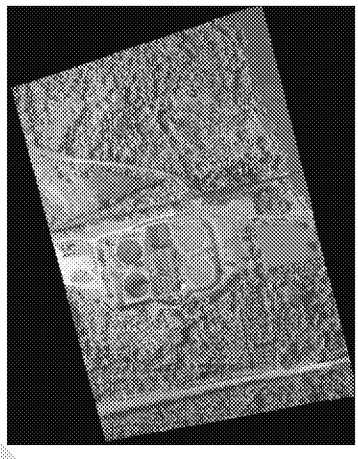
Figure 5: Example of a geo-corrected aerial photo over a water treatment facility. These are part of the rapid needs assessment mission.
