2017 ASPECT Preliminary Report
Arkema Plant Response
Crosby, TX

August 31, 2017
0600 hrs to 1300 hrs

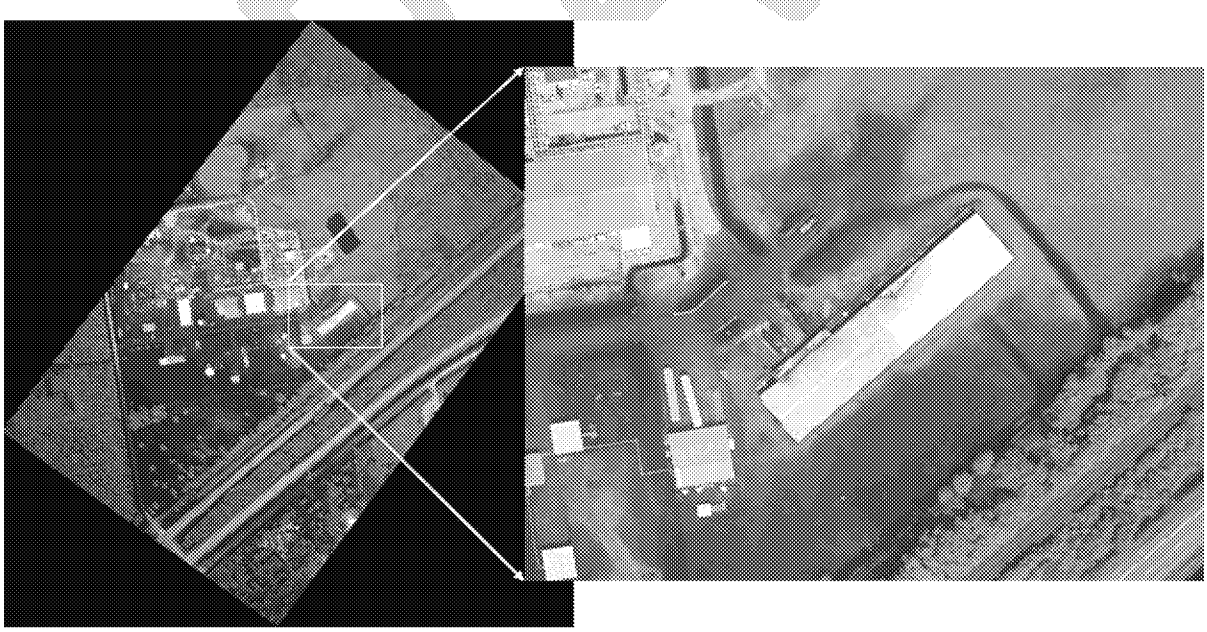
Figure 6: Low resolution aerial image retrieved from the aircraft during the afternoon sortie, approximately 1335 hrs. A copy of the entire image will be provided in an email. A portion of the photo was enlarged to show the affected building.

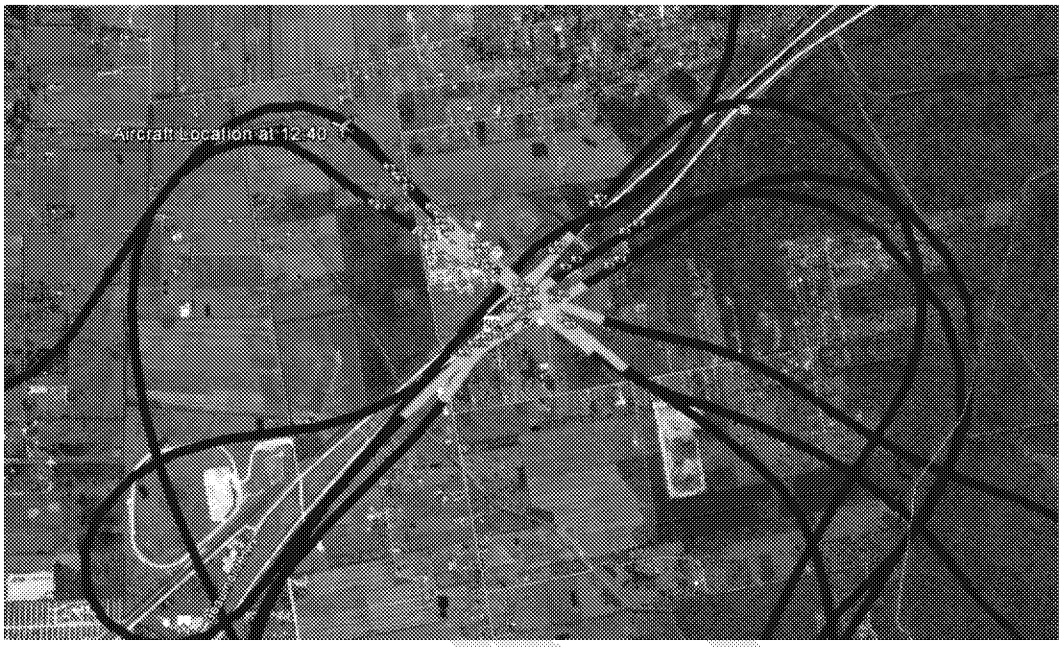
Figure 7: Flight path over the facility at 0731 hrs CST (1231 hrs UTC) showing several passes where aerial imagergy and IR sensors were active.
