2017 ASPECT Preliminary Report
Arkema Plant Response
Crosby, TX

August 31, 2017
0600 hrs to 1900 hrs

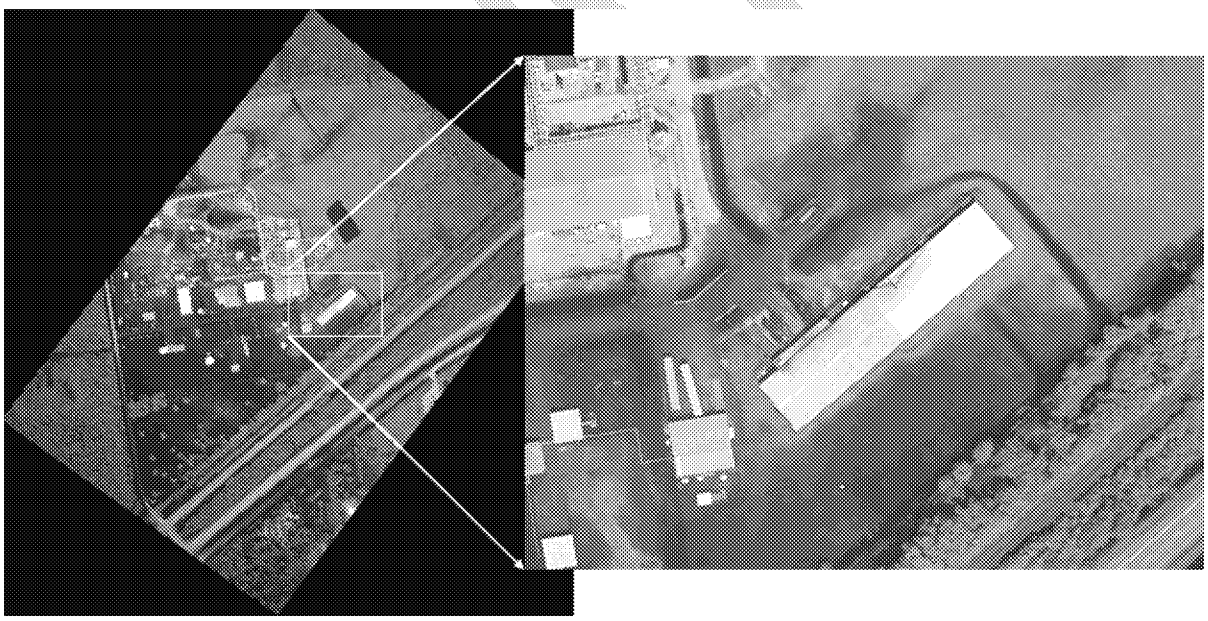
Figure 6: Low resolution aerial image retrieved from the aircraft during the afternoon sortie, approximately 1335 hrs. A copy of the entire image will be provided in an email. A portion of the photo was enlarged to show the affected building.
