2017 ASPECT Preliminary Report
Rapids Needs Assessment

September 6, 2017
0700 hrs to 2000 hrs

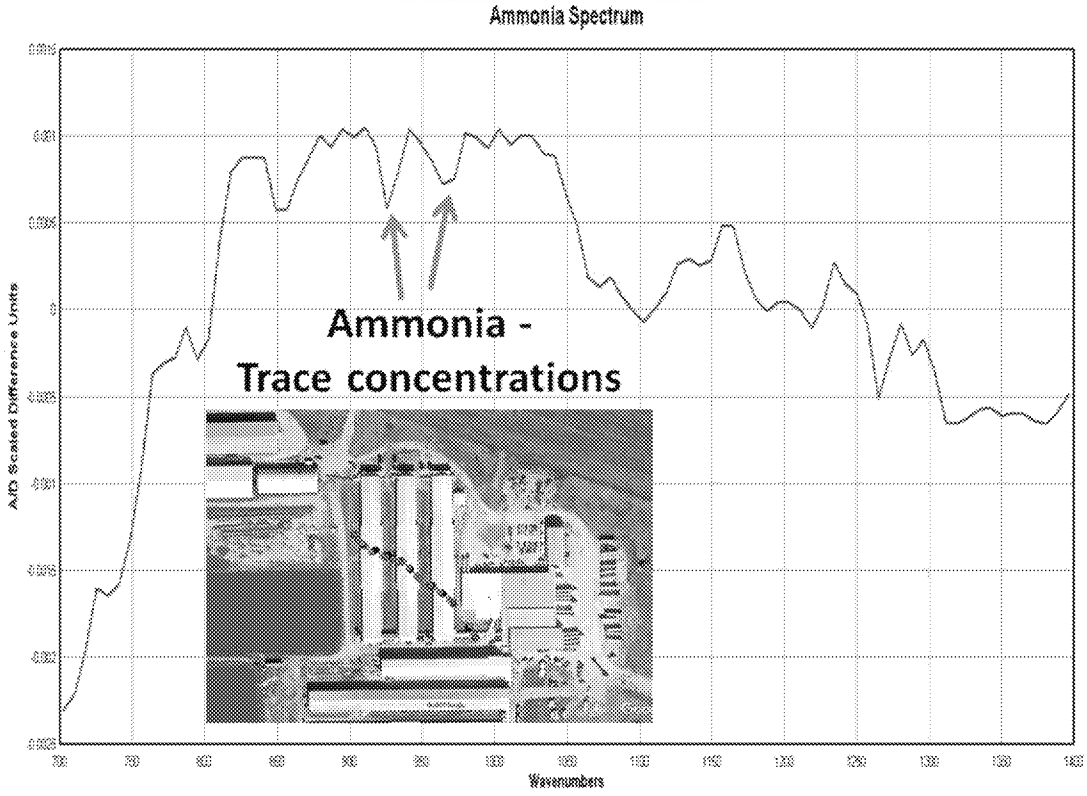
Figure 1: Ammonia detection during the Rapid Needs Assessment Survey on 5 September 2017..
