2017 ASPECT Preliminary Report
Rapids Needs Assessment &
Arkema Plant Response, Crosby, TX

September 3, 2017
0730 hrs to 2040 hrs

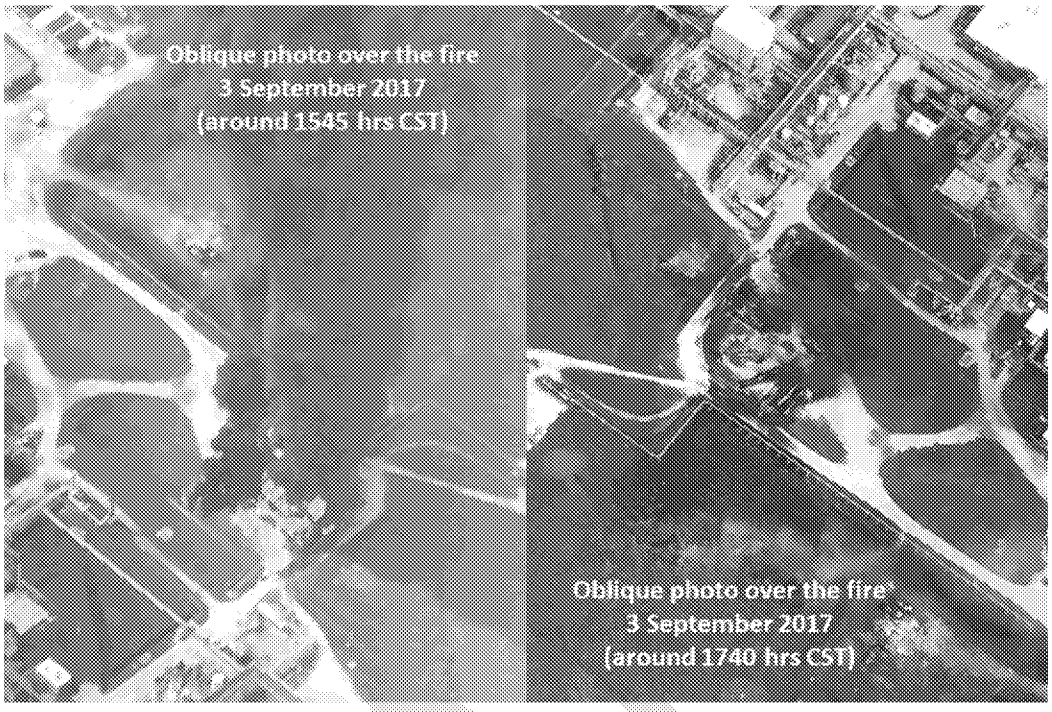
Figure 5: Oblique photos of the Arkema fire take FTIR results are showing low concentrations of peroxide (2 ppm) about 50 meters downwind. The air crew reports just a little fire and very little smoke. The detection limit was lower since we were looking down a thicker plume. Please see the attached IR image, note the greatly reduced with only the trailers showing a hot signature.n from ASPECT aircraft.
