From: Thomas, Mark J.
To: ASPECT_Harvey
Subject: 5 Sept 2017 -- ASPECT Daily Report -- 1830
Date: Tuesday, September 5, 2017 6:32:12 PM
Attachments: Harvey_Sept2017_nlink.kml
ASPECT RNA Detailed Status v1.docx
ASPECT RNA Detailed Status v1.pdf
Zone8_Area.kml
Zone9_Area.kml
20170905 Preliminary Report for ASPECT Hurricane Harvey v1.pdf

2017 ASPECT Preliminary Report
Rapids Needs Assessment

September 5, 2017
0730 hrs to 1900 hrs

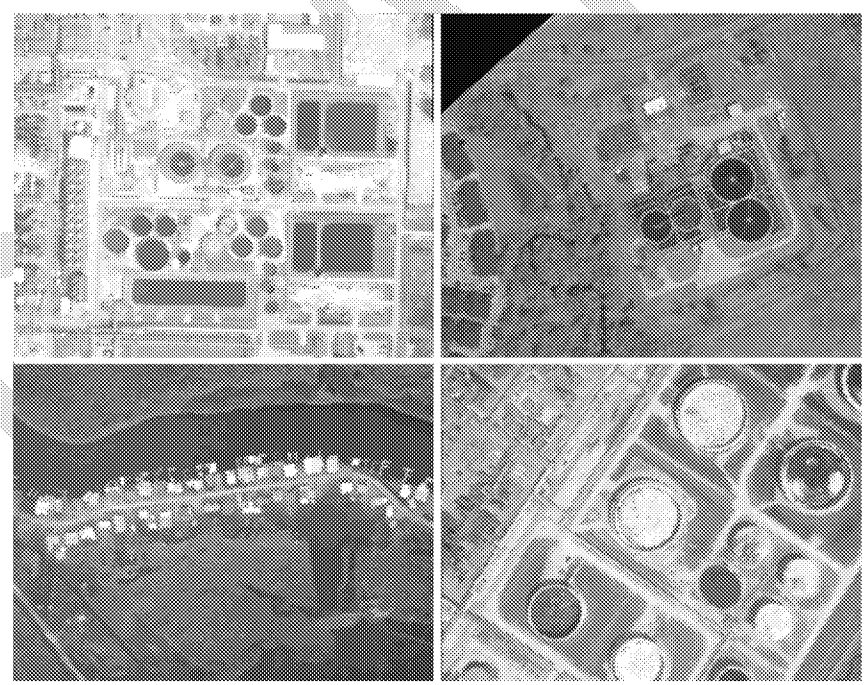
Figure 1: Clockwise from top left: Water treatment facilities showing a range of effects from Harvey and houses near the coast.
