2017 ASPECT Preliminary Report
Arkema Plant Response
Crosby, TX

August 31, 2017
0600 hrs to 0845 hrs

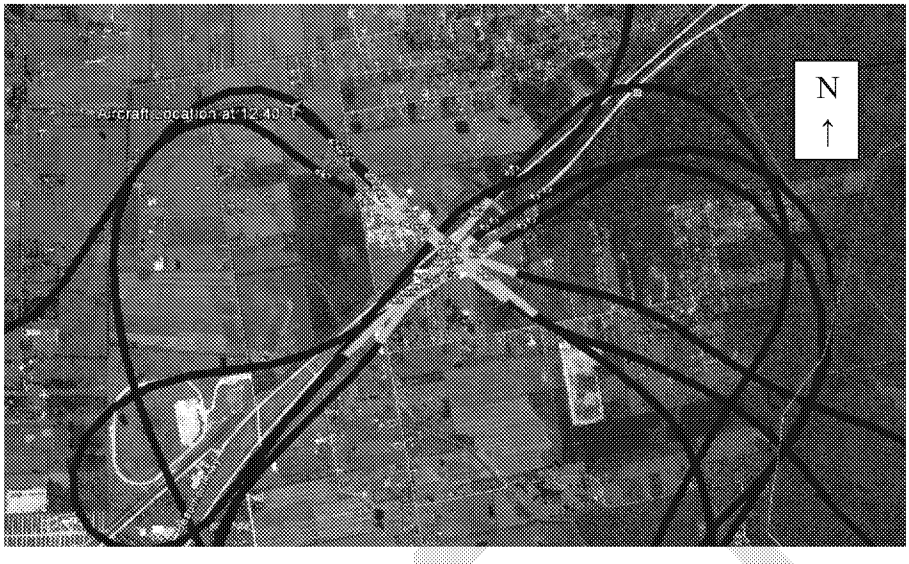
Figures 2 & 3 show a visible image of the facility with no observed plume and the flight path highlighted when IR sensors were active.

Figure 3: Flight path over the facility at 0731 hr CST (1231 hrs UTC) showing several passes where aerial imagery and IR sensors are active.
