2017 ASPECT Preliminary Report
Arkema Plant Response, Crosby, TX
&
Rapids Needs Assessment

September 1, 2017
0500 hrs to 1800 hrs

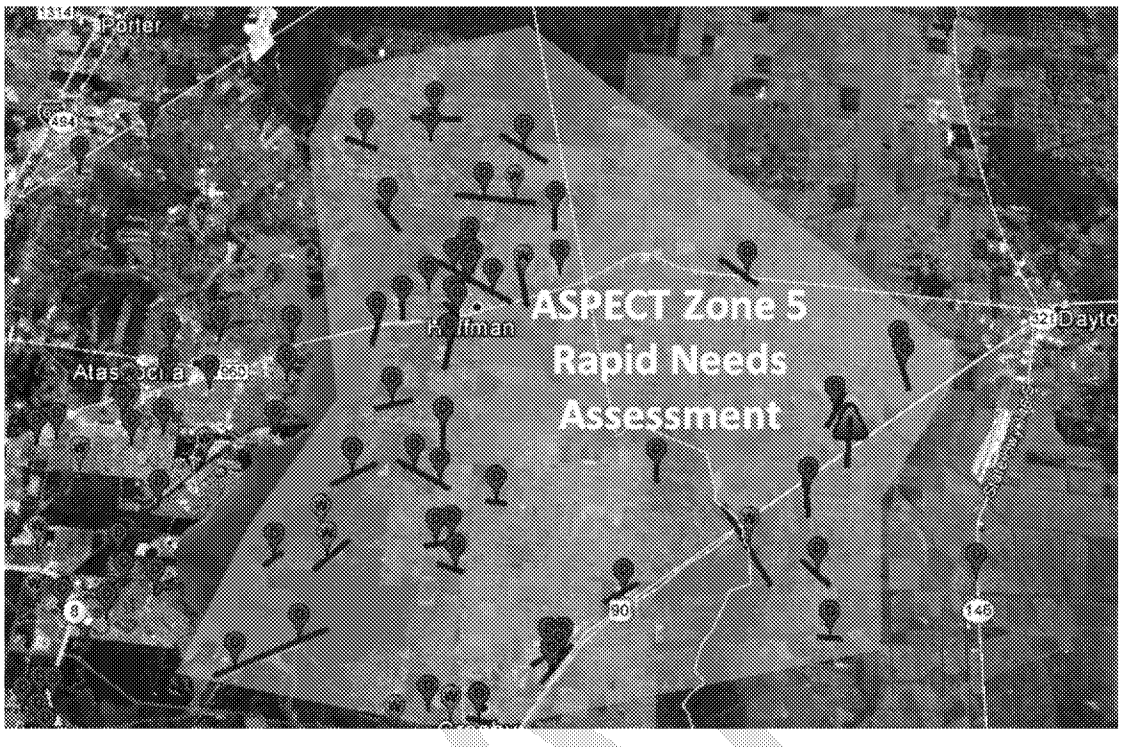
Figure 3: Zone 5 (highlighted area) contains more than 50 targets and 36 flight lines where ASPECT will collect high-resolution aerial photographs. If the target is an industrial facility, the chemical sensors will be activated. "D" icons are drinking water facilities. "W" icons are wastewater treatment facilities. "!" icons are Risk Management Plan sites. Several of the locations are not accurate so it may appear as if they are not covered by the flight line.

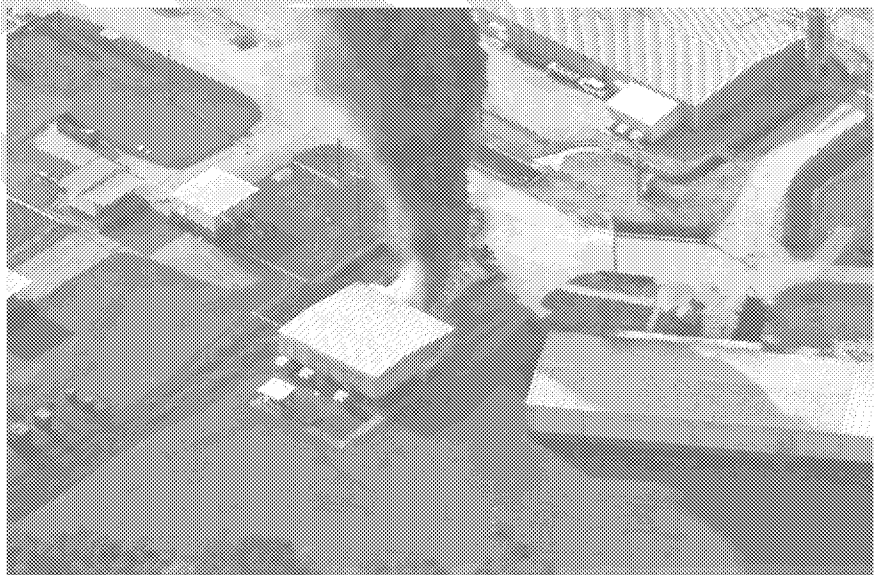
1800 hrs: Figures 7 & 8 show intense heat where the trailers are on fire. Figure 7 is an image that was pulled from the aircraft while in flight. Figure 8 was obtained after the aircraft landed

Figure 8: Oblique image of the trailers on fire.
