2017 ASPECT Preliminary Report
Rapids Needs Assessment &
Arkema Plant Response, Crosby, TX

September 2, 2017
0700 hrs to 2200 hrs

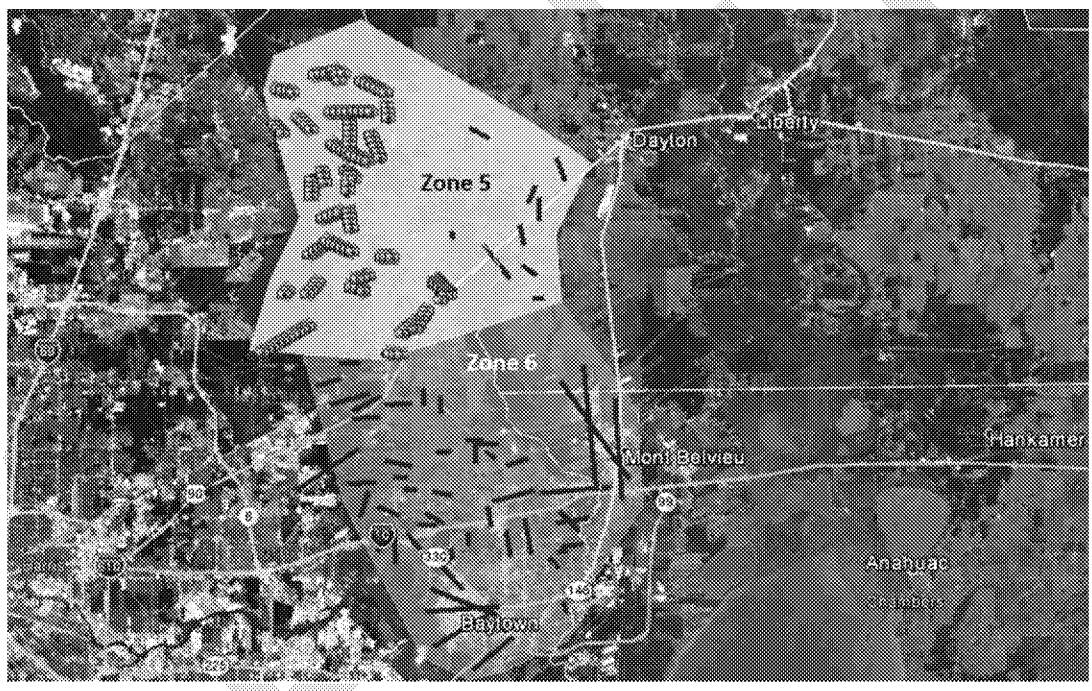
Figure 2: Flight lines in Zones 5 & 6 showing where aerial photography was taken over selected targets on 1 September 2017 for the rapid needs assessment.

On 1 September 2017, ASPECT completed about 50% of Zone 5 (Crosby to Huffman) consisting of approximately 50 targets (36 flight lines). Zone 6 (Crosby down to Baytown) consists of more than 50 targets (49 flight lines).

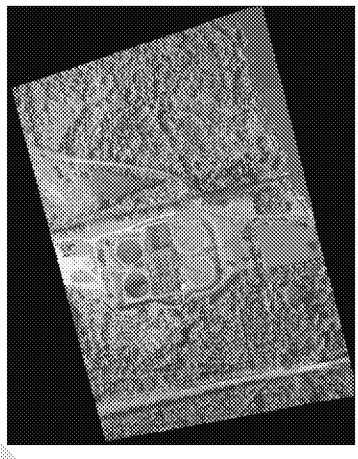
Figure 5: Example of a geo-corrected aerial photo over a water treatment facility. These are part of the rapid needs assessment mission.
