2017 ASPECT Preliminary Report
Rapids Needs Assessment

September 6, 2017
0700 hrs to 2000 hrs

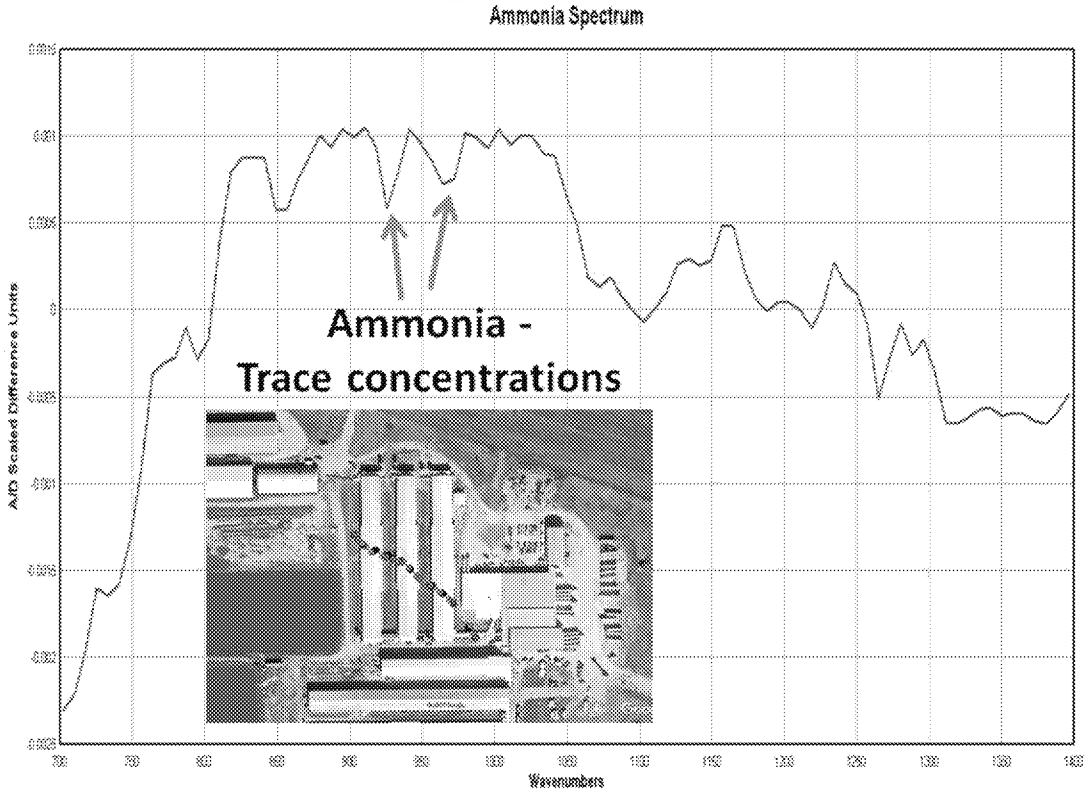
Figure 1: Ammonia detection during the Rapid Needs Assessment Survey on 5 September 2017.
