Field Report for Airborne Data Collected In Support of US EPA Region 6 South 4 Group Fire 05 December 2019

Flight Results for Flight 16, 05 December 2019

Flight Results for Flight 17, 05 December 2019

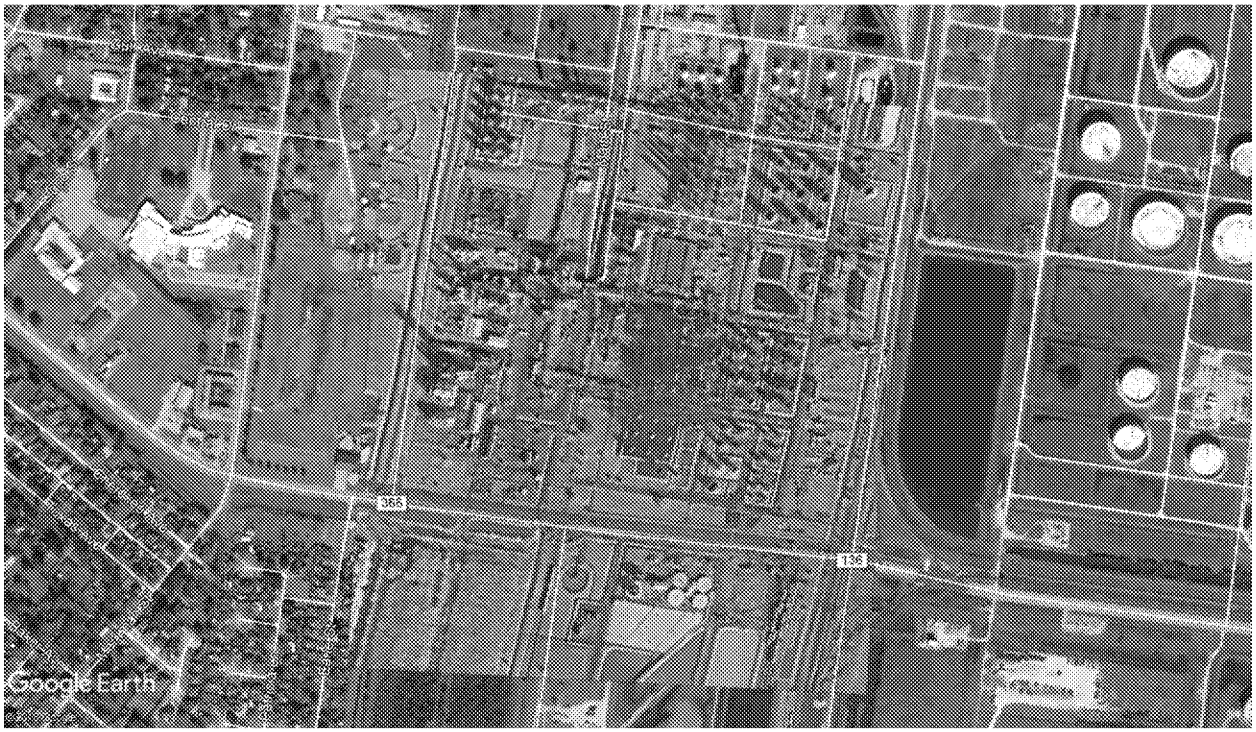
Figure 3: – 3 band IR image, Flight 16, Run 5, South 4 Group Fire

A total of 2 test and 8 data collection passes were made in the proximity of the fire and an infrared line scanner image was generated for each pass. Figure 3 shows a typical 3-band infrared image obtained from data collected for Run 5. Analysis of the image shows a flat thermal environment for the process unit other than isolated spots heated by solar radiation. As reported by the crew, IR imagery showed no evidence of a plume being emitted from the site. The thermal environment of the unit continues to be low. Figure 4 shows a thermal close-up of the process unit with the only noteworthy content being the low thermal levels generated by 5 water cannons being to flood the process unit and nearby tanks. To assess possible oil sheen presence on the Naches River, ASPECT collected IR data along the drainage waterway leading into the river (figure 5). No oil sheen signatures were detected.

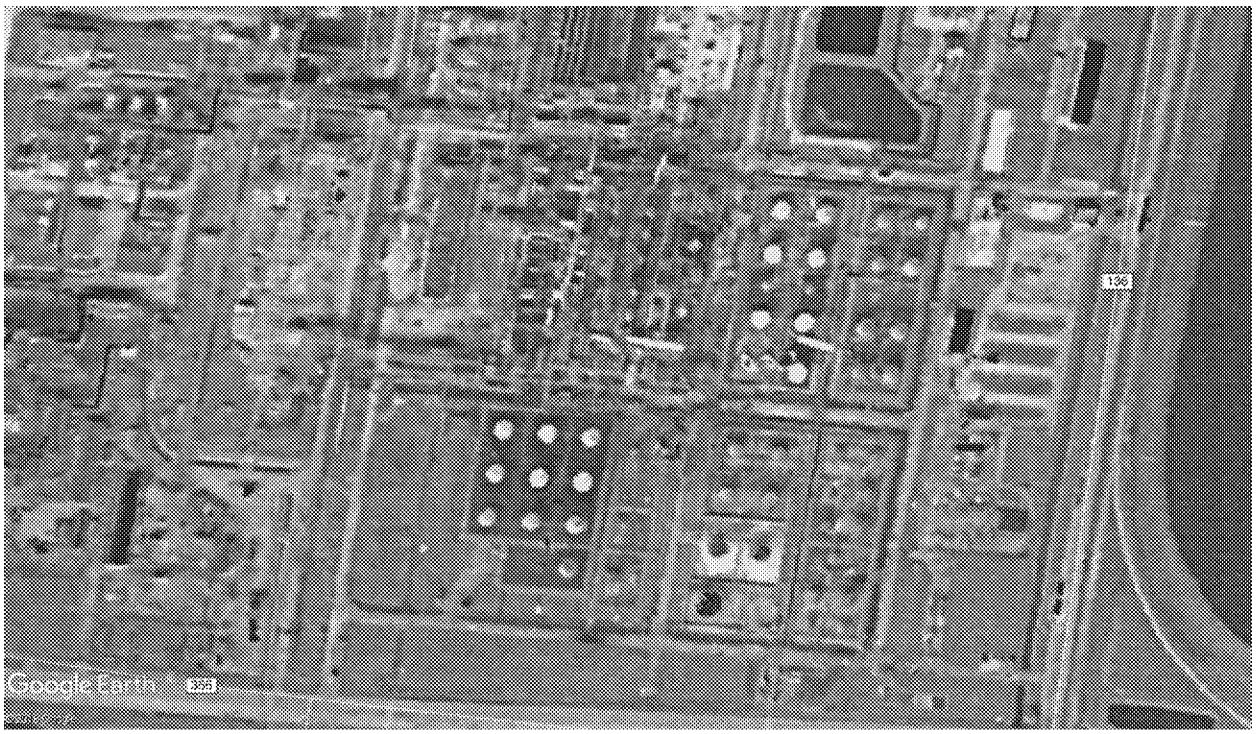
Figure 12: -- 3 band IR Image, Flight 17, Run 5, South 4 Group Thermal Image

A total of 1 test and 7 data collection passes were made in the proximity of the facility and an infrared line scanner image was generated for each pass. Figure 11 shows a typical 3-band infrared image obtained from data collected for Run 2. Analysis of the image shows a flat thermal environment for the process unit other than solar heating of tanks and metal surfaces. Smoke or other emissions are absent in the imagery. A closeup thermal image (figure 12) shows only solar heating. At the time of the IR collection, the signatures of water cannon are not present. A collection pass over the confluence of the drainage waterway and Naches River shows tidal effects pulling water out of the channel but no oil sheen signatures were detected (figure 13).
