Field Report for Airborne Data Collected In Support of US EPA Region VI TPC Fire 27 November 2019

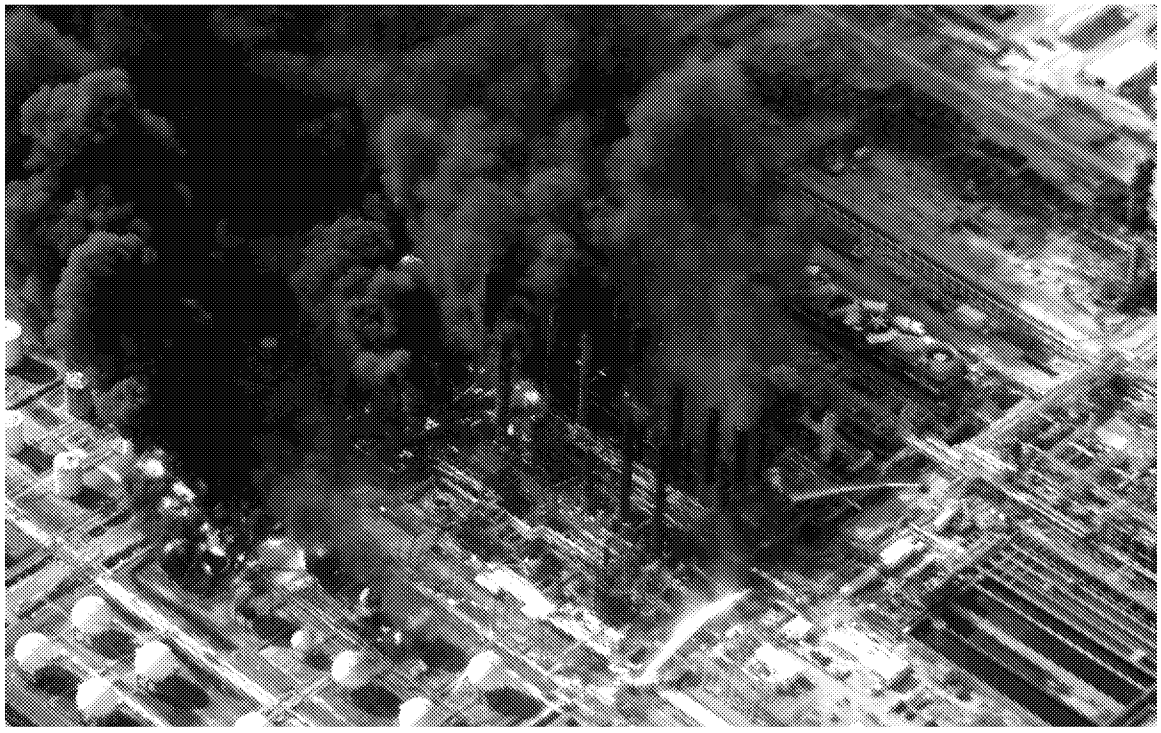
Figure 9: Oblique Image of the TCP Group Fire, Flight 2
