# Field Report for Airborne Data Collected In Support of US EPA Region VI South 4 Group Fire 30 November 2019

**Flight 6 -- 30 November 2019**

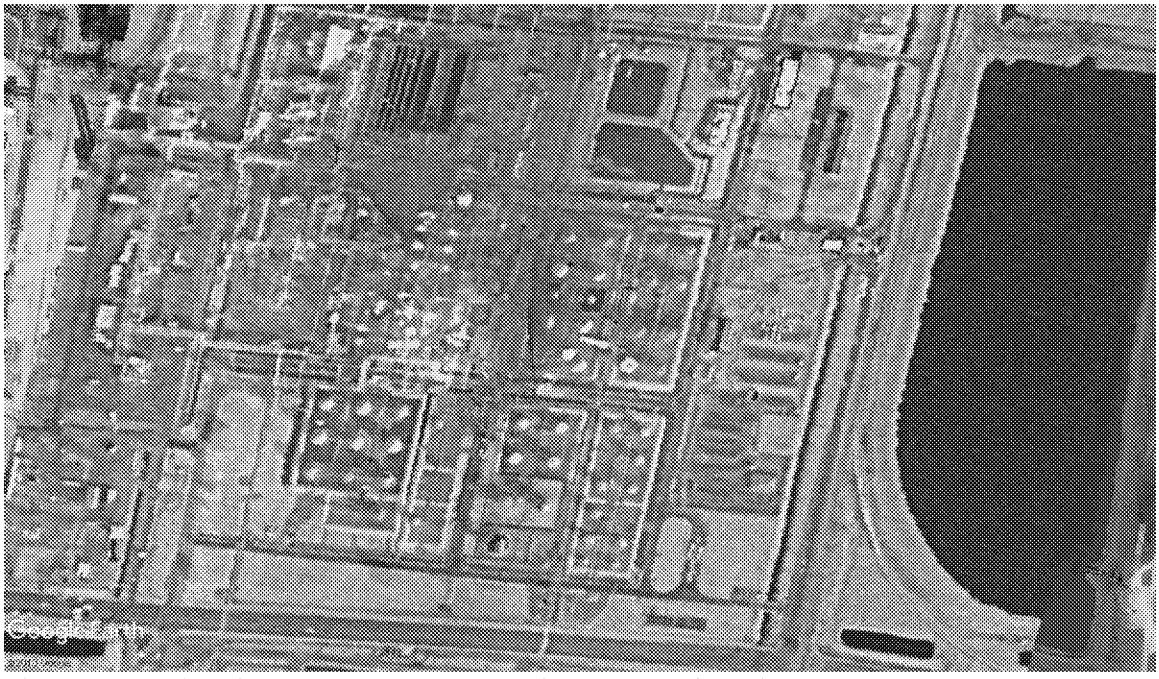
Figure 3: – 3 band IR image, Run 8, South 4 Group Fire

A total of 2 test and 9 data collection passes were made in the proximity of the fire and an infrared line scanner image was generated for each pass. Figure 3 shows a typical 3-band infrared image obtained from data collected for Run 8. This image was generated by flying approximately directly over the facility on a northerly flight path. The color of the image is a result of the blackbody settings and generally shows greatly reduced thermal content from prior flights. Figure 4 shows a close-up of the facility. The white content of the image shows the hottest targets which corresponds to reactors,

piping, and tanks within the production unit. Close examination of the image does show the presence of water streams directed into the unit. There does not appear to be any plumes leaving the site.
