Field Report for Airborne Data Collected In Support of US EPA Region 6 South 4 Group Fire 30 November 2019

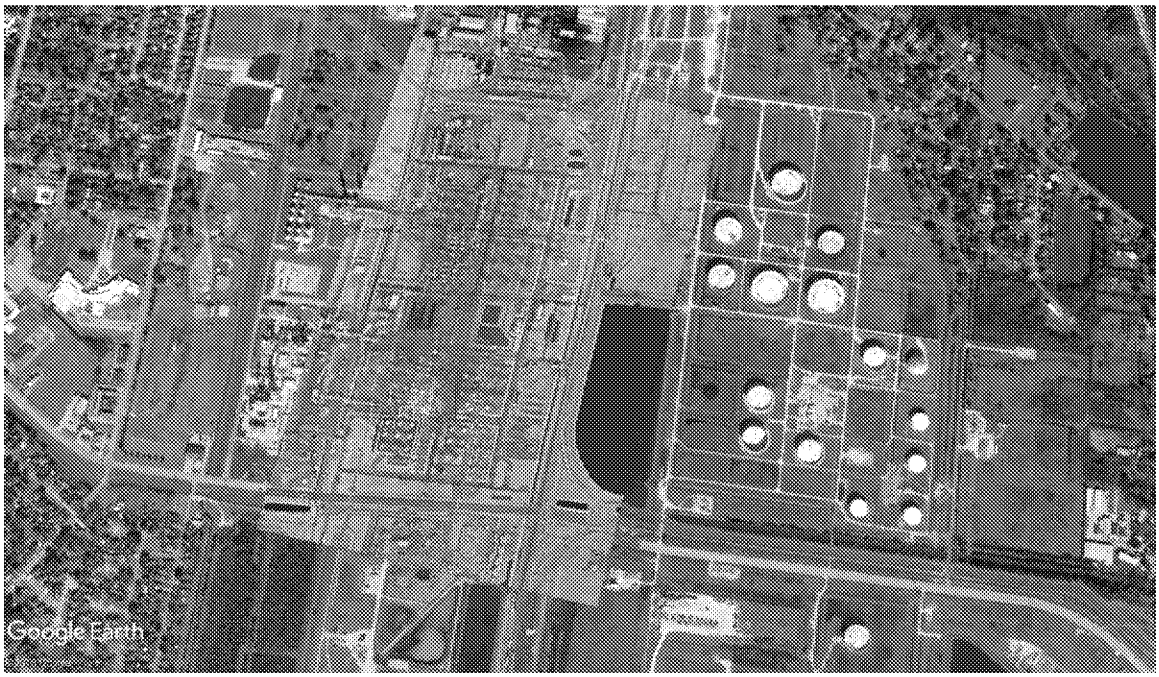
A total of 2 test and 9 data collection passes were made in the proximity of the fire and an infrared line scanner image was generated for each pass. Figure 3 shows a typical 3-band infrared image obtained from data collected for Run 8. This image was generated by flying approximately directly over the facility on a northerly flight path. The color of the image is a result of the blackbody settings and generally shows greatly reduced thermal content from prior flights. Figure 4 shows a close-up of the facility. The white content of the image shows the hottest targets which corresponds to reactors,

piping, and tanks within the production unit. Close examination of the image does show the presence of water streams directed into the unit. There does not appear to be any plumes leaving the site.

Figure 3: – 3 band IR image, Run 8, South 4 Group Fire

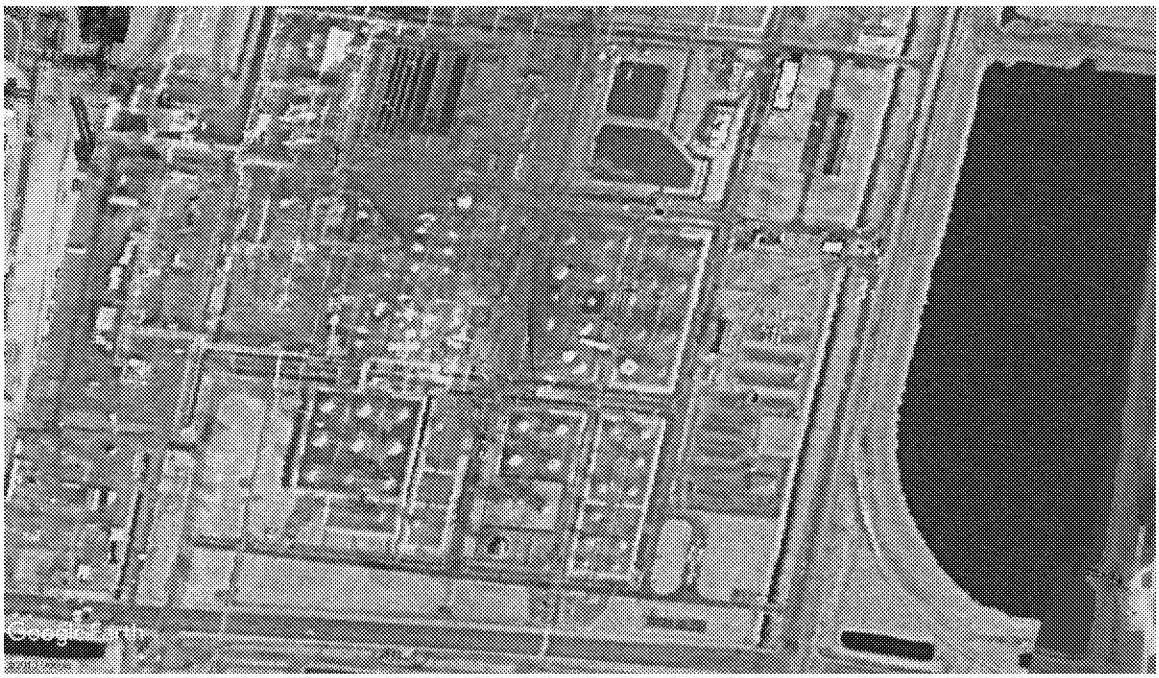
Figure 4: -- 3 band IR Image, Run 8, South 4 Group Fire Closeup

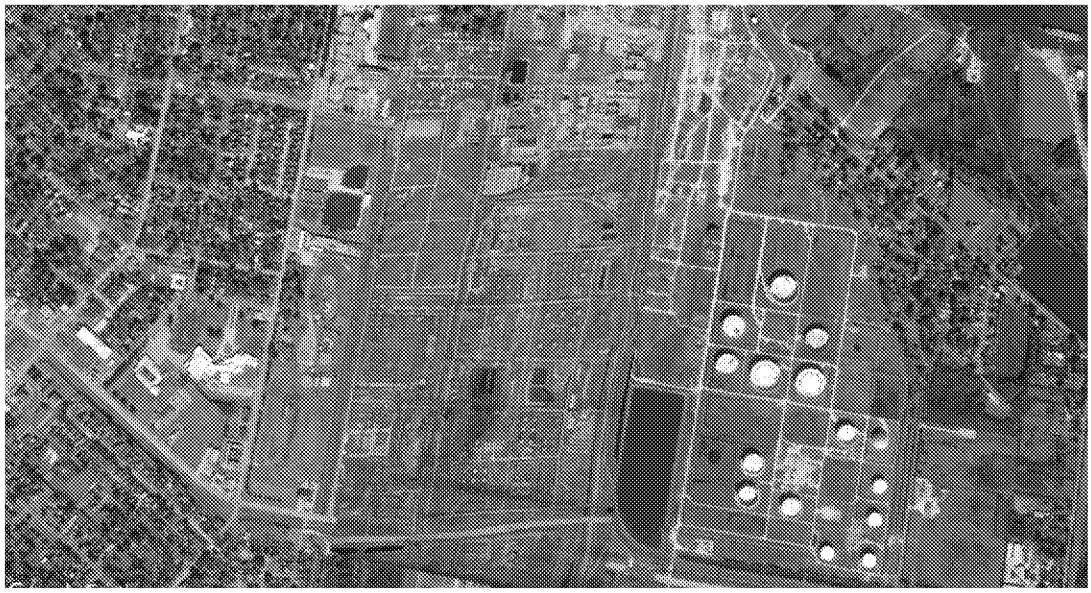
A total of 2 test and 4 data collection passes were made in the proximity of the fire and an infrared line scanner image was generated for each pass. Figure 8 shows a typical 3-band infrared image obtained from data collected for Run 8. This image is somewhat distorted due an extreme crosswind at the flight altitude. Analysis of the image generally shows minimal elevated thermal sources with a cooler signature leaving the site; most likely water spray from the water cannon. No chemical plume can be seen being emitted from the site. Figure 9 was generated by flying the system over the Neches river in an effort to image any oil sheen in the waterway. No sheen was observed. It should be noted that the image features on the east side of the image are clouds below the aircraft.

Figure 8: – 3 band IR image, Flight 7, Run 4, South 4 Group Fire

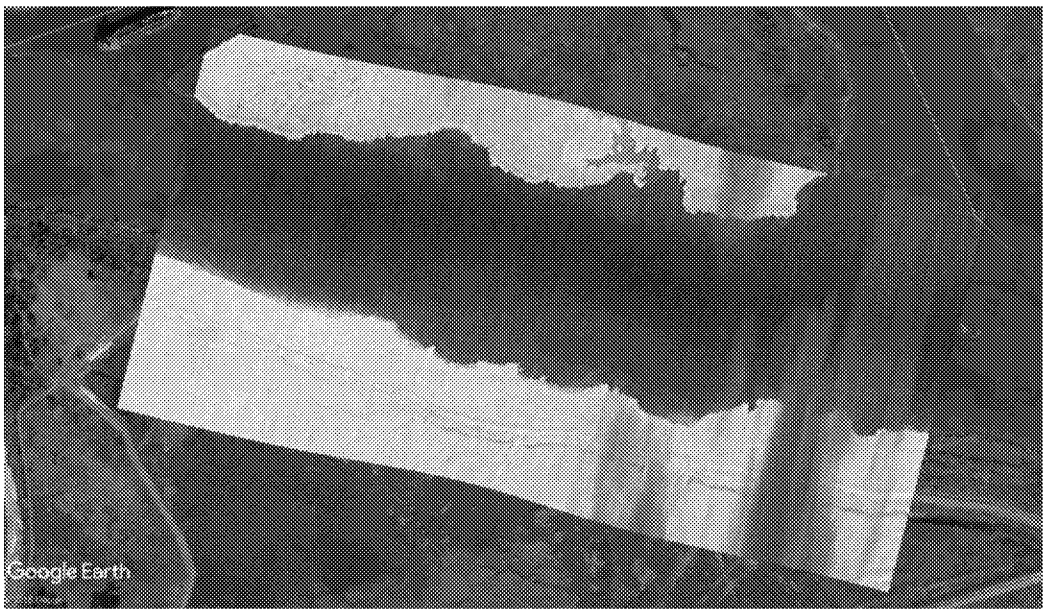
Figure 9: -- 3 band IR image, Flight 7, Run 5, South 4 Group Fire

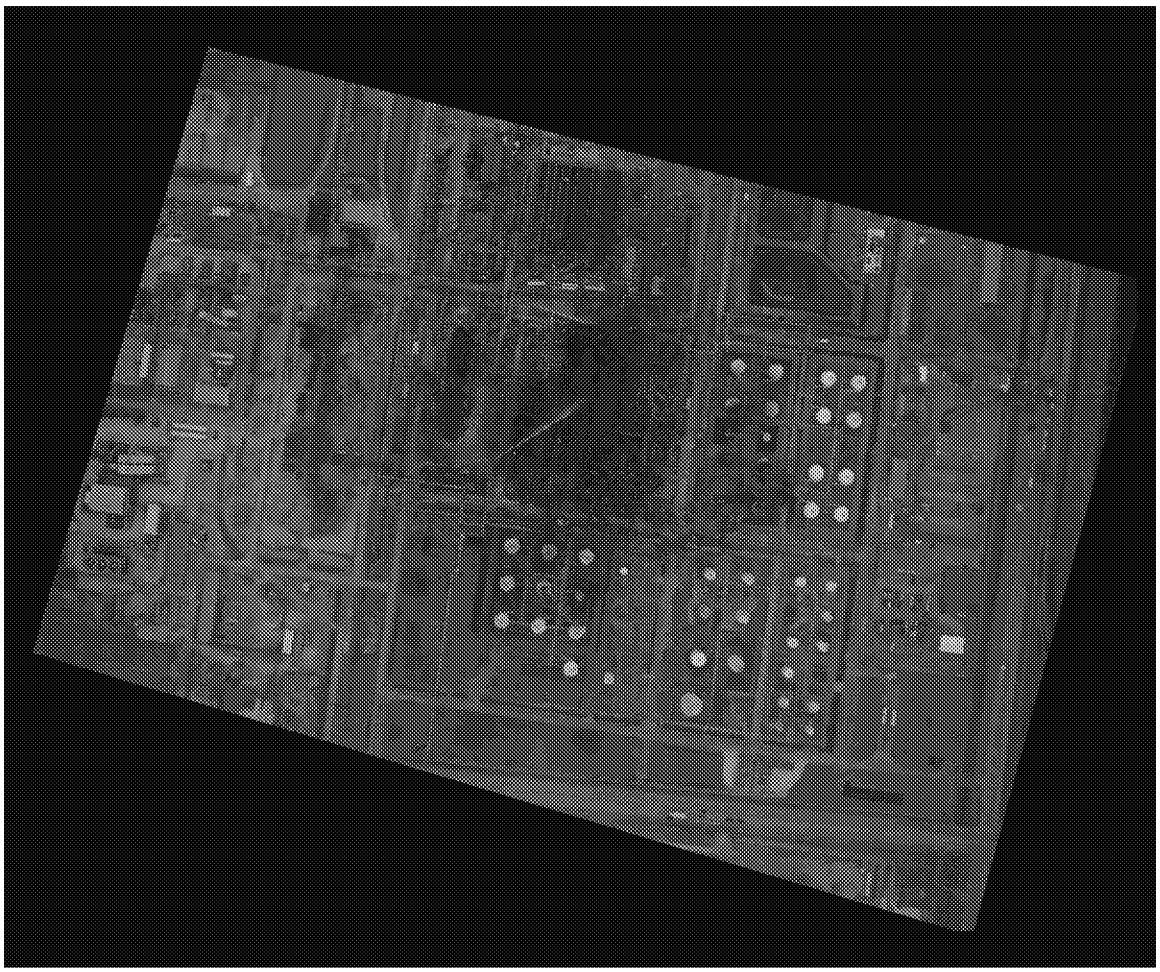
A full set of high resolution aerial digital photography were collected as part of the flight. Figure 10 shows a representative image collected as part of each pass. Due to the time of day and cloud cover the image is dark. As with flight 6, the image shows that little if any smoke is being emitted from the site. At the time of collection, only one water cannon was in operation. Oblique image collection was not possible due to the onset of IFR (low ceiling) conditions.

Figure 10: Aerial Image of the South 4Group Fire
