Field Report for Airborne Data Collected In Support of US EPA Region VI South 4 Group Fire 27 November 2019

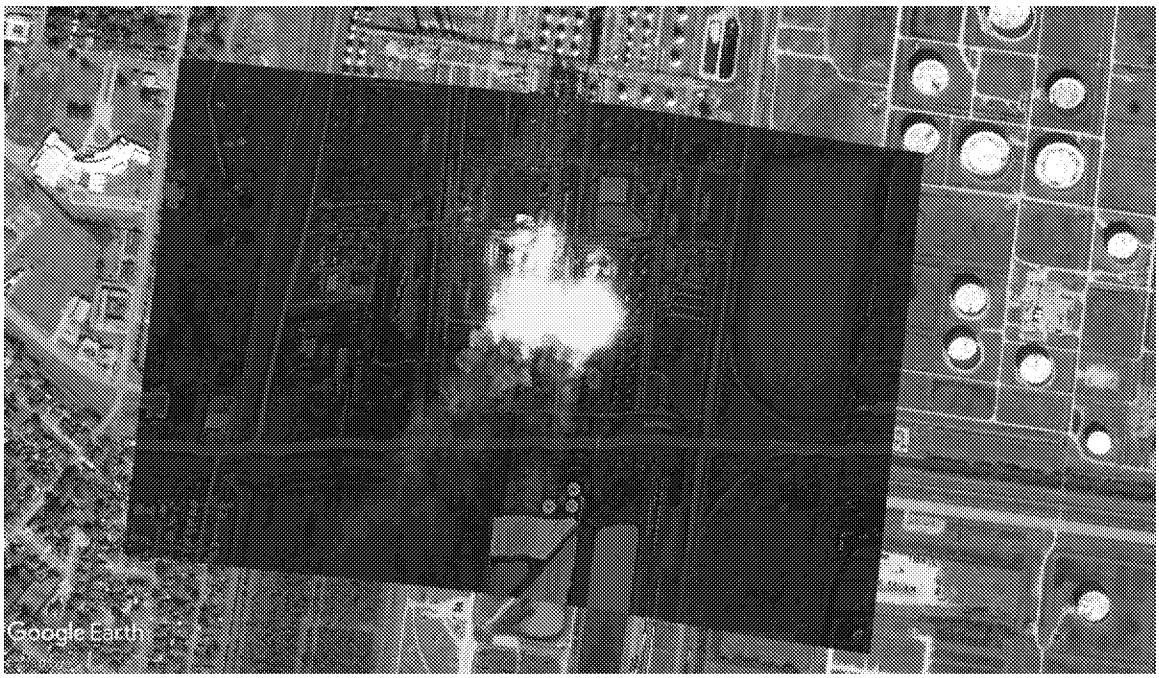
A total of 1 test and 11 data collection passes were made in the proximity of the fire and an infrared line scanner image was generated for each pass. Figure 3 shows a typical 3-band infrared image obtained from data collected for Run 2. This image was generated by flying approximately 100 meters downwind of the facility. The white area within the image is the hot signature of the fire. A thermal plume can be seen being emitted from the active fire location within the facility perimeter with no evidence of a chemical plume being generated by the fire.

Figure 3: – 3 band IR image, Run 5, TPC Group Fire

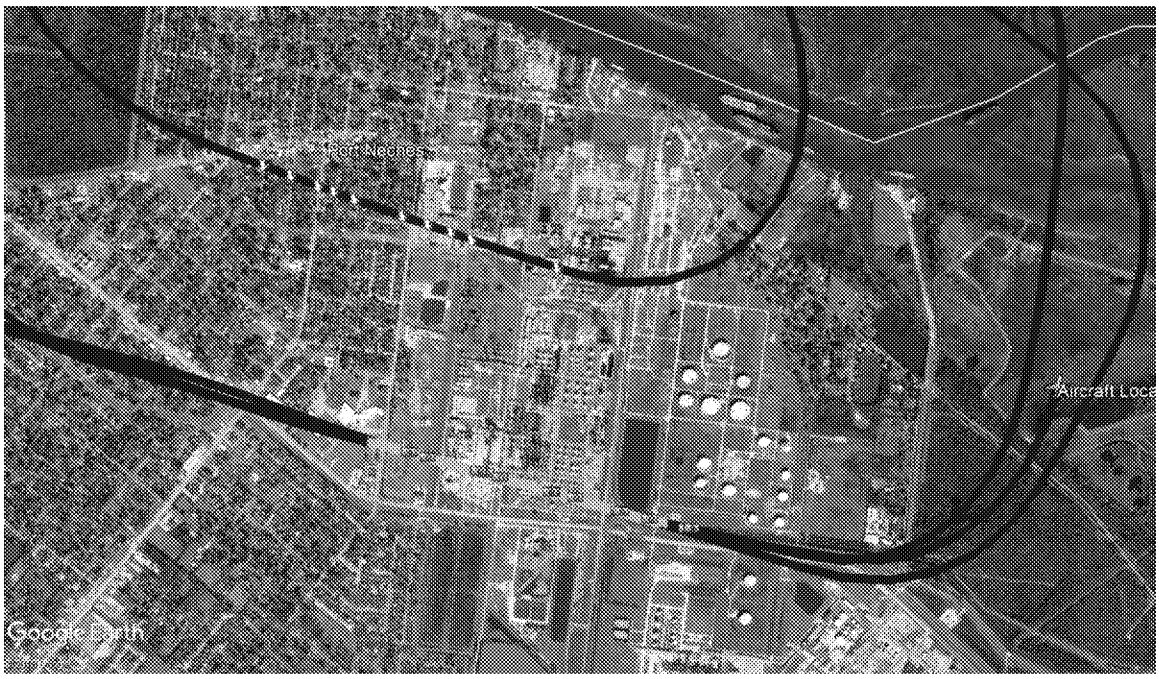
Figure 6: Data collection passes, TPC Group Fire, Port Neches, TX. The blue lines represent the ASPECT flight path, green lines represent when the FTIR was actively collecting data, the yellow icons with star is the centroid of the line scanner image, and the camera icons represent when a photo was taken.

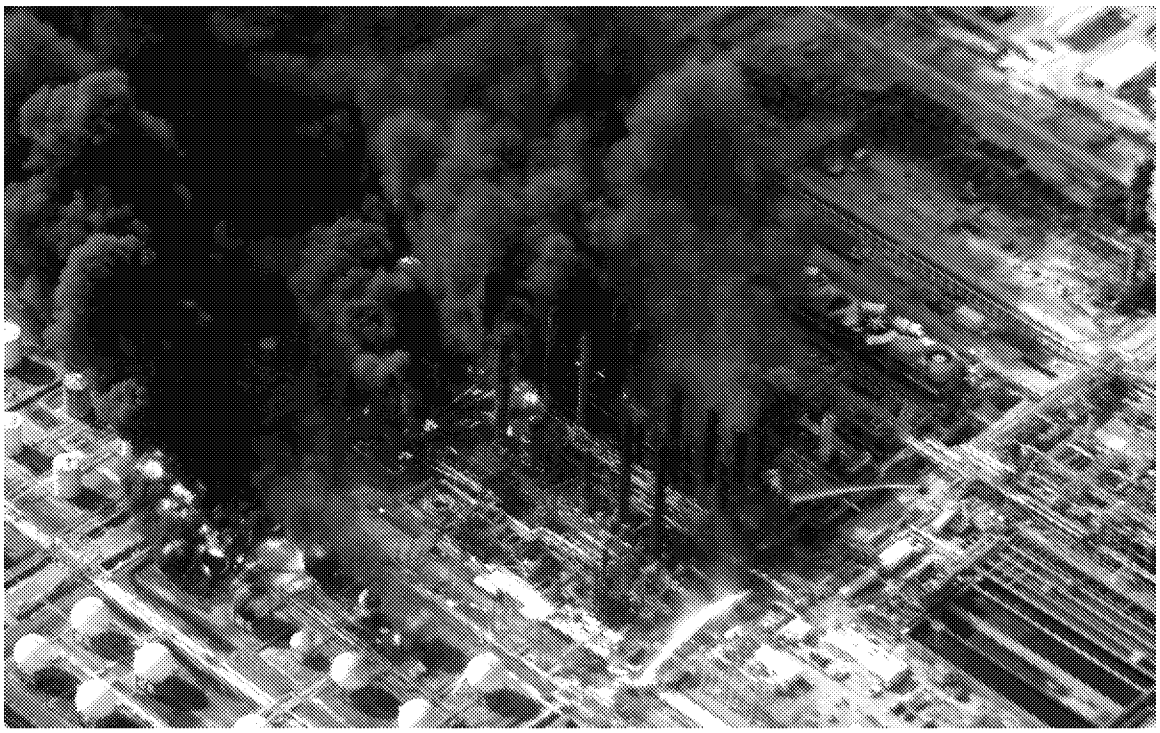
A full set of high resolution aerial digital photography were collected as part of the flight. Figure 8 shows a representative image collected as part of each pass. The image illustrates that several fires continue to burn in the area, but the intensity of the smoke appears to be somewhat diminished. Figure 9 shows confirms that several fires are present with some indication that the number of individual fires has expanded.

Figure 9: Oblique Image of the TCP Group Fire, Flight 2

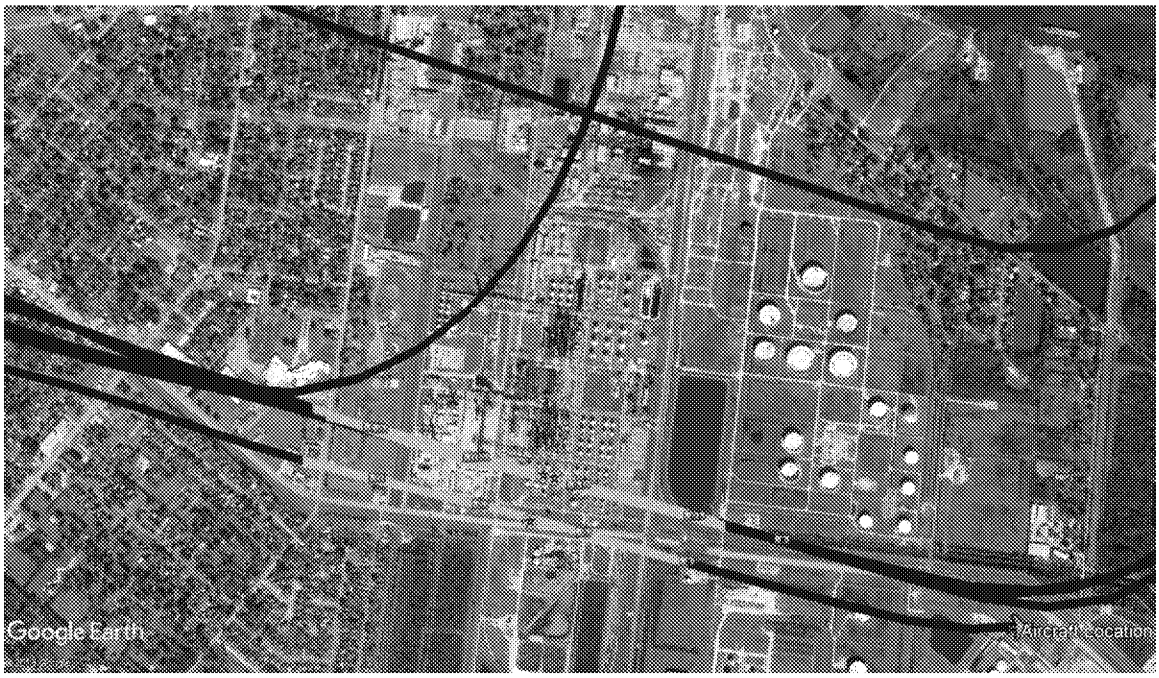
Figure 10: Data collection passes, TPC Group Fire, Port Neches, TX. The blue lines represent the ASPECT flight path, green lines represent when the FTIR was actively collecting data, the yellow icons with star is the centroid of the line scanner image, and the camera icons represent when a photo was taken.

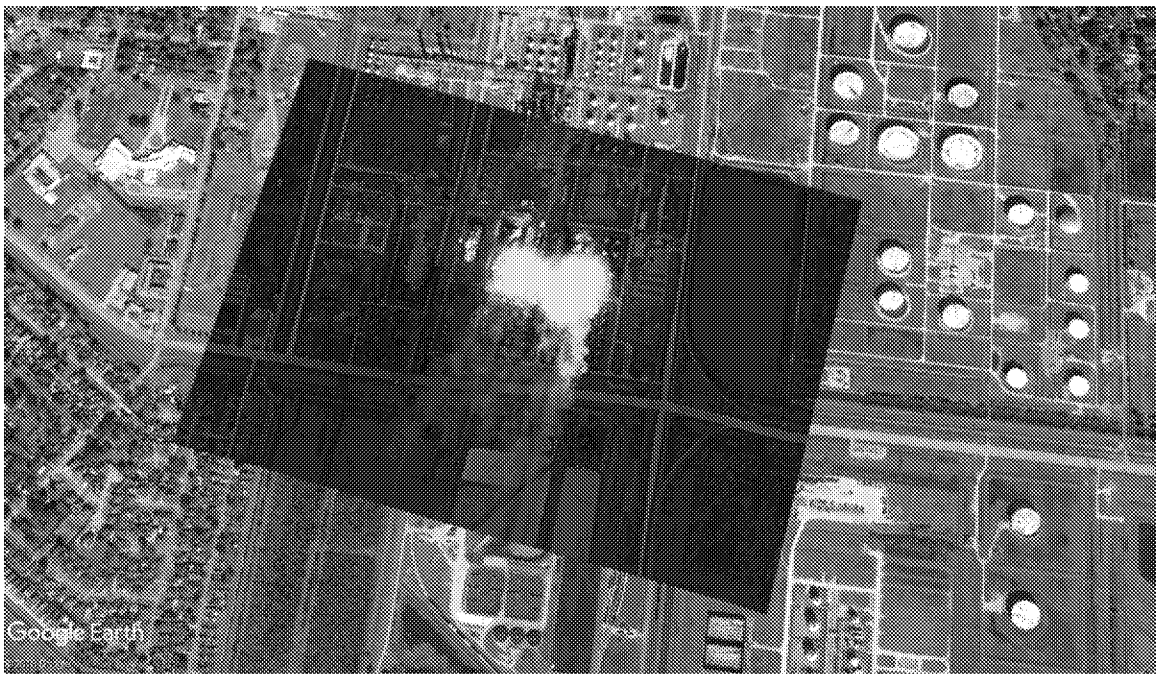
A total of 4 test and 3 data passes were made in the proximity of the fire and an infrared line scanner image was generated for each pass. Analysis of IR imagery generally shows consistency from early flights namely very intense heat within the field of view (figure 11).

Figure 11: – 3 band IR image, TPC Group fire, Flight 3, Run 6
