FULCRUM
environmental consulting

March 23, 2017

RE: Air and Wipe Sampling in Select Areas – March 2017 – Update
Sky Valley Educational Center, 351 Short Columbia Street, Monroe, Washington

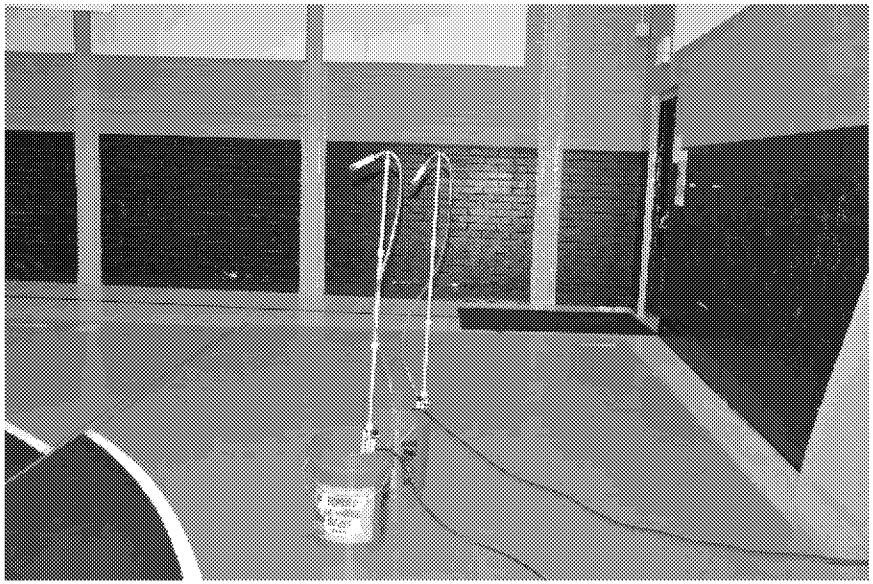
030617-03: Girl's Locker Room.

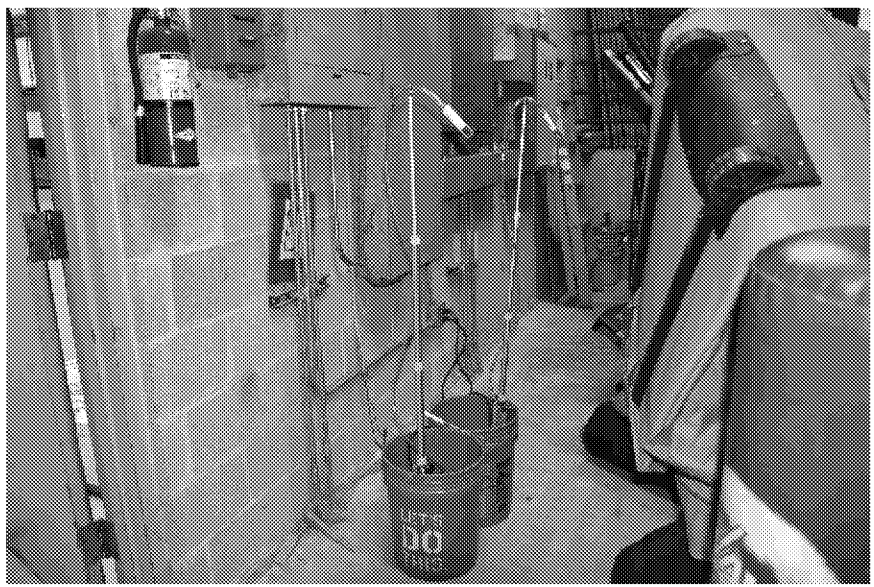
030617-04: Small Gym.

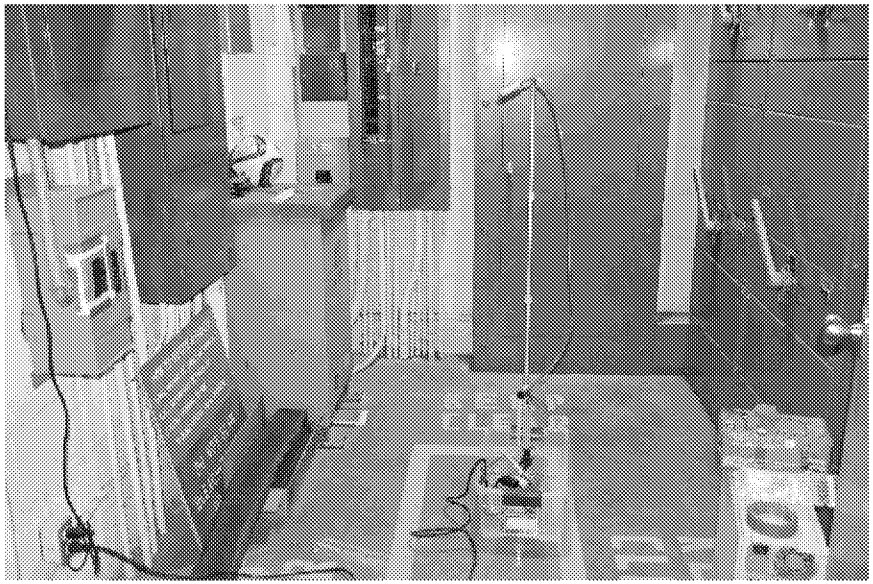
030617-07: CTE Classroom.

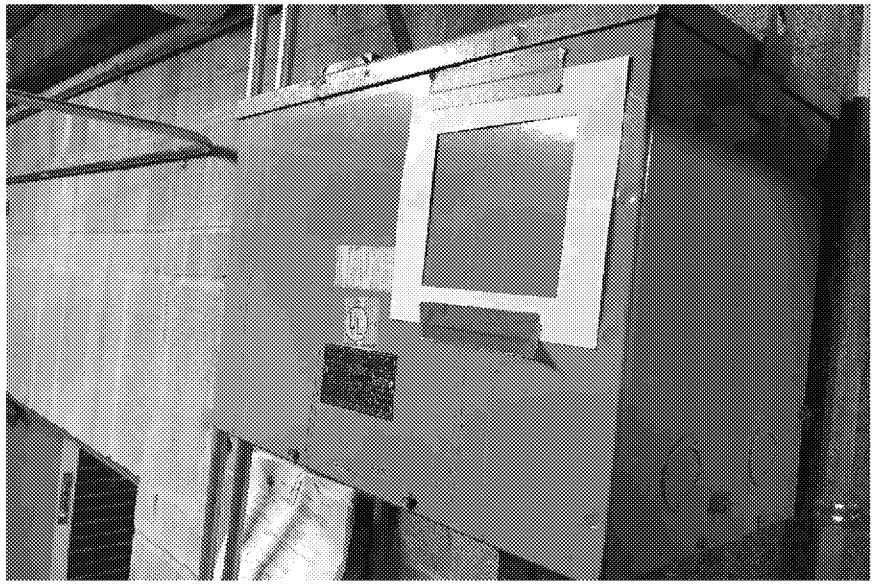
030617-10: West Pod – Mezzanine.

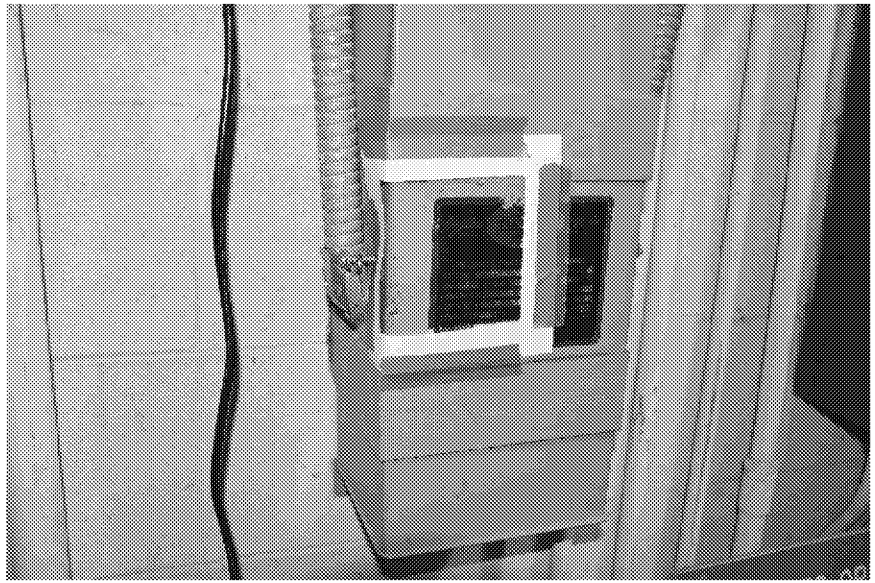
030617-12: Small Gym – Electrical Closet. Sample taken directly below transformer on electrical box.

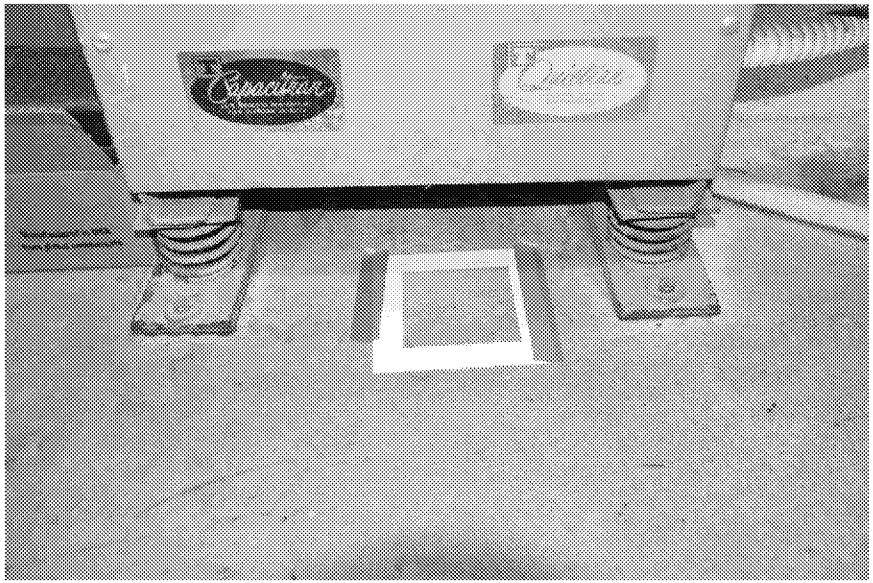
Aroclor 1260 were present in samples from the concrete floors in the Large Gym Electrical Room and the CTE Electrical Room. Both wipe samples were reported with total PCB concentrations below the EPA threshold of 10 micrograms (µg) per 100 cm^2.

Laboratory analysis identified low concentrations of Aroclor 1260 on the concrete floors in the Large Gym Electrical Room and the CTE Electrical Room. While remediation is not required based on the PCB concentrations present, Fulcrum recommends that the District consider implementation of best management practices where practicable and feasible and with the overall goal of reducing the presence of detectable PCBs within the building.

030617-13: Large Gym – Electrical Closet. Sample taken from side of transformer in an area with discoloration.

As such, Fulcrum recommends that the floor surfaces within each of the electrical rooms be cleaned of free dust by trained District staff or a qualified remediation contractor. Furthermore, given the difficulty of cleaning the porous concrete surface, Fulcrum recommends application of an approved paint/sealer to the concrete floors. Given the potential for unpleasant odors associated with the paint/sealer, Fulcrum recommends that application occur as build use and school schedules permit.

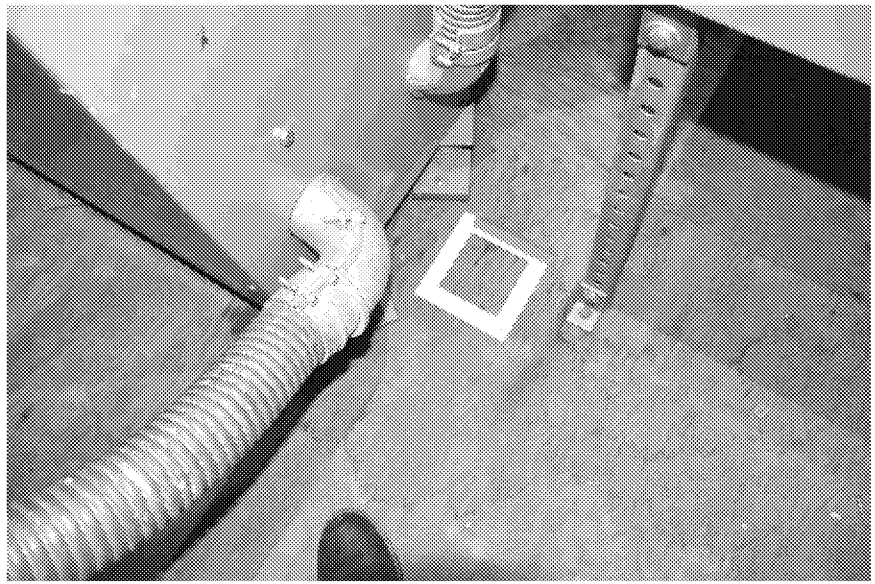
030617-15 & 030617-16: CTE Classroom – Electrical Room. Samples collected from the side of the transformer and directly below transformer on concrete floor.

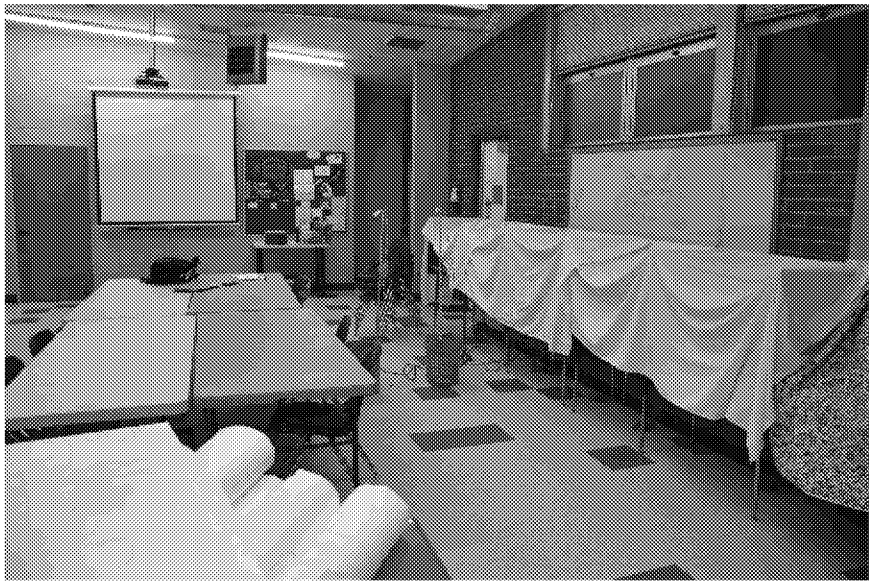
031317-01: CTE Classroom. All windows and doorways remained closed during the sampling process.

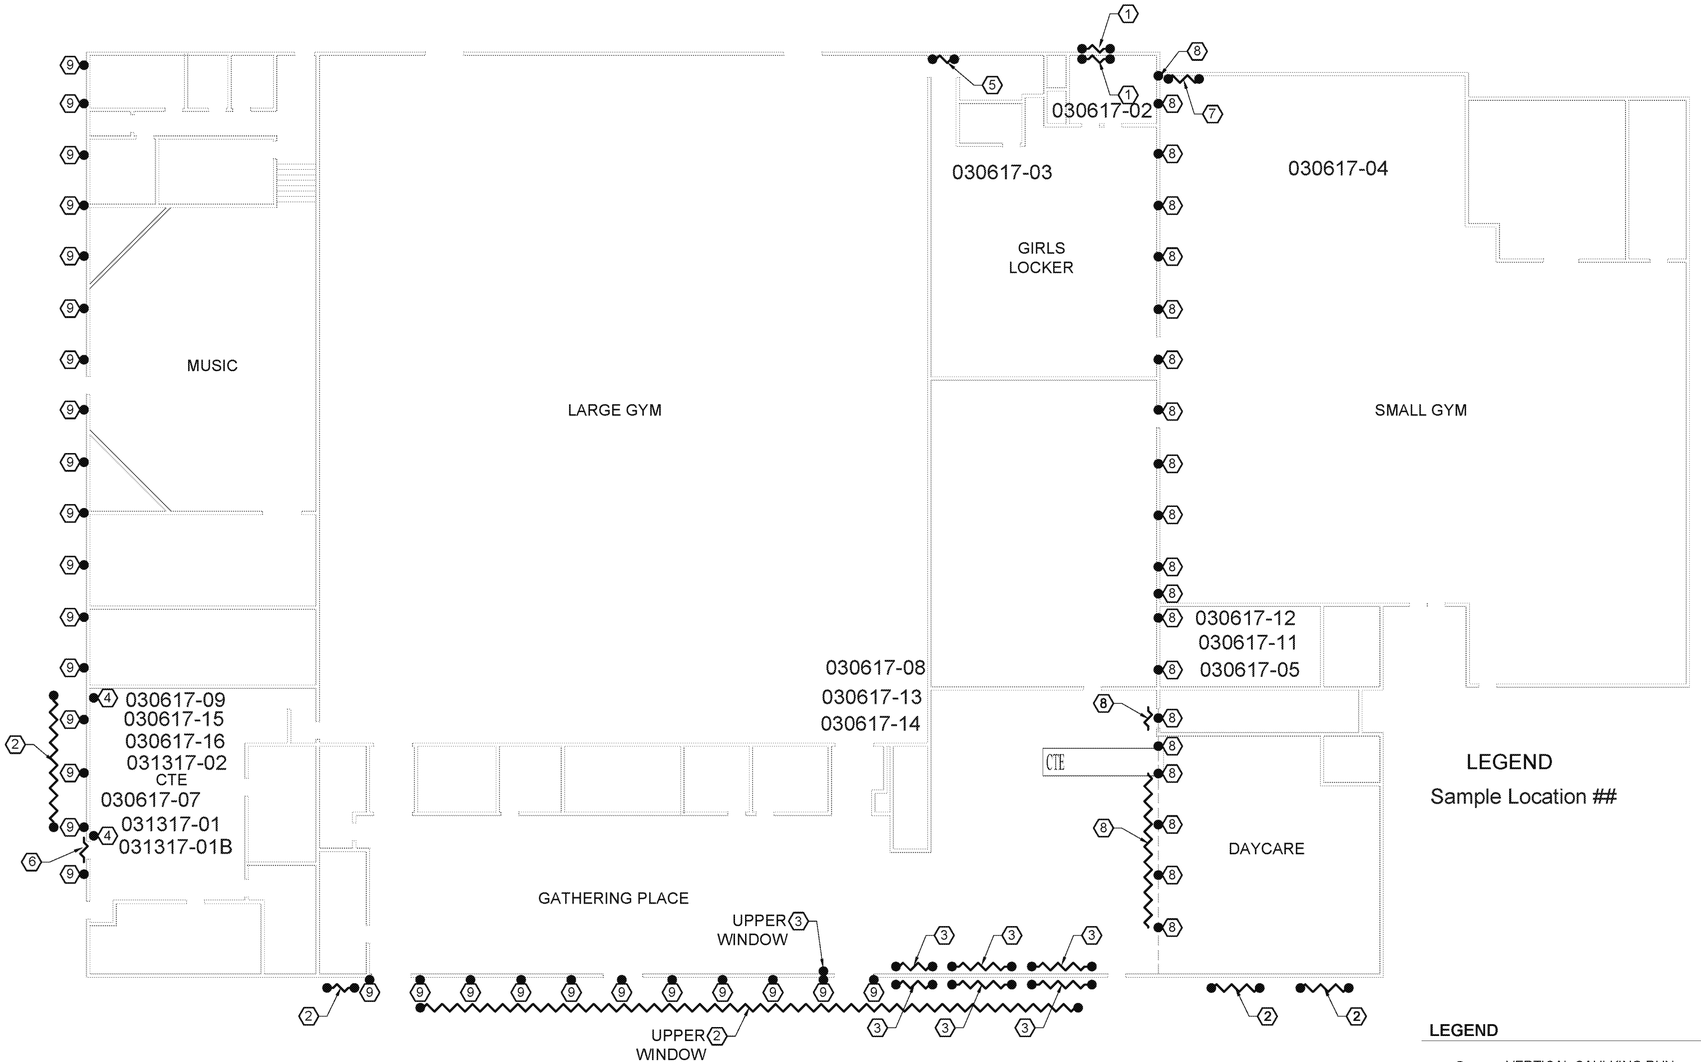
GYM BUILDING CAULKING ABATEMENT PLAN

Drawing does not indicate electrical room

Sample	Location	Air/Wipe	Result
030617-02	Storage in Girls Locker Room	Air	No PCBs Present
030617-03	Girls Locker Room	Air	No PCBs Present
030617-04	Small Gym	Air	No PCBs Present
030617-05	Small Gym Electrical Room	Air	No PCBs Present
030617-06	Gathering Room	Air	No PCBs Present
030617-07	CTE	Air	HOLD / NOT ANALYZED
030617-08	Large Gym Electrical Room	Air	No PCBs Present
030617-09	CTE Electrical Room	Air	SAMPLE DAMAGED / NOT ANALYZED
030617-11	Small Gym Electrical Room	Wipe	No PCBs Present
030617-12	Small Gym Electrical Room	Wipe	No PCBs Present
030617-13	Large Gym Electrical Room	Wipe	No PCBs Present
030617-14	Large Gym Electrical Room	Wipe	Aroclor 1260 at 5.2 ug/100 cm2
030617-15	CTE Electrical Room	Wipe	No PCBs Present
030617-16	CTE Electrical Room	Wipe	Aroclor 1260 at 8.5 ug/100 cm2
031317-01	CTE	Air	No PCBs Present
031317-02	CTE Electrical Room	Air	No PCBs Present

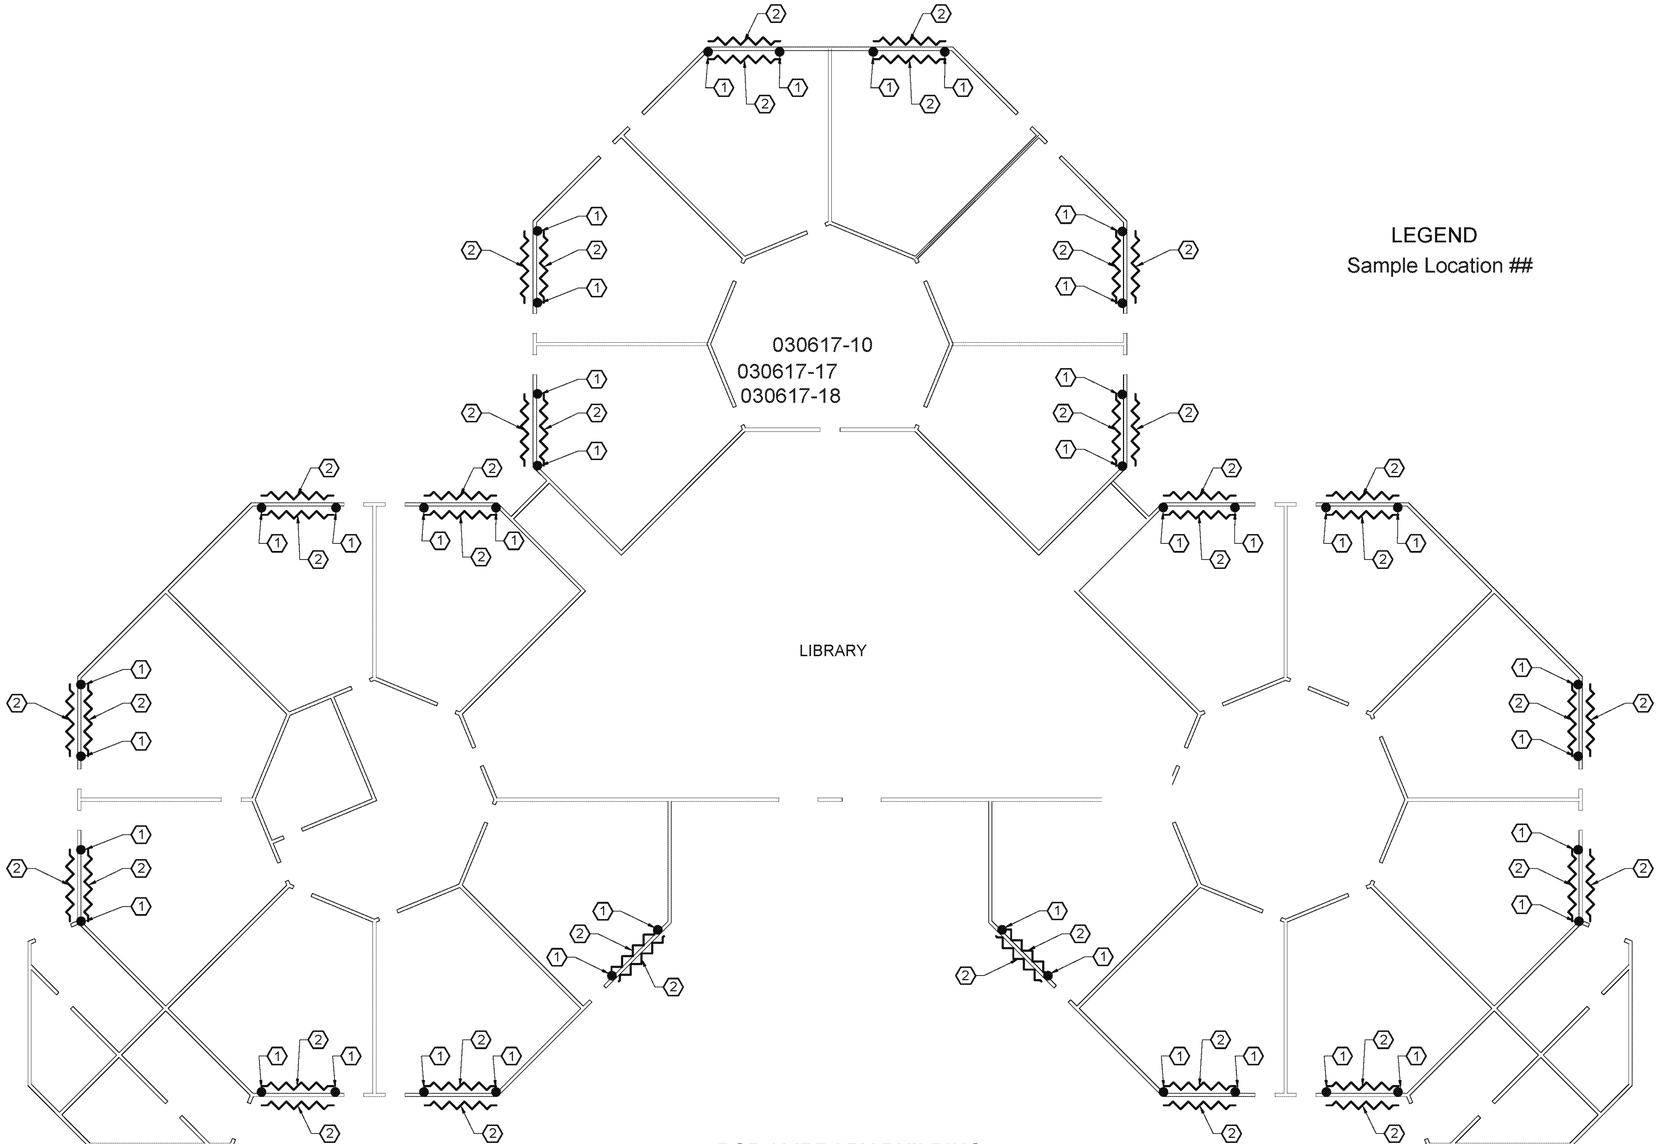
POD/LIBRBAY BUILDING CAULKING ABATEMENT PLAN

Sample	Location	Air/Wipe	Result
030617-10	West Pod Mezzanine	Air	No PCBs Present
030617-17	West Pod Mezzanine	Wipe	No PCBs Present
030617-18	West Pod Mezzanine	Wipe	No PCBs Present

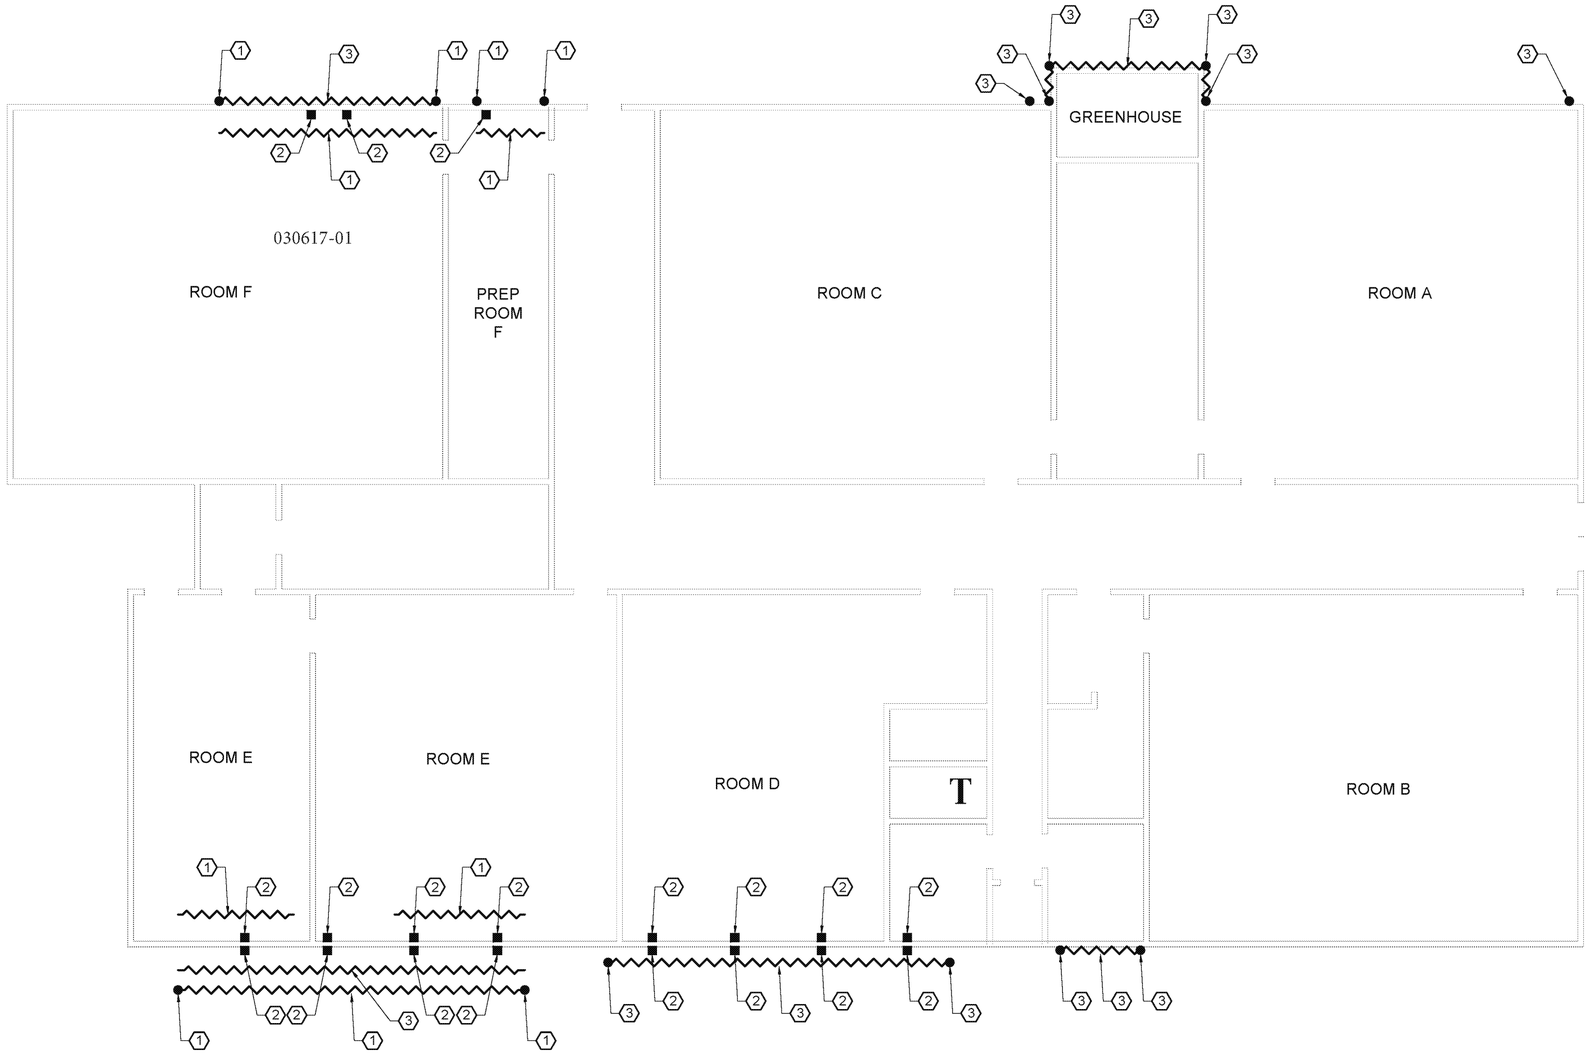
ANNEX BUILDING CAULKING ABATEMENT PLAN

Sample	Location	Air/Wipe	Result
030617-01	Room F, Annex Building	Air	No PCBs Present
