August 23, 2019

RE: 2019 Annual PCB Wipe Testing
Sky Valley Educational Center
351 Short Columbia Street
Monroe, Washington

Table 1 – Wipe Sampling Results

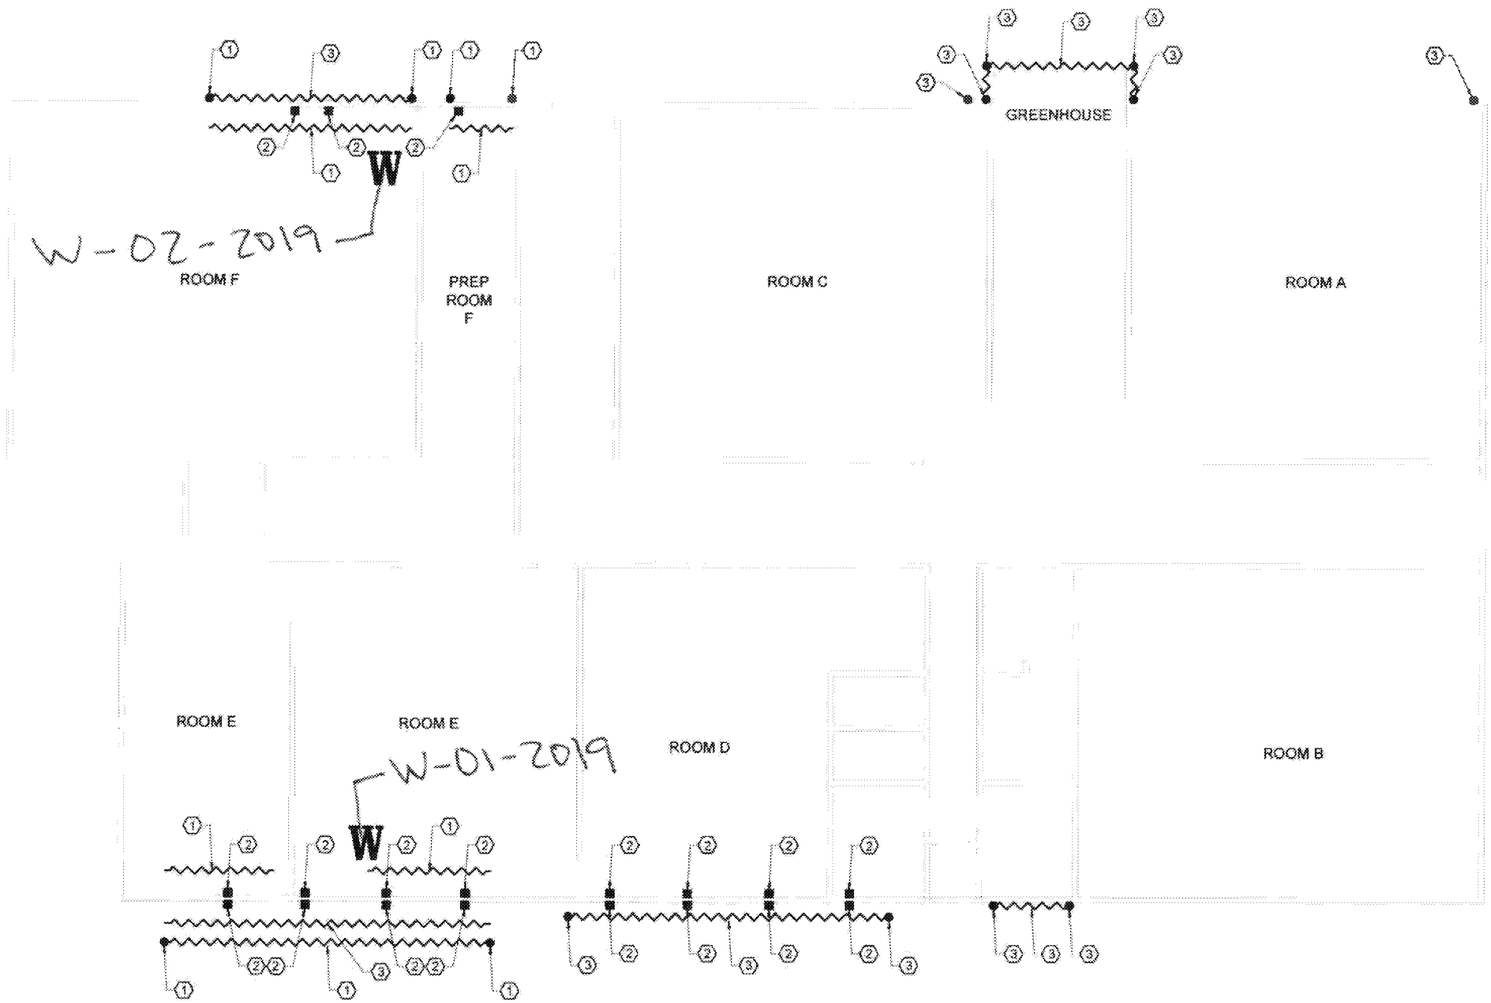
ANNEX BUILDING CAULKING ABATEMENT PLAN

① REMOVE APPROX. 200 LF OF PCB-CONTAINING CAULKING LOCATED ON INTERIOR PERIMETER METAL WINDOW FRAME TRANSITIONS. THIS INCLUDES REMOVAL OF CAULKING WHICH EXISTS ON EXTERIOR METAL WINDOW FRAME TRANSITIONS ON THE NORTH AND SOUTH BUILDING ELEVATION WINDOWS AS SHOWN.

② REMOVE APPROX. 80 LF OF PCB-CONTAINING CAULKING ON WOOD CEILING/SOFFIT BEAMS AT PERIMETER WALL/CEILING TRANSITIONS IN ROOMS E, F AND PREP ROOM F AS SHOWN.

③ REMOVE APPROX. 300 LF OF PCB AND ASBESTOS-CONTAINING TAN CAULKING LOCATED ON VARIOUS VERTICAL AND HORIZONTAL METAL WINDOW FRAME TRANSITIONS ON THE NORTH AND SOUTH ELEVATIONS OF THE ANNEX BUILDING AS SHOWN.

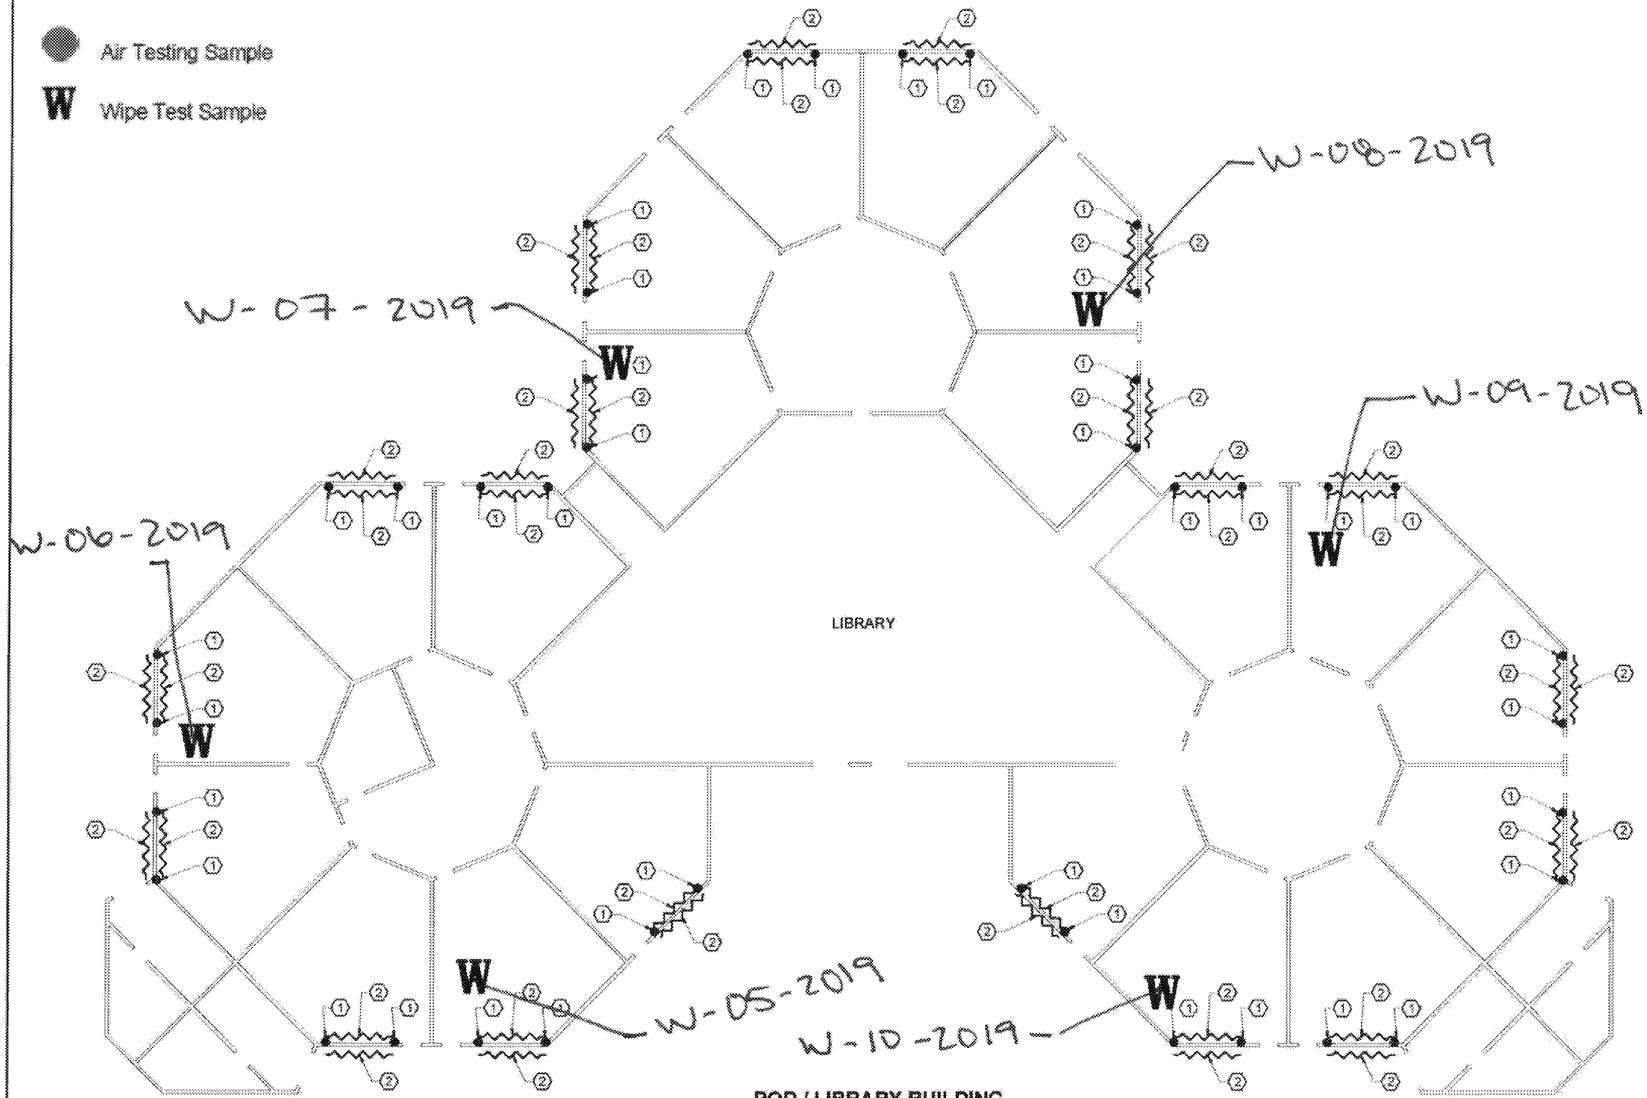
POD/LIBRBAY BUILDING CAULKING ABATEMENT PLAN

1. REMOVE APPROX. 500 LF OF PCB-CONTAINING CAULKING LOCATED ON INTERIOR PERIMETER METAL WINDOW FRAME TO BRICK TRANSITION VERTICALS IN EACH OF CLASSROOMS 1-20 AS SHOWN.
2. REMOVE APPROX. 1,400 LF OF PCB-CONTAINING CAULKING ON THE INTERIOR AND EXTERIOR SIDES OF THE CEMENT ASBESTOS BOARD (CAB) WINDOW INFILL PANELS. THE CAULKING FILLS THE GAP BETWEEN THE METAL WINDOW FRAME AND CAB TRANSITION IN EACH OF CLASSROOMS 1-20 AS SHOWN.

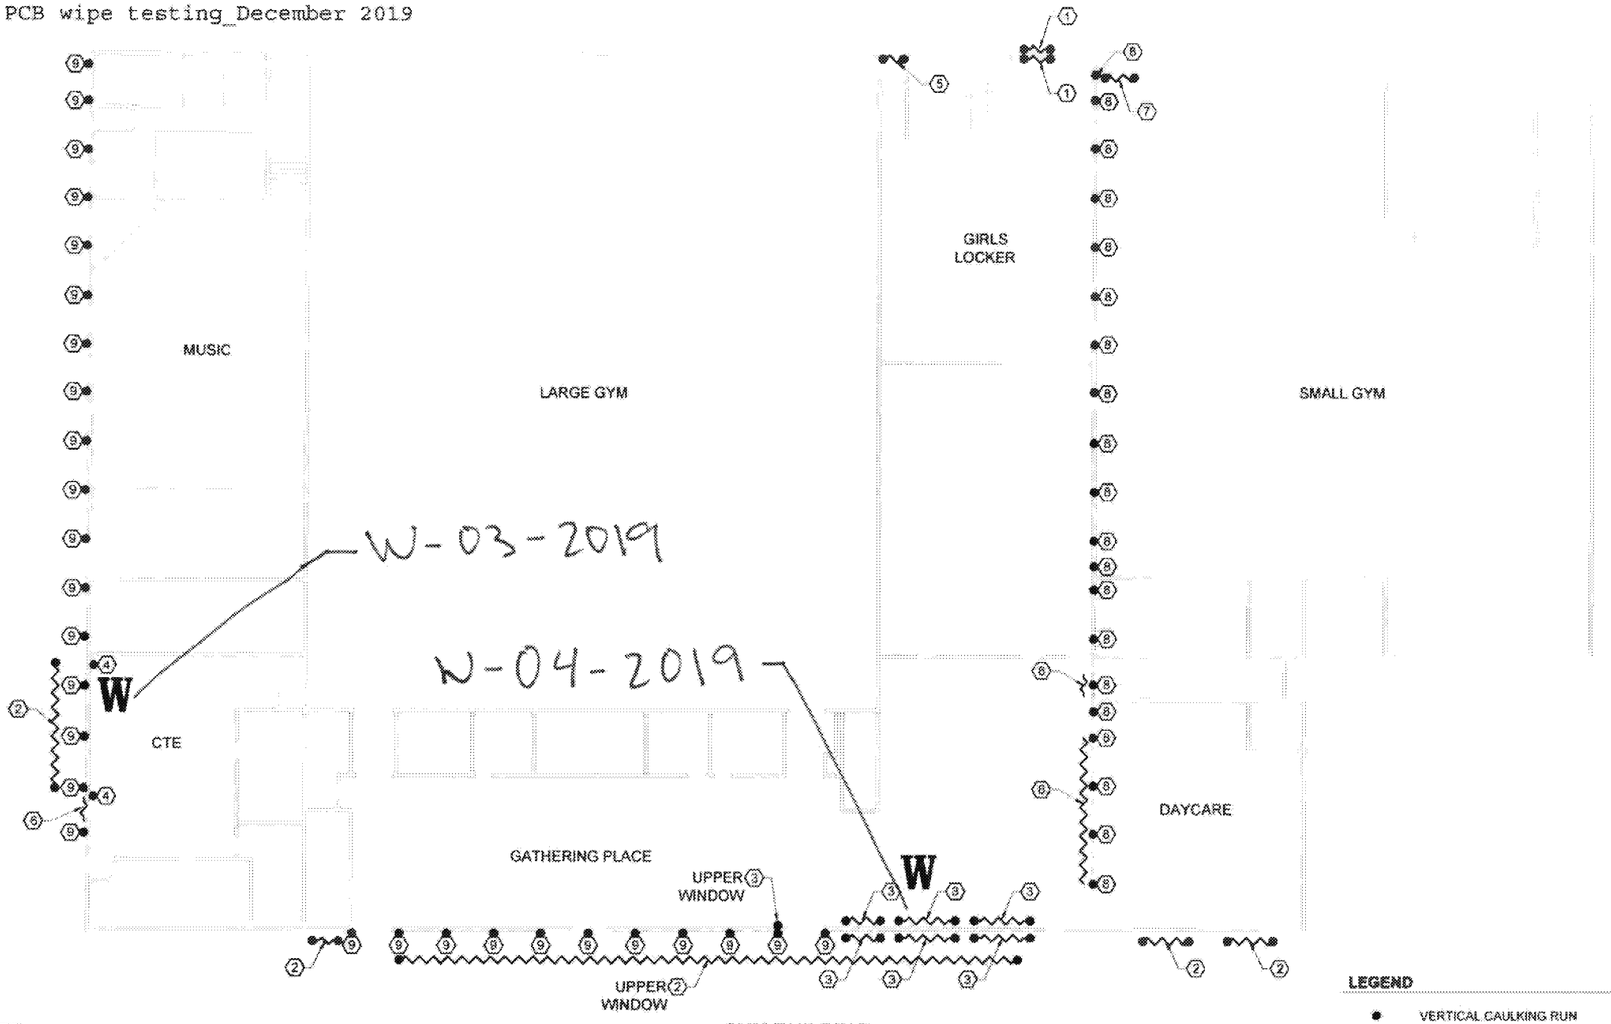
GYM BUILDING
CAULKING ABATEMENT PLAN
SKY VALLEY EDUCATIONAL CENTER

1. REMOVE APPROX. 20 LF OF PCB-CONTAINING CAULKING LOCATED ON THE EXTERIOR AND INTERIOR METAL WINDOW FRAME ON THE GIRLS LOCKER ROOM NORTH PERIMETER WINDOW AS SHOWN.

2. REMOVE APPROX. 300 LF OF PCB-CONTAINING CAULKING ON THE EXTERIOR METAL WINDOW FRAMES ON ALL WINDOWS AT THE SOUTH AND WEST ELEVATIONS OF THE LARGE GYM BUILDING AS SHOWN. THIS INCLUDES CAULKING THAT EXISTS AROUND EACH WINDOW INFILL PANEL METAL FRAME TRANSITION ON THE WEST ELEVATION. THESE INFILL PANELS ARE CEMENT ASBESTOS BOARD.

3. REMOVE APPROX. 40 LF OF PCB-CONTAINING CAULKING LOCATED ON INTERIOR SIDE OF THE THREE LOWER WINDOWS AND THE UPPER WINDOW BANK EAST VERTICAL IN THE GATHERING PLACE AS SHOWN.

4. REMOVE APPROX. 10 LF OF PCB-CONTAINING OF CAULK ON INTERIOR WINDOW FRAME VERTICALS IN THE CTE ROOM AS SHOWN.
5. REMOVE APPROX. 18 LF OF PCB-CONTAINING OF CAULK ON INTERIOR SIDE OF NORTH EXTERIOR GIRLS LOCKER ENTRY DOOR AS SHOWN.

6. REMOVE APPROX. 18 LF OF PCB-CONTAINING OF CAULK ON EXTERIOR SIDE OF NORTH CTE ENTRY DOOR AS SHOWN.
7. REMOVE APPROX. 18 LF OF PCB-CONTAINING OF CAULK ON THE INTERIOR SIDE OF THE NORTHWEST PERIMETER ENTRY DOOR FRAME OF THE SMALL GYM AS SHOWN.

8. REMOVE APPROX. 500 LF OF PCB-CONTAINING CAULKING LOCATED ON ALL VERTICAL STRUCTURAL METAL COLUMN TRANSITIONS THROUGHOUT THE EAST ELEVATION OF THE LARGE GYM AS SHOWN. THIS INCLUDES THE REMOVAL OF ALL CAULKING ON THE INTERIOR DEMISING WALL METAL BEAMS (VERTICAL AND HORIZONTAL) BETWEEN THE DAYCARE AND THE GATHERING PLACE/CAFETERIA AS SHOWN. THE CAULKING IS HEAVILY PAINTED THROUGHOUT THE WORK SCOPE AREA.

9. REMOVE APPROX. 780 LF OF PCB-CONTAINING CAULKING LOCATED ON ALL EXTERIOR VERTICAL STRUCTURAL METAL COLUMN TRANSITIONS THROUGHOUT THE LOWER WEST AND SOUTH ELEVATIONS OF THE LARGE GYM BUILDING AS SHOWN.

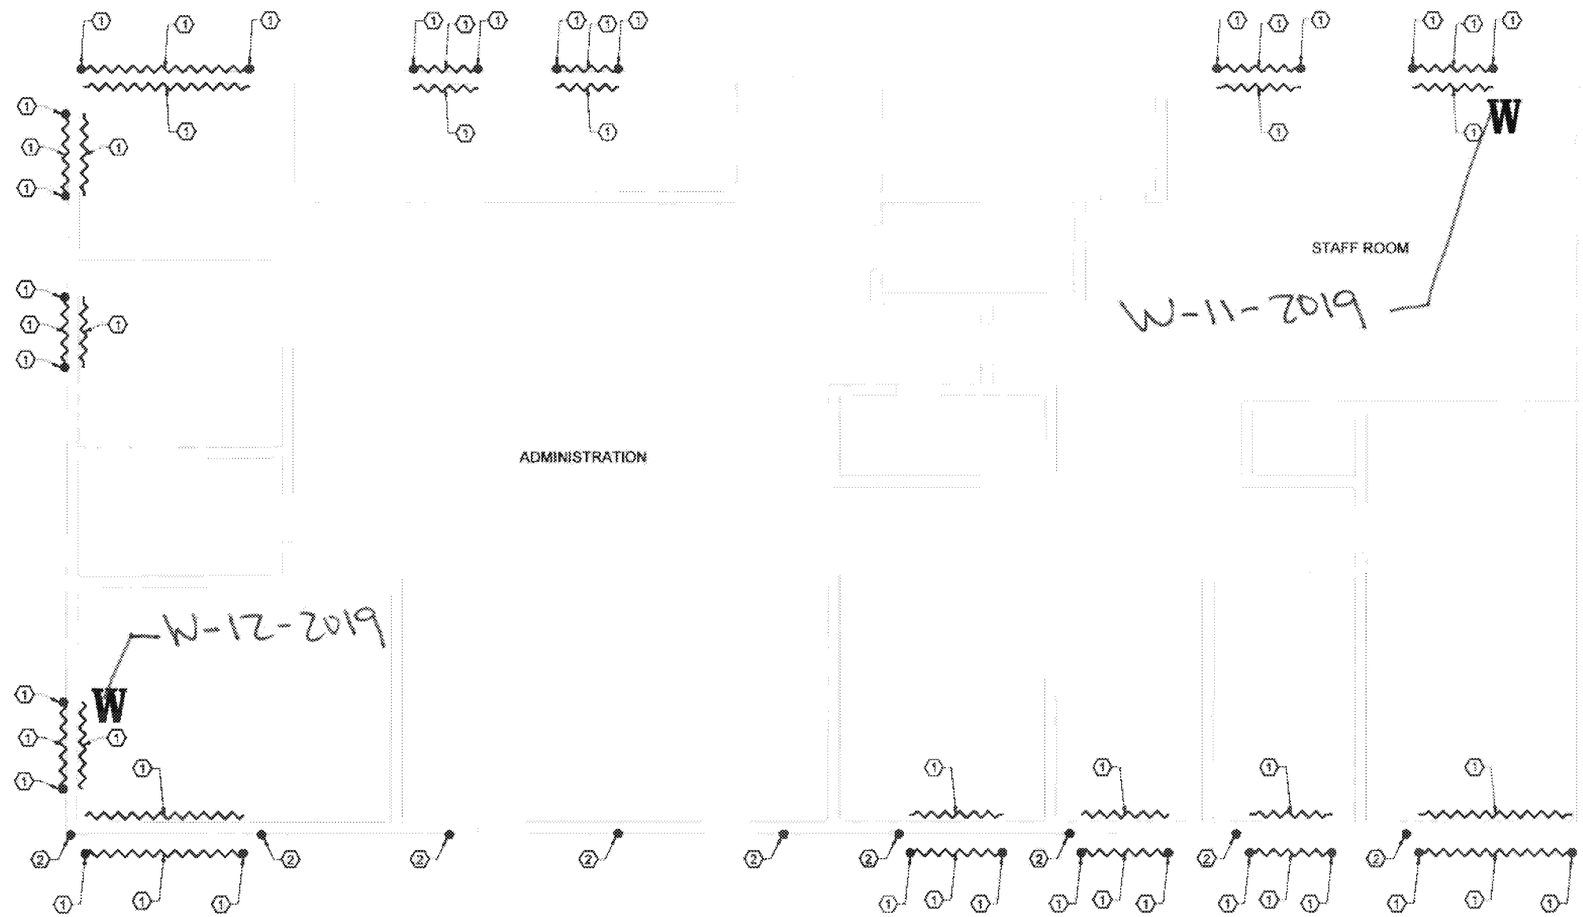
ADMIN BUILDING
CAULKING ABATEMENT PLAN
SKY VALLEY EDUCATIONAL CENTER

① REMOVE APPROX. 400 LF OF PCB-CONTAINING CAULKING LOCATED ON ALL INTERIOR METAL WINDOW SILL TRANSITIONS AND ALL EXTERIOR METAL WINDOW FRAME TRANSITIONS THROUGHOUT THE ADMINISTRATION BUILDING AS SHOWN.

② REMOVE APPROX. 175 LF OF PCB-CONTAINING CAULKING LOCATED ON ALL EXTERIOR VERTICAL STRUCTURAL METAL BEAM TRANSITIONS THROUGHOUT THE ADMINISTRATION BUILDING AS SHOWN.
