RE: PCB Monitoring
Sky Valley Educational Center – Administration Building
351 Short Colombia Street
Monroe, Washington

PCB TESTING PLAN
SKY VALLEY EDUCATIONAL CENTER
351 SHORT COLUMBIA STREET, MONROE, WASHINGTON

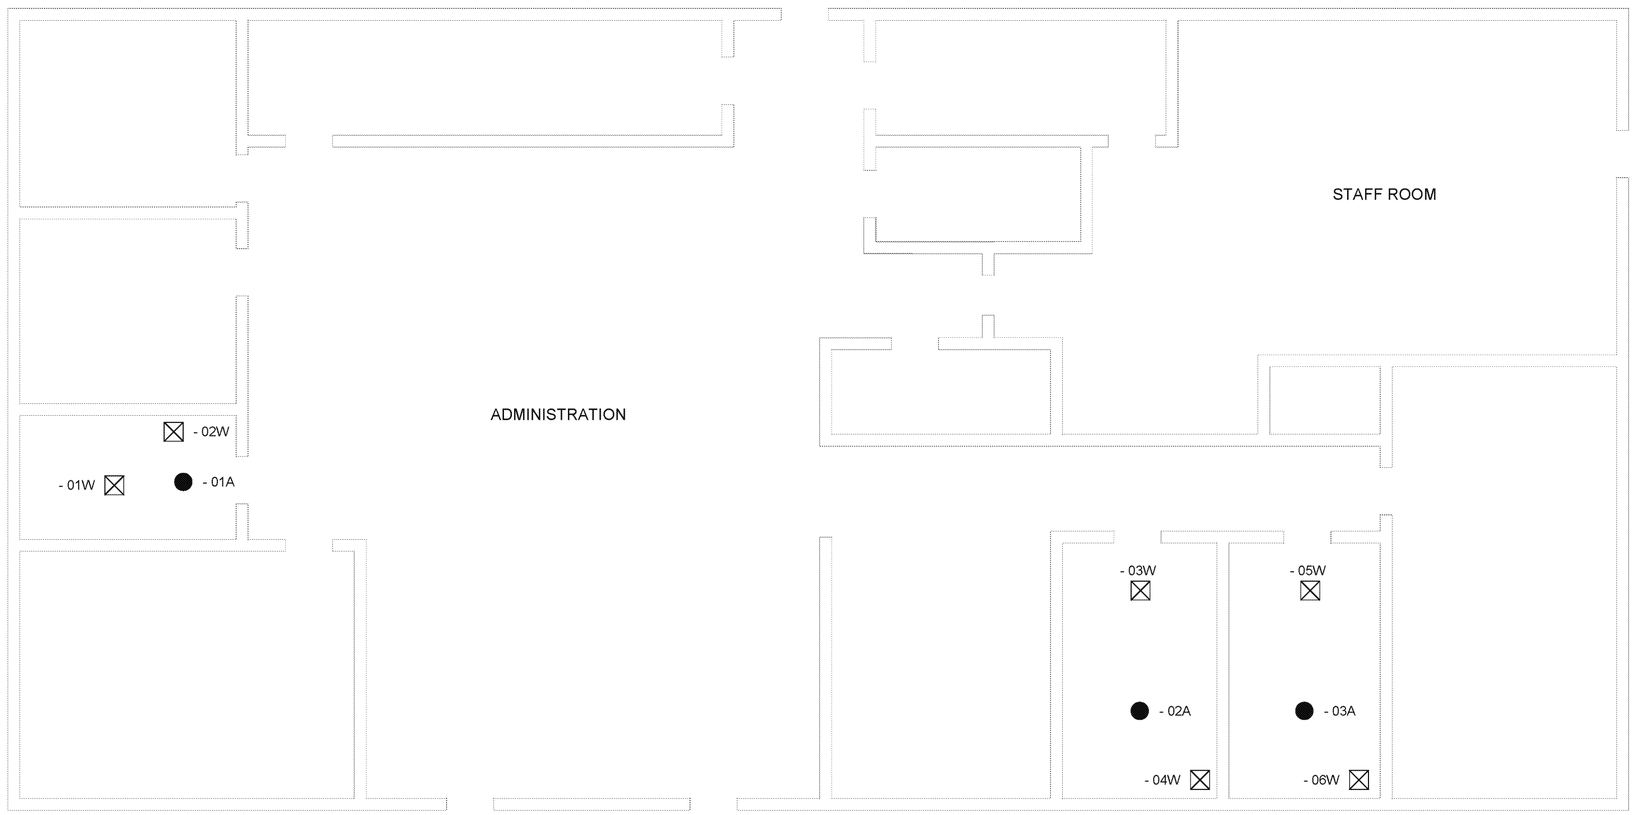
ADMINISTRATION BUILDING
NOT TO SCALE

PBS collected indoor air samples at three (3) locations within the Administration Building. These include the Storage/Server, West Office and East Office. See attached sample location diagram. The PCB air samples were collected using the Low Volume Polyurethane Foam Sampling Method. This method uses a vacuum pump with a glass tube that is fitted with a polyurethane foam (PUF) plug and no pre-filter. The PUF tube was pre-assembled and provided by Eurofins Test America in Sacramento, California. The air pump is calibrated before and after testing with a pre-calibrated rotameter. The rotameter is calibrated annually with a primary standard. PBS personnel wore disposable nitrile gloves to protect against cross-contamination between samples. The samples were labeled with unique identification numbers, packaged and delivered with chain-of-custody documentation to Eurofins Test America. The samples were analyzed for PCBs using EPA Method T0-10A. Field Blanks (negative controls) were collected and included with air samples that were sent to the laboratory. A total of two (2) field blanks were collected during this activity. "Blanks" are unused PUF tubes that were handled similarly to all

PCB Surface Wipe Samples
PBS collected six (6) surface wipe samples in the same three (3) locations as identified above. See attached sample location diagram. The PCB surface sampling was performed using the wipe sampling method in 40 CFR Part 761. This method uses a gauze pad wetted with hexane and placed in a glass jar. The sample media was provided by ALS Laboratories. The hexane wetted gauze pad is wiped over a 100 cm^2 area using a disposable template as a guide and then placed in a glass jar. PBS personnel wore disposable nitrile gloves to protect against cross-contamination between samples. A total of two (2) field blanks were collected during this activity. The wipe samples were collected to determine the presence of PCB's. The samples were labeled with unique identification numbers, packaged and delivered with chain-of-custody documentation to ALS Laboratories. The samples were analyzed by NIOSH Method 5503 for PCBs.

Based on laboratory results of the air and surface wipe samples, no detectable PCBs were found in the locations tested.
