PCB ABATEMENT CLOSEOUT SUMMARY REPORT

SKY VALLEY EDUCATION CENTER
351 Short Columbia Street
Monroe, Washington

October 2016
PBS Project # 41373.000

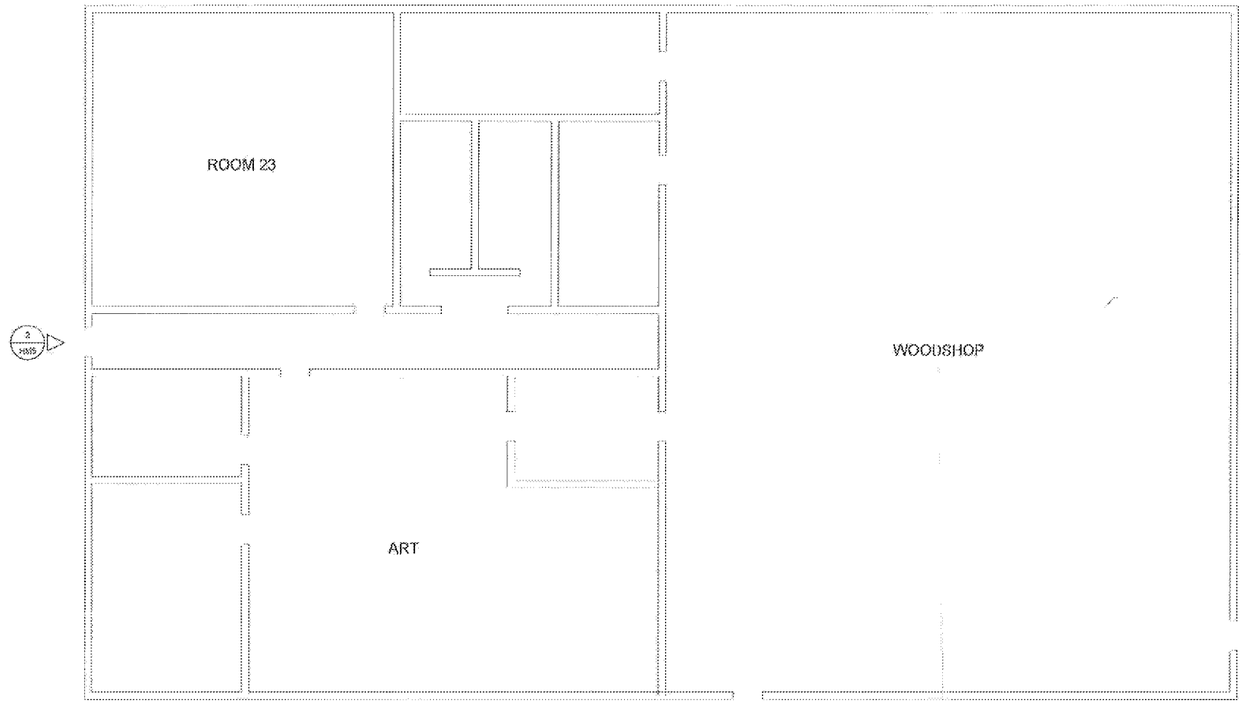
TECHNOLOGY BUILDING
NOT TO SCALE

visually cleared 8/30/16
44in x 2 = 88in
21in x 2 = 42in
130 in = 10.8 ft

~~60~~ 50 LF
Total

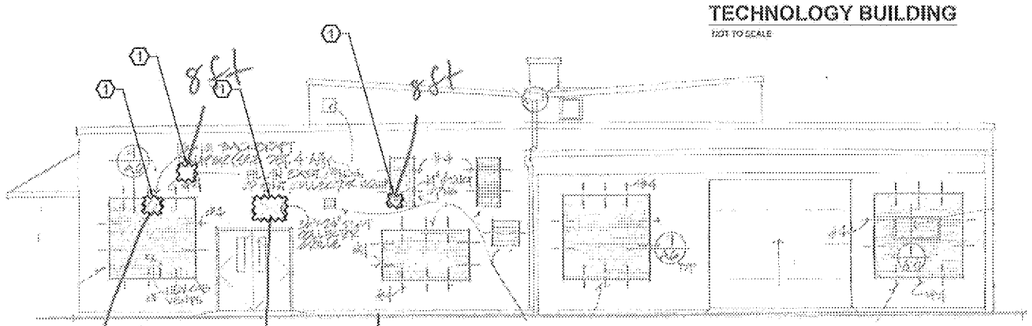
1 TECHNOLOGY BUILDING EAST
NOT TO SCALE

10ft
cleared 8/30/16
3ft x 4 = 12ft

1. REMOVE APPROX. 60 LF OF PCB-CONTAINING CAULKING LOCATED ON EXTERIOR LOUVERS, VENTS AND DUCTING ON METAL TRANSITIONS ON THE WEST AND EAST EXTERIOR ELEVATIONS OF THE TECHNOLOGY BUILDING AS SHOWN.

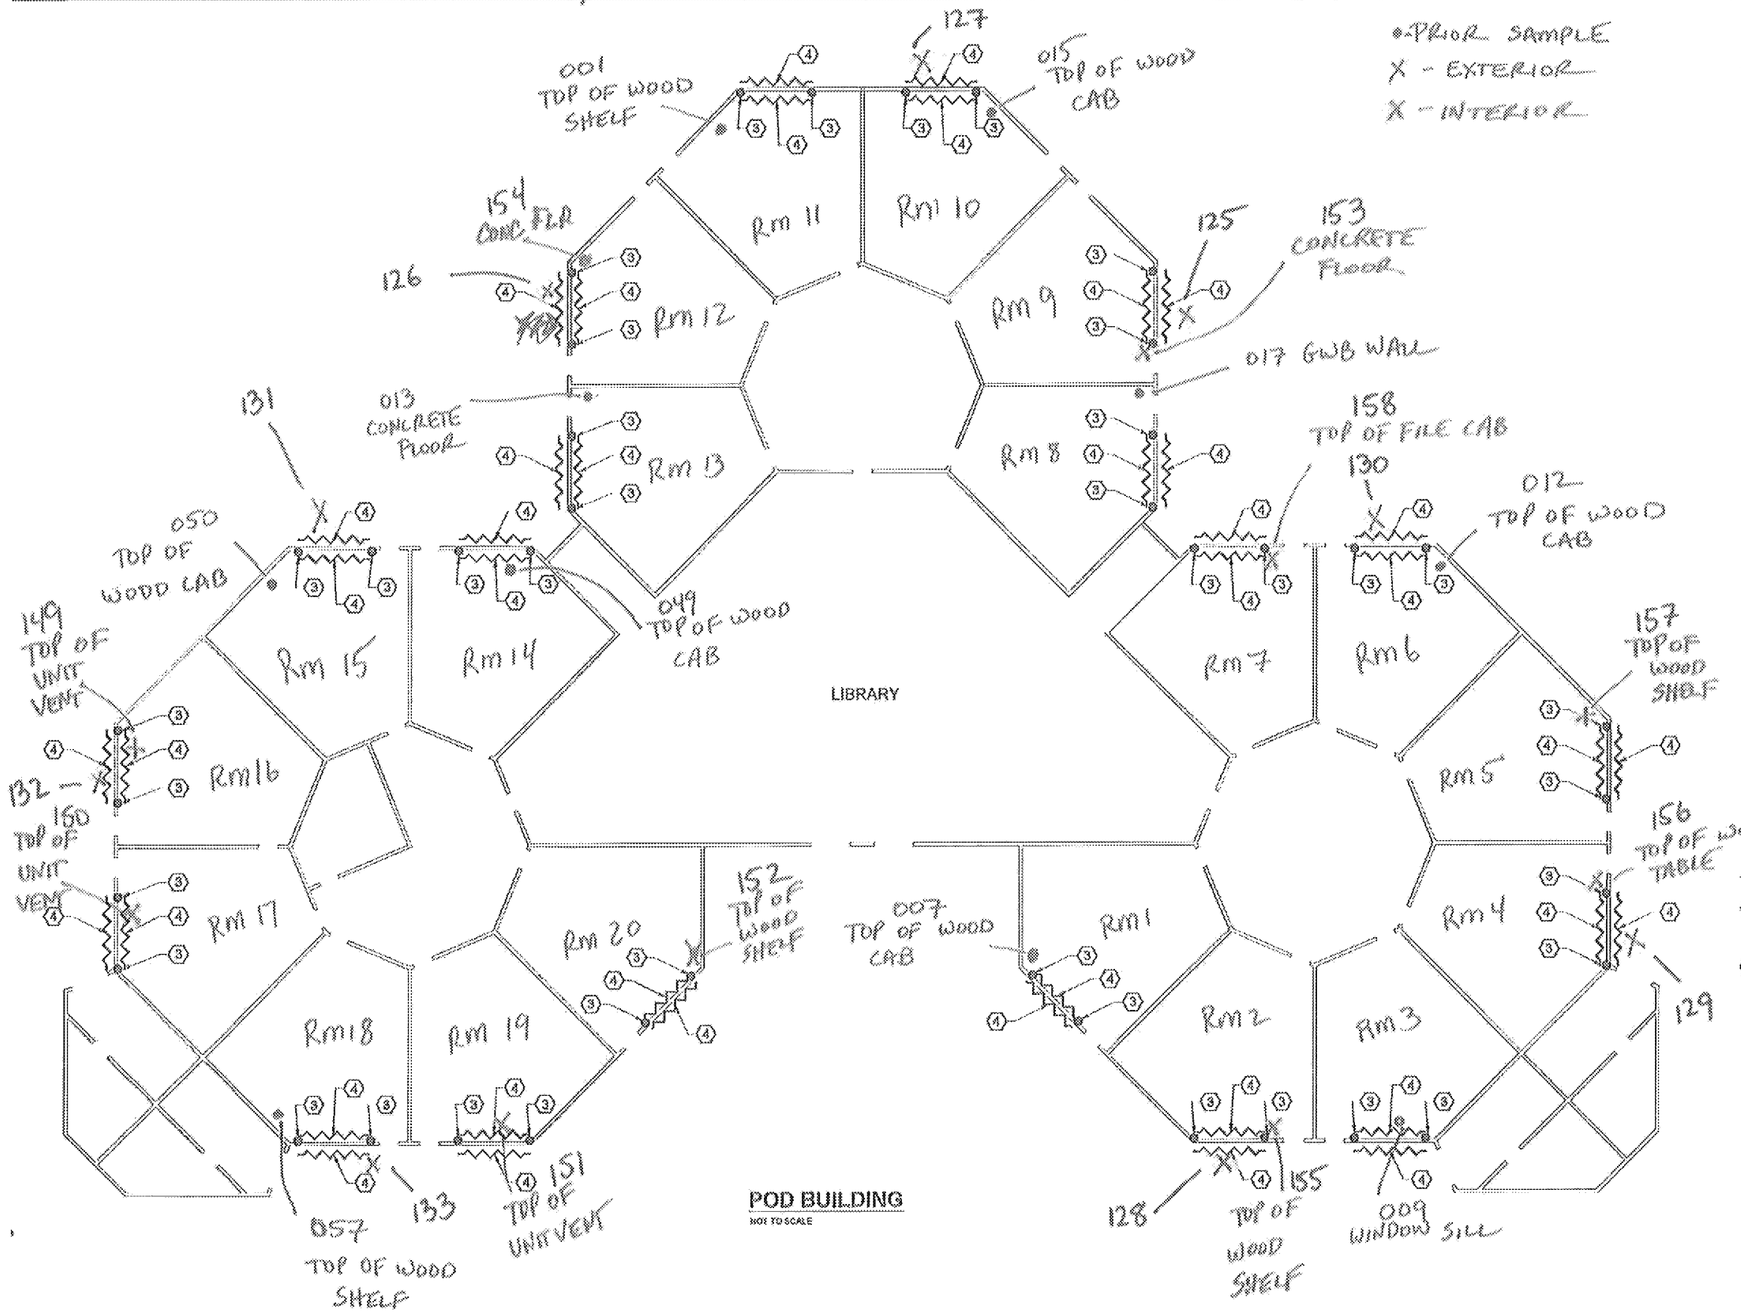
POD BUILDING
NOT TO SCALE

Sample ID	Location	Analyte	Result (ug/100 cm2)
-100-PCB-W	Room D Contaminated vinyl floor tile	Aroclor 1016 Aroclor 1221 Aroclor 1232 Aroclor 1242 Aroclor 1248 Aroclor 1254 Aroclor 1260 **Total PCB's**	516.00 ND ND ND ND ND ND **516.00**
-1001	Room 11 Leaking Motor Oil Unit Ventilator	Aroclor 1016 Aroclor 1221 Aroclor 1232 Aroclor 1242 Aroclor 1248 Aroclor 1254 Aroclor 1260 **Total PCB's**	ND ND ND ND ND 0.68 ND **0.68**
-1002	Room 11 Debris in Return Unit Ventilator	Aroclor 1016 Aroclor 1221 Aroclor 1232 Aroclor 1242 Aroclor 1248 Aroclor 1254 Aroclor 1260 **Total PCB's**	ND ND ND ND ND 1.74 ND **1.74**
-1003	Room 11 Dust from Left Control Panel Unit Ventilator	Aroclor 1016 Aroclor 1221 Aroclor 1232 Aroclor 1242 Aroclor 1248 Aroclor 1254 Aroclor 1260 **Total PCB's**	ND ND ND ND ND 6.48 ND **6.48**

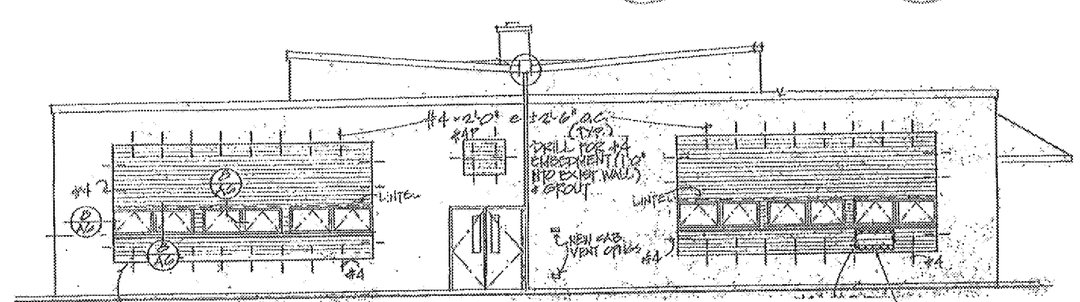
TECHNOLOGY BUILDING WEST
NOT TO SCALE

124-PCB-W
ASPHALT
