PCB ABATEMENT CLOSEOUT SUMMARY REPORT

SKY VALLEY EDUCATION CENTER
351 Short Columbia Street
Monroe, Washington

June – September 2016

October 2016
PBS Project # 41373.000

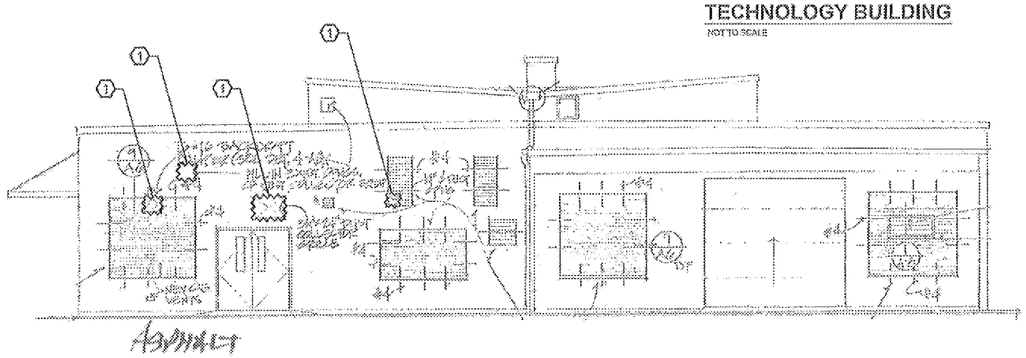
1 HM5 TECHNOLOGY BUILDING EAST
NOT TO SCALE

1 REMOVE APPROX. 60 LF OF PCB-CONTAINING CAULKING LOCATED ON EXTERIOR LOUVERS, VENTS AND DUCTING ON METAL TRANSITIONS ON THE WEST AND EAST EXTERIOR ELEVATIONS OF THE TECHNOLOGY BUILDING AS SHOWN.
