PCB ABATEMENT CLOSEOUT SUMMARY REPORT

SKY VALLEY EDUCATION CENTER
351 Short Columbia Street
Monroe, Washington

June – September 2016

October 2016
PBS Project # 41373.000

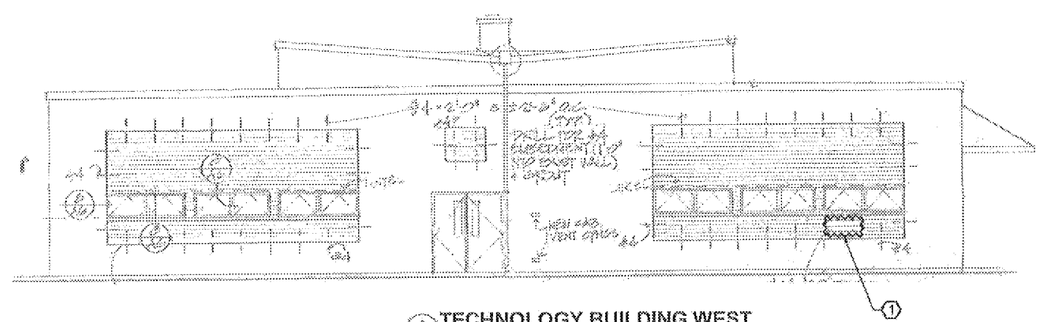
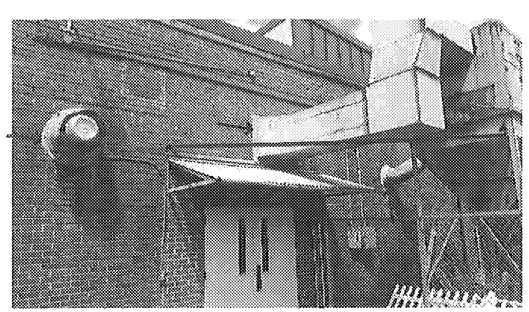
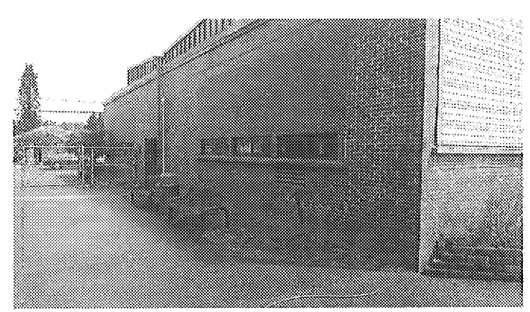
1. REMOVE APPROX. 60 LF OF PCB-CONTAINING CAULKING LOCATED ON EXTERIOR LOUVERS, VENTS AND DUCTING ON METAL TRANSITIONS ON THE WEST AND EAST EXTERIOR ELEVATIONS OF THE TECHNOLOGY BUILDING AS SHOWN.

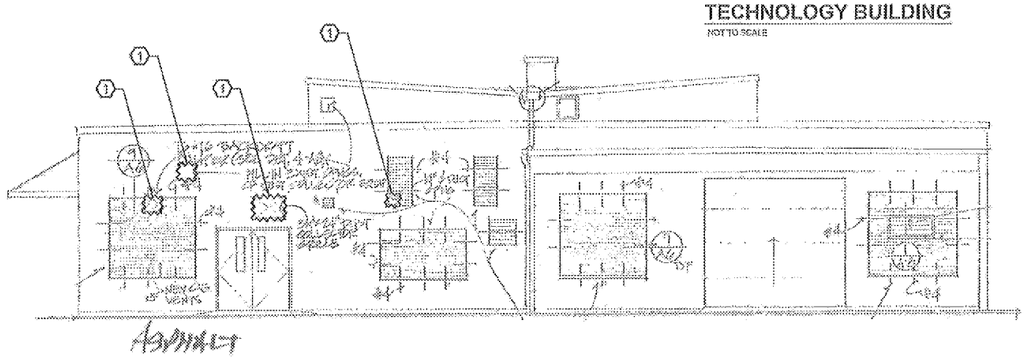
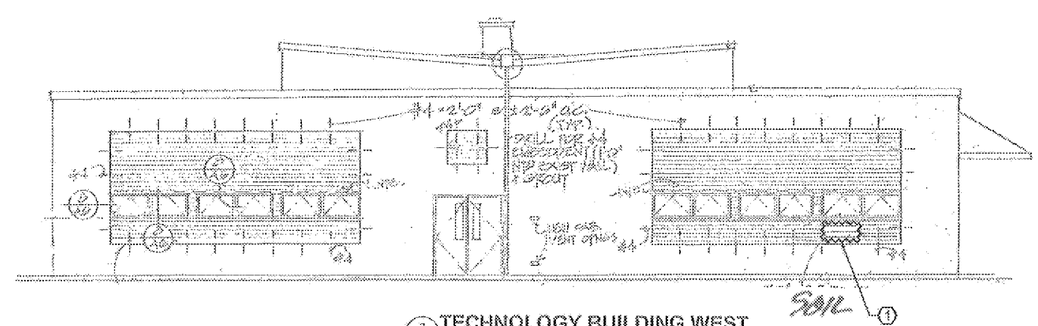
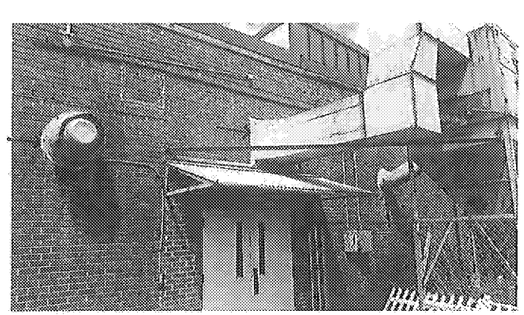
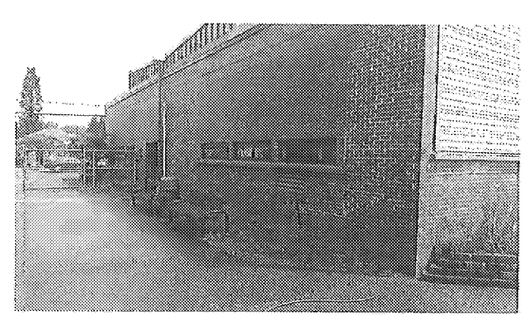
(1) REMOVE APPROX. 60 LF OF PCB-CONTAINING CAULKING LOCATED ON EXTERIOR LOUVERS, VENTS AND DUCTING ON METAL TRANSITIONS ON THE WEST AND EAST EXTERIOR ELEVATIONS OF THE TECHNOLOGY BUILDING AS SHOWN.
