PCB ABATEMENT CLOSEOUT SUMMARY REPORT

SKY VALLEY EDUCATION CENTER
351 Short Columbia Street
Monroe, Washington

October 2016
PBS Project # 41373.000

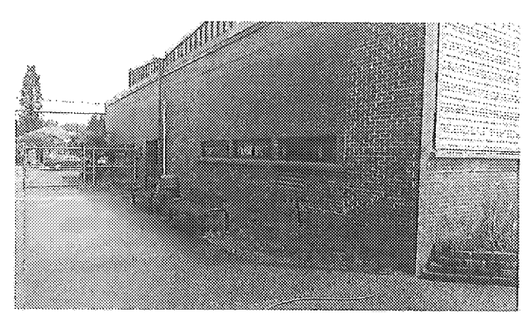
1 PHOTO DETAIL

1 REMOVE APPROX. 60 LF OF PCB-CONTAINING CAULKING LOCATED ON EXTERIOR LOUVERS, VENTS AND DUCTING ON METAL TRANSITIONS ON THE WEST AND EAST EXTERIOR ELEVATIONS OF THE TECHNOLOGY BUILDING AS SHOWN.
