FULCRUM environmental consulting

March 23, 2017

RE: Air and Wipe Sampling in Select Areas – March 2017 – Update
Sky Valley Educational Center, 351 Short Columbia Street, Monroe, Washington

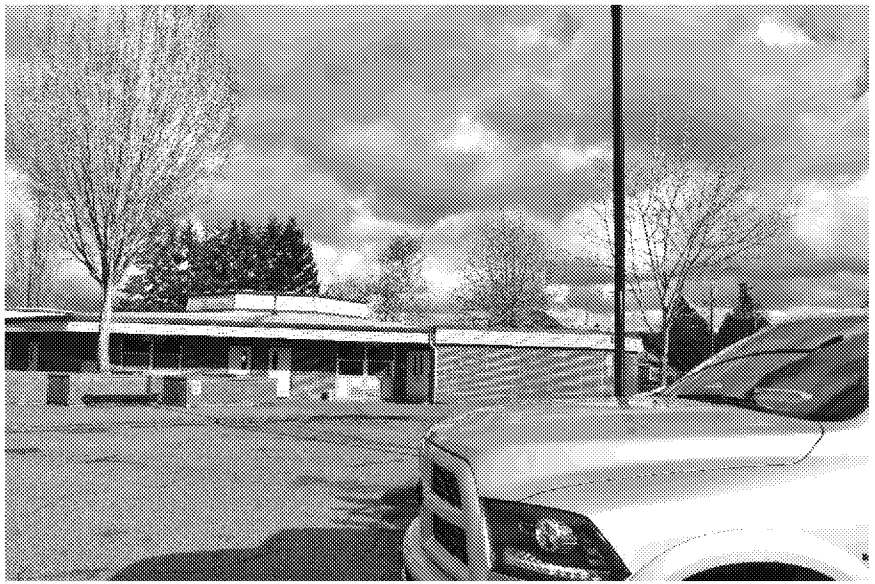
Sky Valley Education Center located at 351 Short Columbia Street in Monroe, Washington

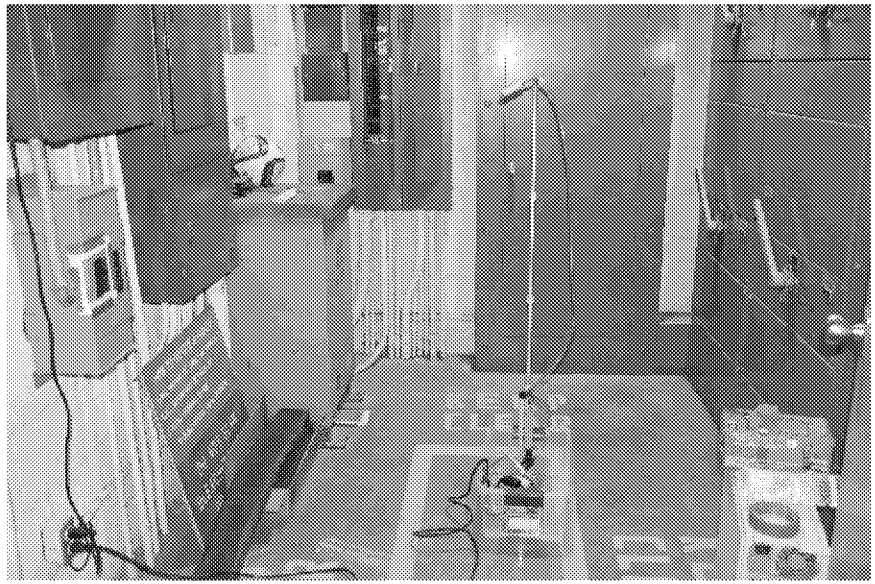
030617-05: Small Gym Electrical Room.

030617-06: Gathering Room.

030617-07: CTE Classroom.

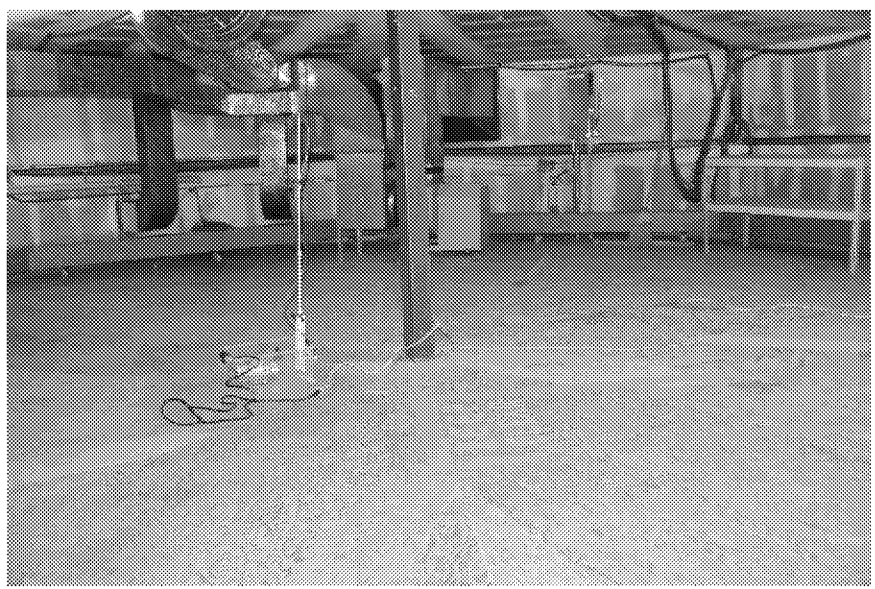
030617-08: Large Gym – Electrical Room.

030617-09: CTE Classroom – Electrical Room.

Laboratory analysis identified low concentrations of Aroclor 1260 on the concrete floors in the Large Gym Electrical Room and the CTE Electrical Room. While remediation is not required based on the PCB concentrations present, Fulcrum recommends that the District consider implementation of best management practices where practicable and feasible and with the overall goal of reducing the presence of detectable PCBs within the building.

As such, Fulcrum recommends that the floor surfaces within each of the electrical rooms be cleaned of free dust by trained District staff or a qualified remediation contractor. Furthermore, given the difficulty of cleaning the porous concrete surface, Fulcrum recommends application of an approved paint/sealer to the concrete floors. Given the potential for unpleasant odors associated with the paint/sealer, Fulcrum recommends that application occur as build use and school schedules permit.
