# PCB ABATEMENT CLOSEOUT SUMMARY REPORT

## SKY VALLEY EDUCATION CENTER
## 351 Short Columbia Street
## Monroe, Washington

## June – September 2016

October 2016
PBS Project # 41373.000

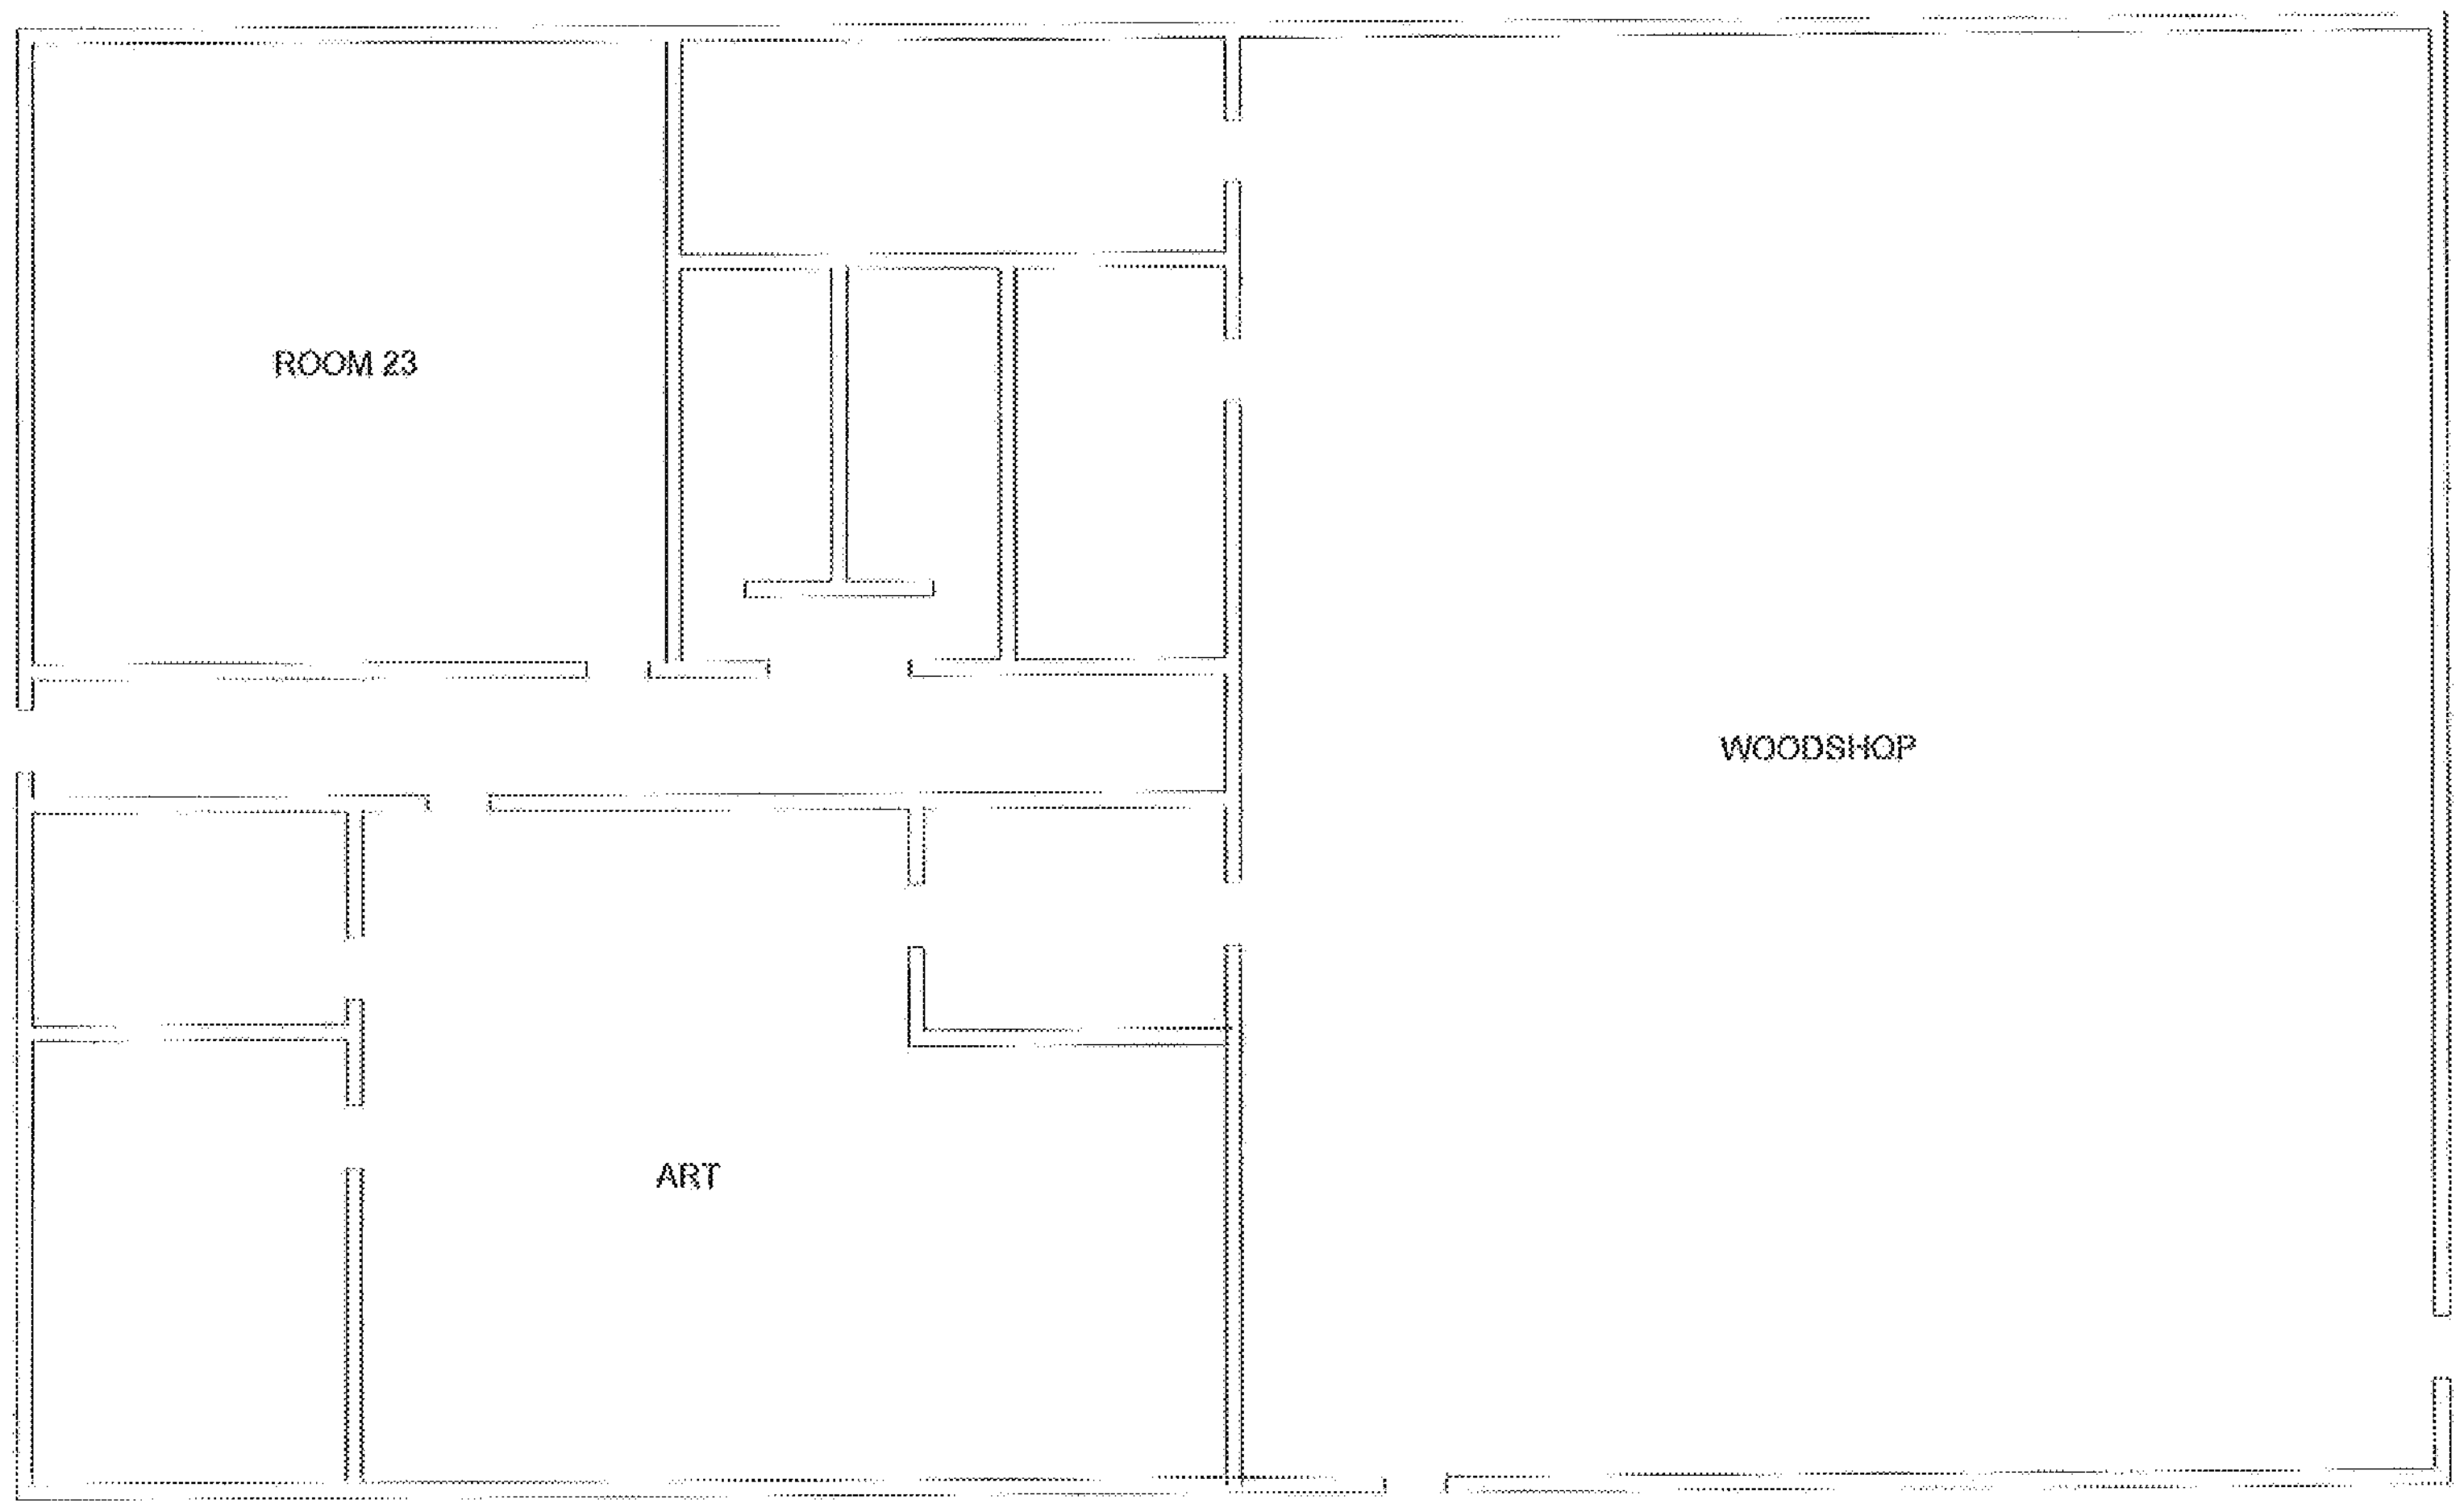
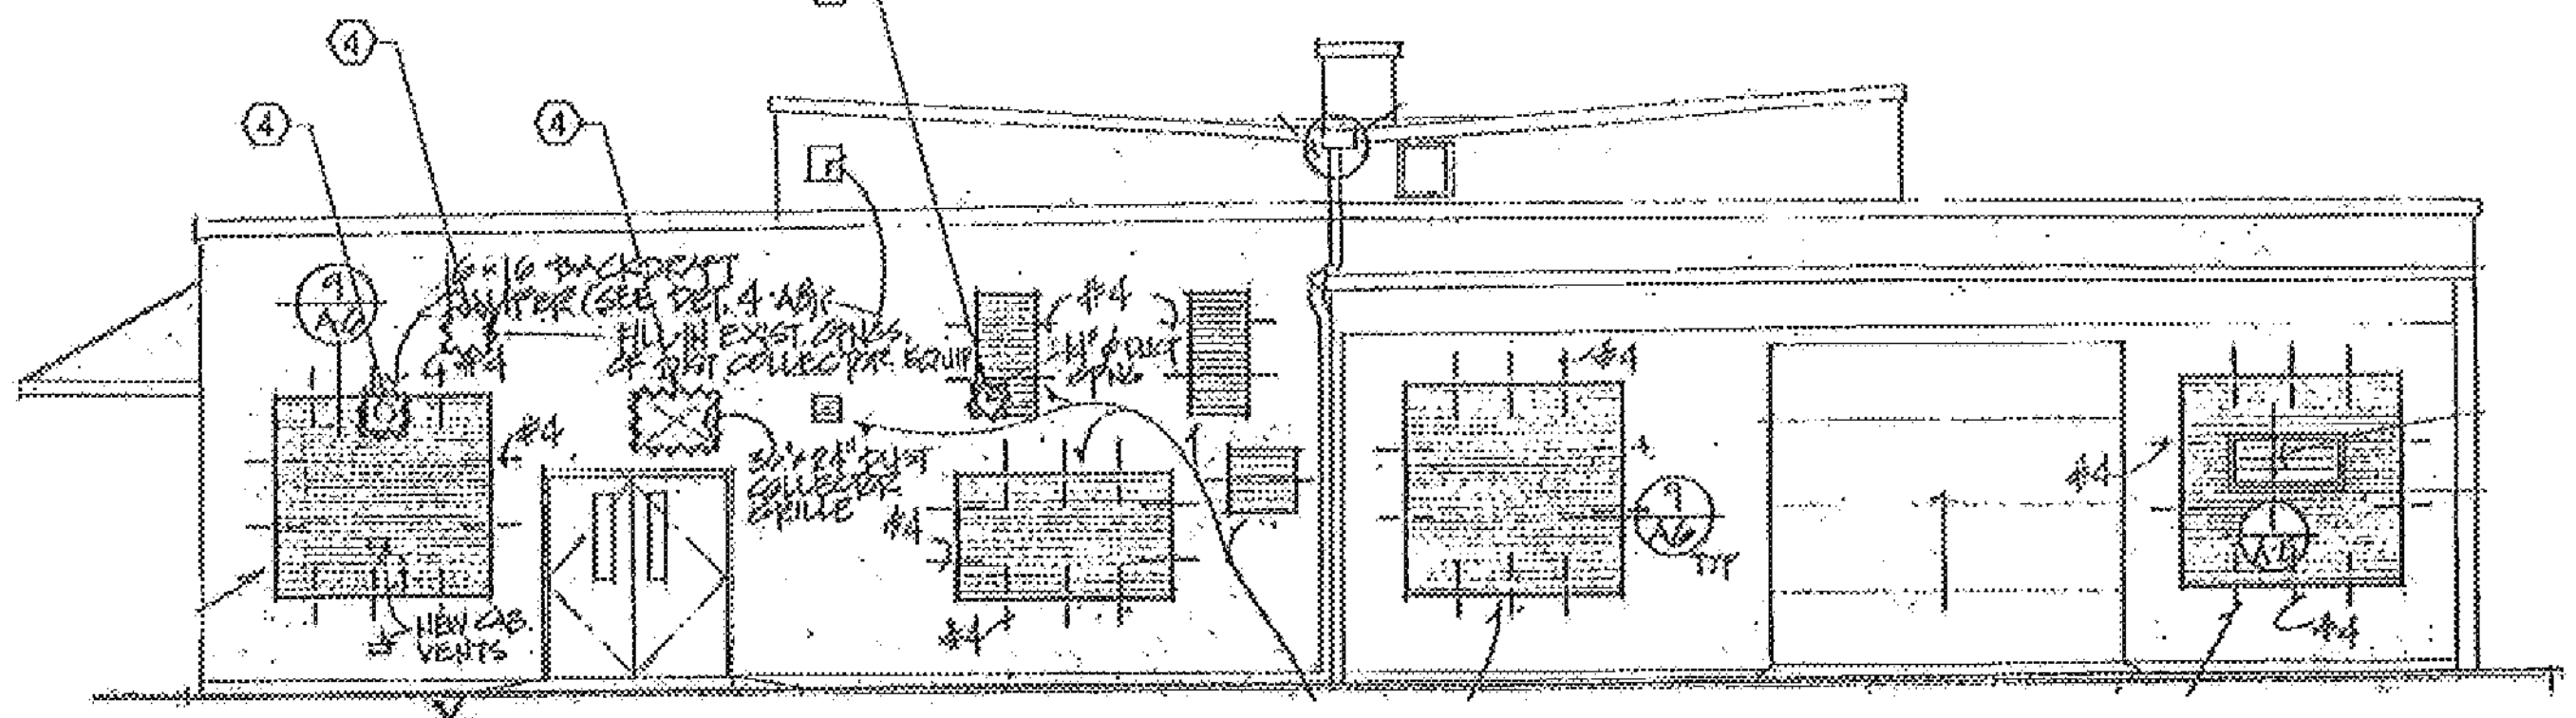
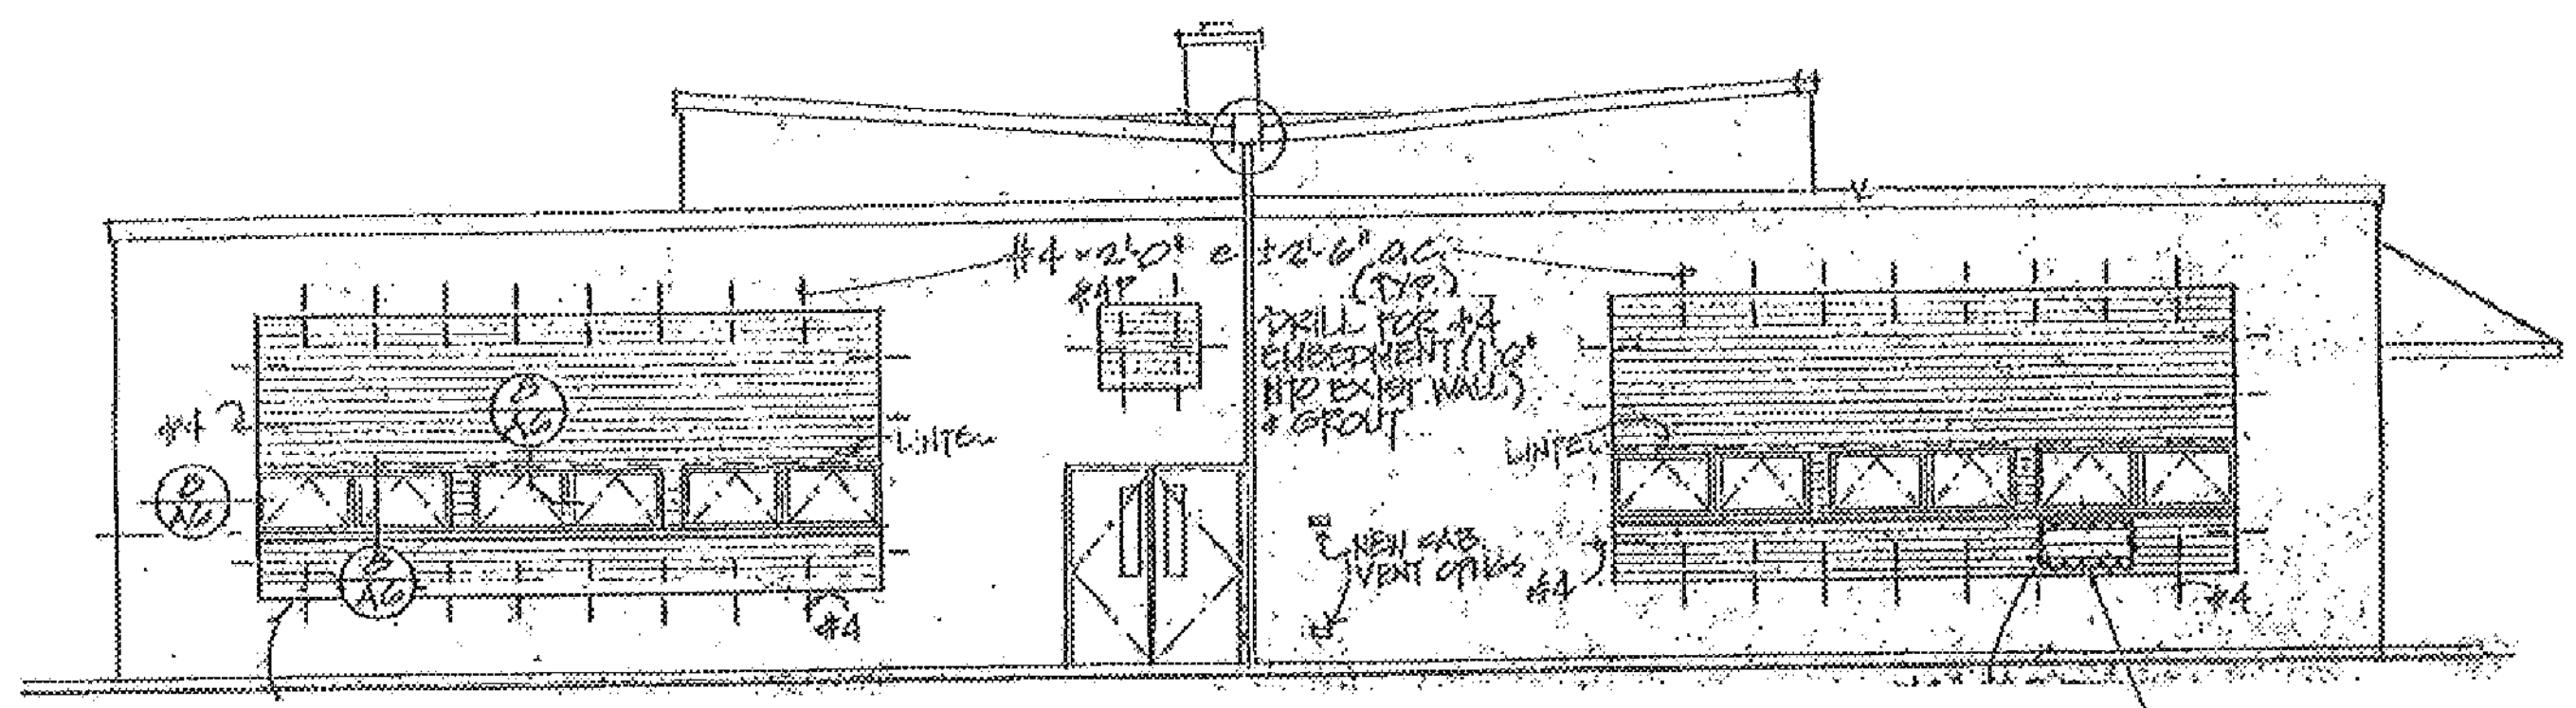
TECHNOLOGY BUILDING
NOT TO SCALE

(4) REMOVE PCB-CONTAINING SOFT GREY CAULKING. SEE DRAWING NOTE 1.

(*) NO INTERIOR PCB CONTAINING CAULK IDENTIFIED
