March 23, 2017

RE: Air and Wipe Sampling in Select Areas – March 2017 – Update
Sky Valley Educational Center, 351 Short Columbia Street, Monroe, Washington

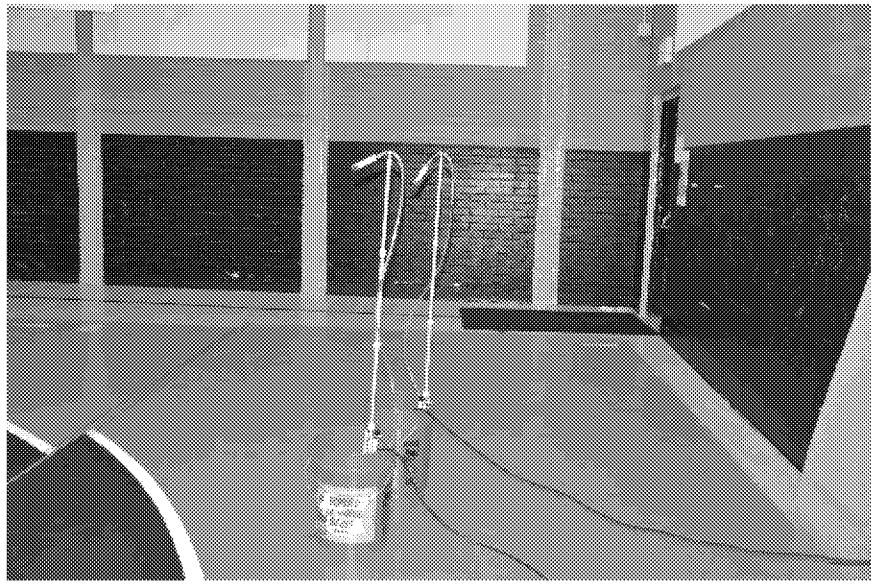
030617-01: Room F, located in the Annex.

030617-02: Girl's Locker Room Storage Room, located in Girl's Locker Room.

030617-03: Girl's Locker Room.

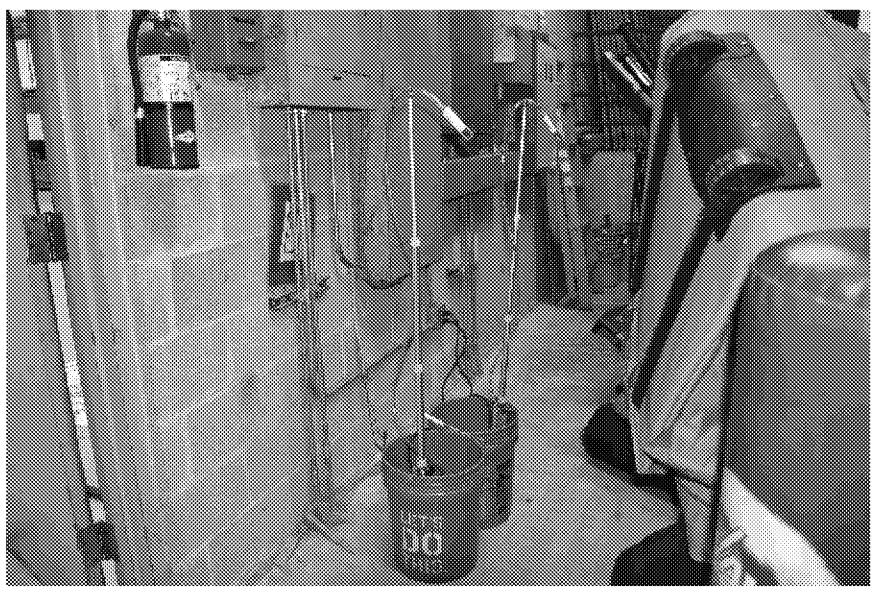
030617-04: Small Gym.

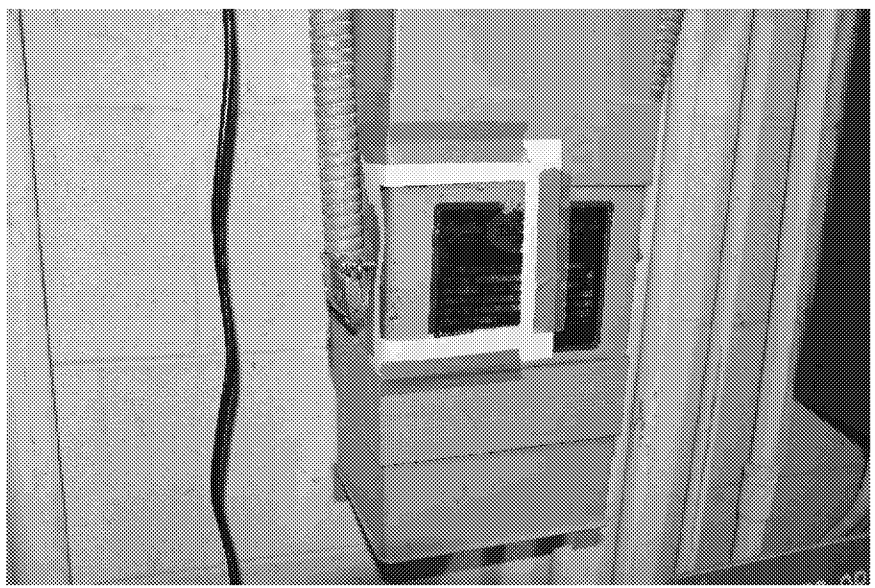
030617-13: Large Gym – Electrical Closet. Sample taken from side of transformer in an area with discoloration.

As such, Fulcrum recommends that the floor surfaces within each of the electrical rooms be cleaned of free dust by trained District staff or a qualified remediation contractor. Furthermore, given the difficulty of cleaning the porous concrete surface, Fulcrum recommends application of an approved paint/sealer to the concrete floors. Given the potential for unpleasant odors associated with the paint/sealer, Fulcrum recommends that application occur as build use and school schedules permit.

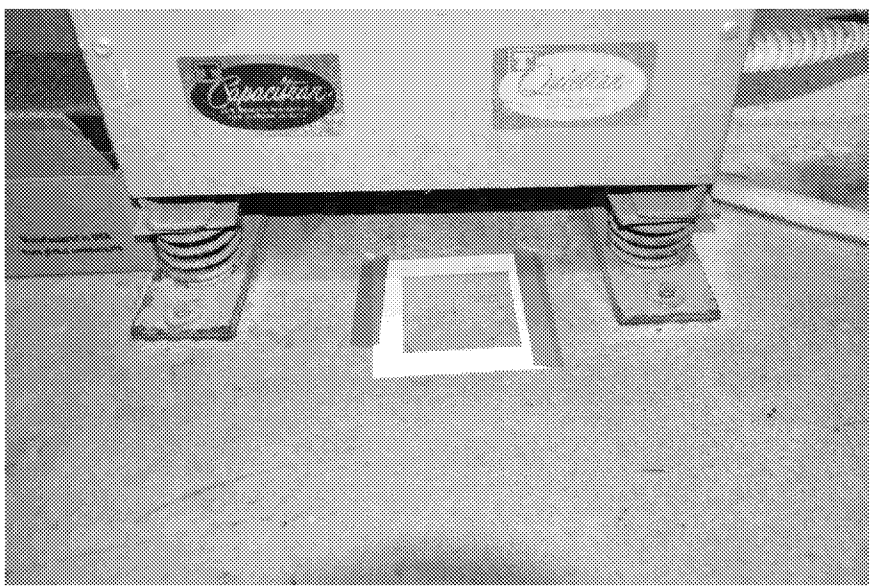
Aroclor 1260 were present in samples from the concrete floors in the Large Gym Electrical Room and the CTE Electrical Room. Both wipe samples were reported with total PCB concentrations below the EPA threshold of 10 micrograms (µg) per 100 cm^2.

030617-14: Large Gym – Electrical Closet. Sample taken directly beneath the transformer on the concrete floor. No staining was observed.

030617-15 & 030617-16: CTE Classroom – Electrical Room. Samples collected from the side of the transformer and directly below transformer on concrete floor.

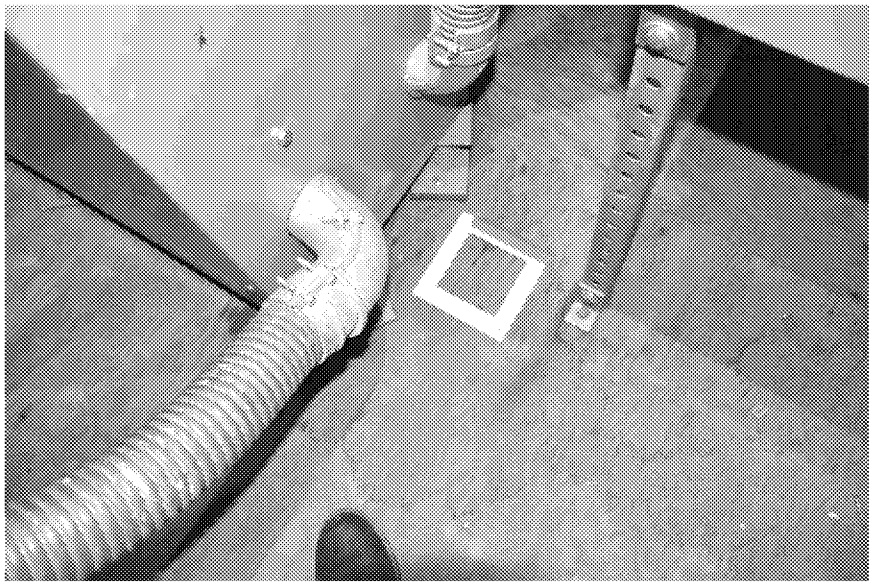
030617-17: West Pod – Mezzanine. Sample collected on the wood flooring directly below the transformer. Slight staining was observed.

030617-18: West Pod – Mezzanine. Sample taken from side of transformer. No staining or streaking was observed.
