FULCRUM environmental consulting

September 5, 2017

RE: Quarterly Air and Wipe Sampling – July 2017
Sky Valley Educational Center, 351 Short Columbia Street, Monroe, Washington

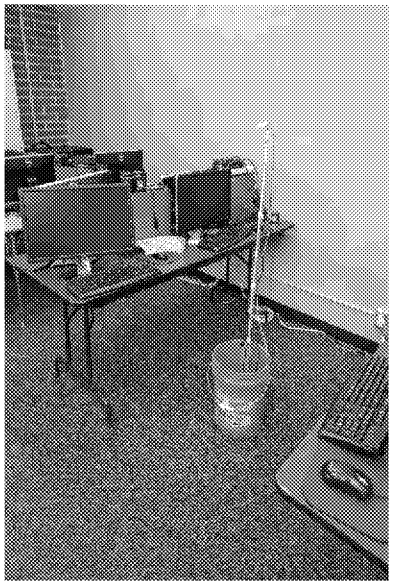
72417-POD-RM1: POD room 1.

72417-POD-RM2: POD room 2.

72417-POD-RM3: POD room 3.

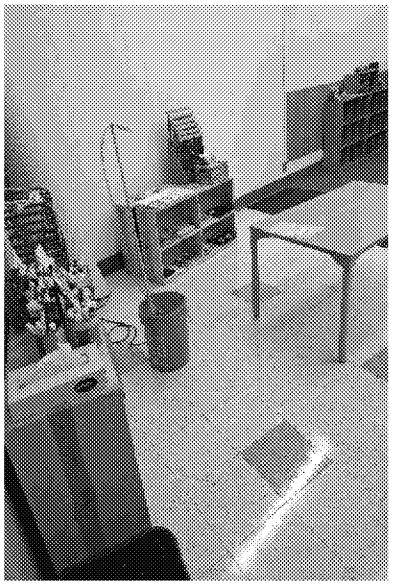
72417-POD-RM4: POD room 4.

72417-POD-RM5: POD room 5.

72417-POD-RM6: POD room 6.

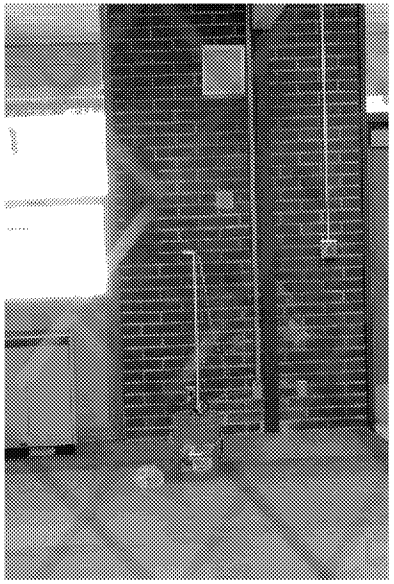
72417-POD-RM7: POD room 7.

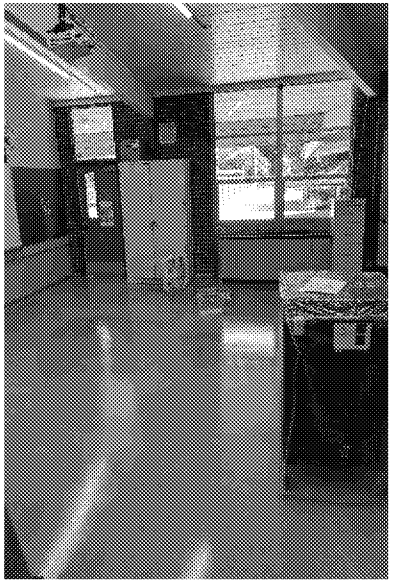
72417-POD-RM8: POD room 8.

72417-POD-RM9: POD room 9.

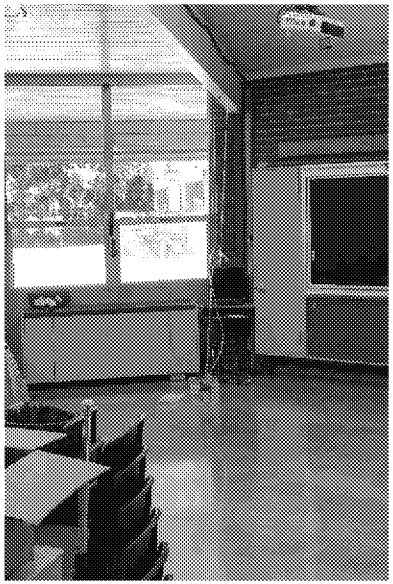
72417-POD-RM10: POD room 10.

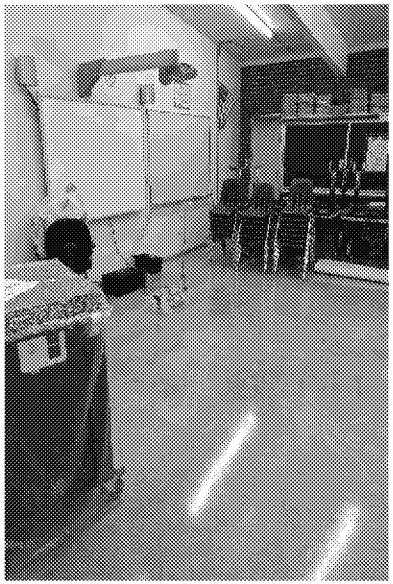
72417-POD-RM11: POD room 11.

72417-POD-RM12: POD room 12.

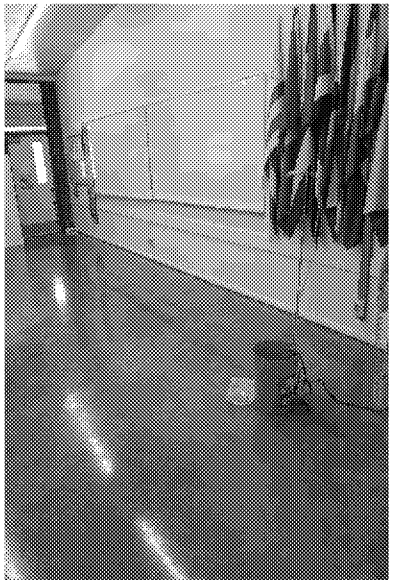
72417-POD-RM1: POD room 13.

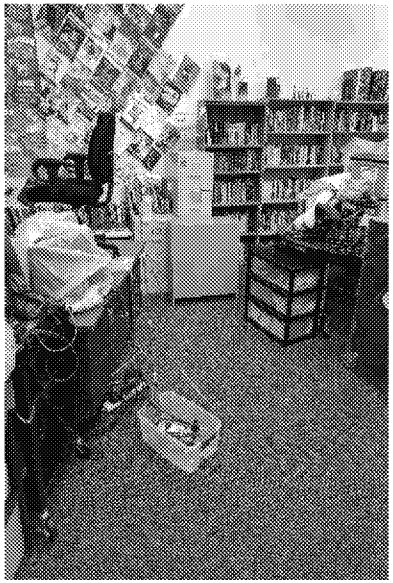
72417-POD-RM15: POD room 14.

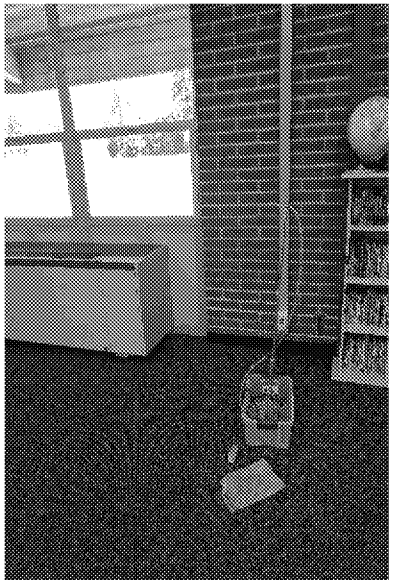
72417-POD-RM15: POD room 15.

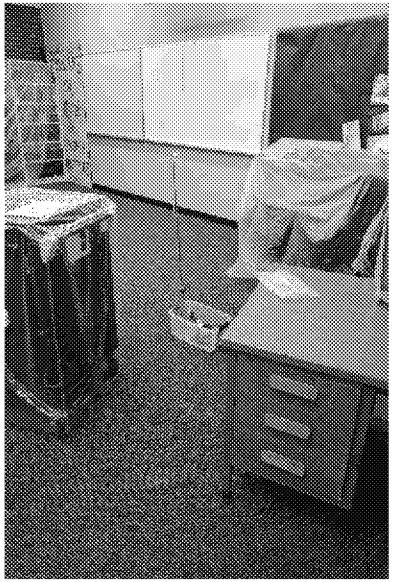
72417-POD-RM16: POD room 16.

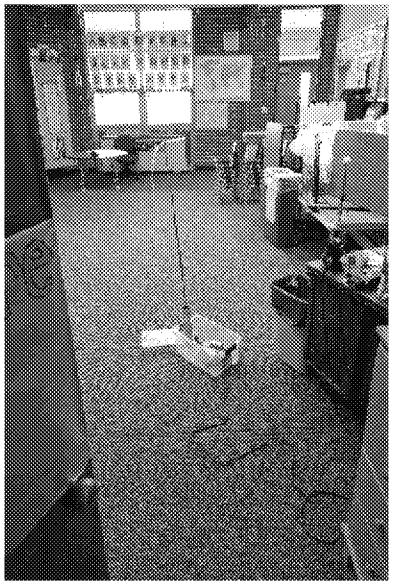
72417-POD-RM17: POD room 17.

72417-POD-RM18: POD room 18.

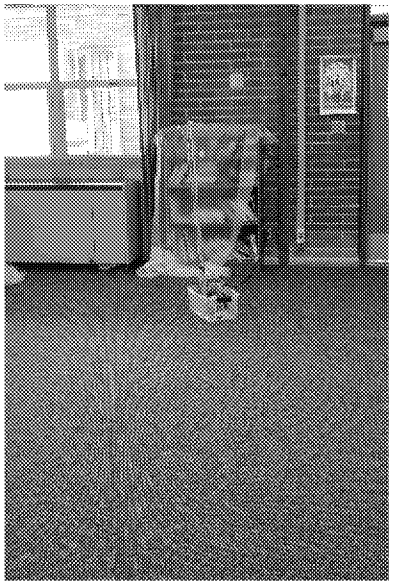
72417-POD-RM19: POD room 19.

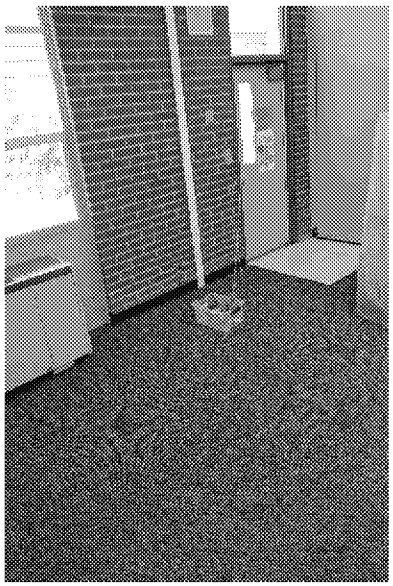
72417-POD-RM20: POD room 20.

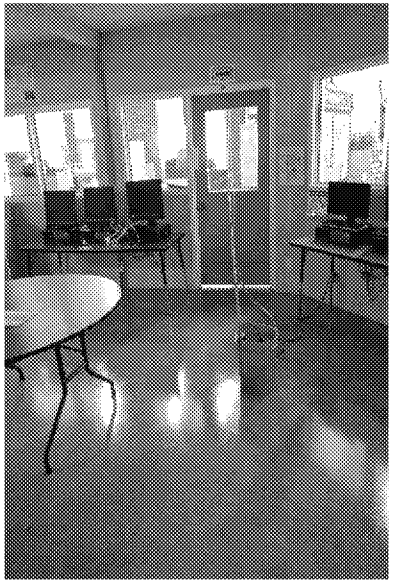
72417-POD-Ecenter: POD east center.

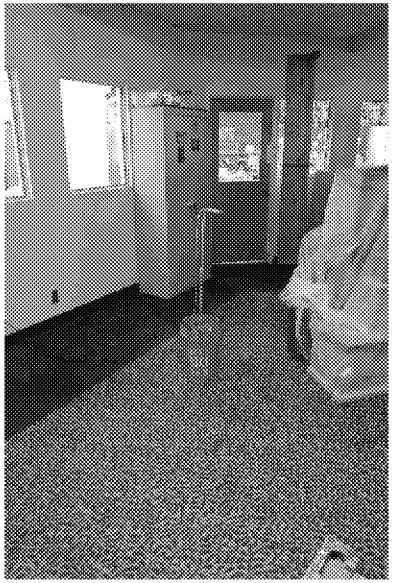
72417-POD-Scenter: south center.

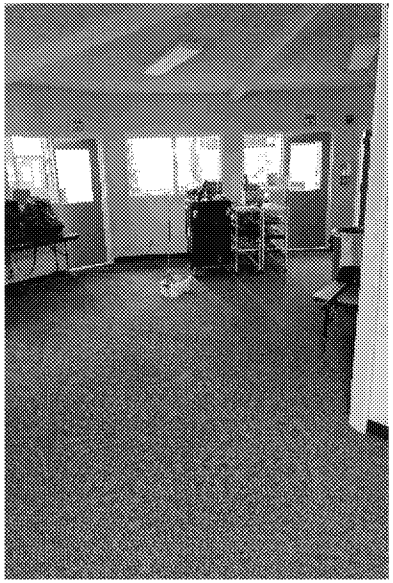
72417-POD-Ncenter: north center.

72417-POD-Library: POD library.

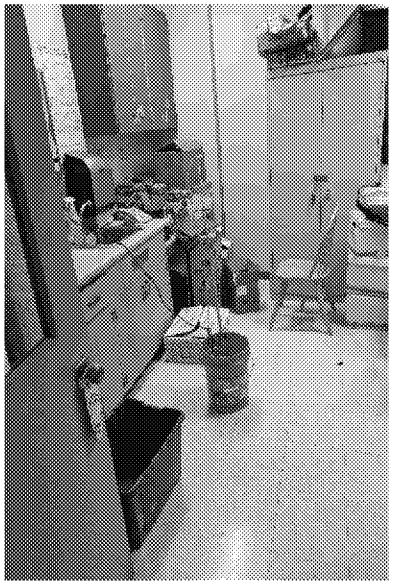
72417-ADM-Nurse: Admin office nurse's office.

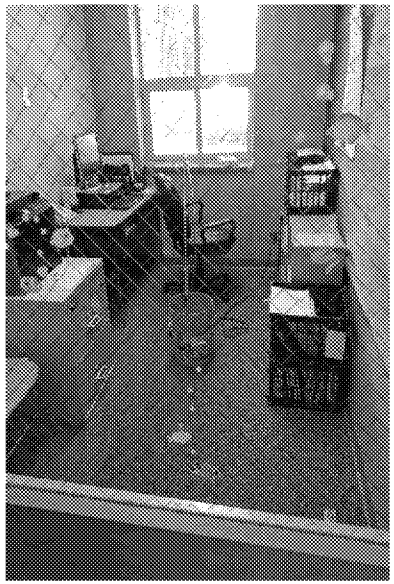
72517-ADM-SEoffice: Admin south east office.

72517-ADM-Soffice: Admin south office.

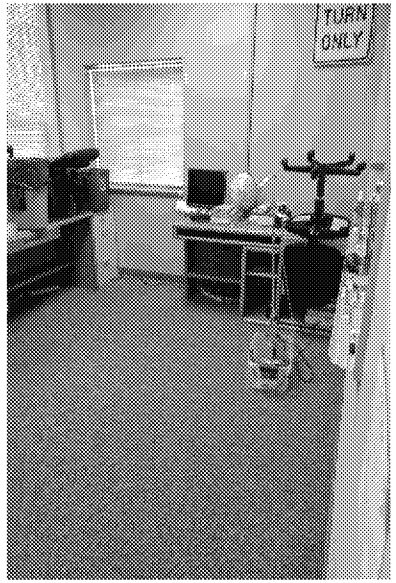
72517-ADM-SWoffice: Admin south west office.

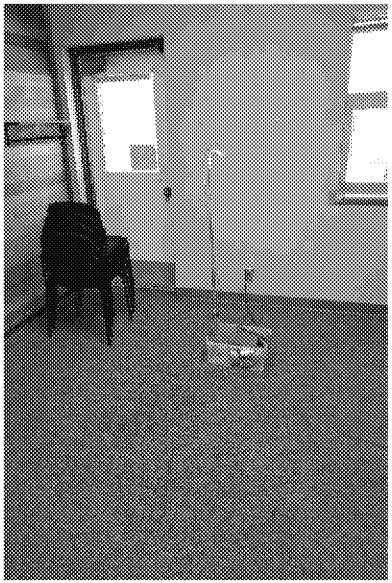
72517-ADM-Woffice: Admin west office.

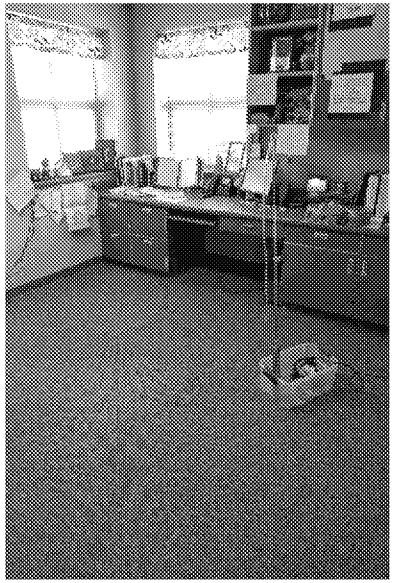
72517-ADM-NWoffice: Admin northwest office.

72517-ADM-Conference: Admin conference.

72517-ADM-Staff Room: Admin staff room.

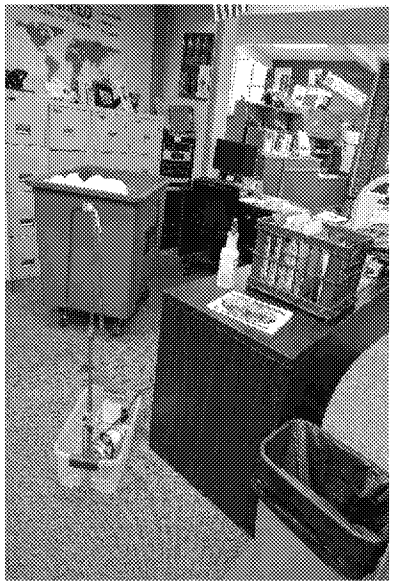
72517-ADM-Office Center: Admin office center.

72517-ANX-RMA: Annex room A.

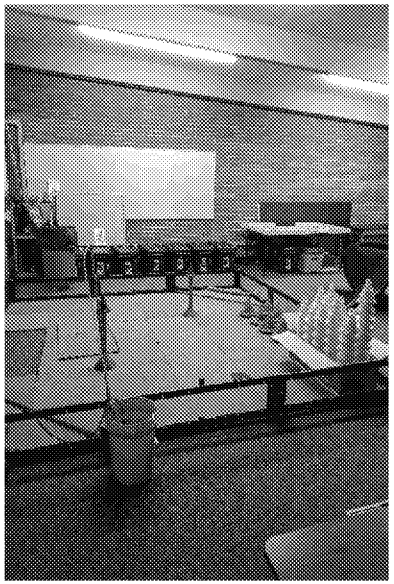
72517-ANX-RMB: Annex room B.

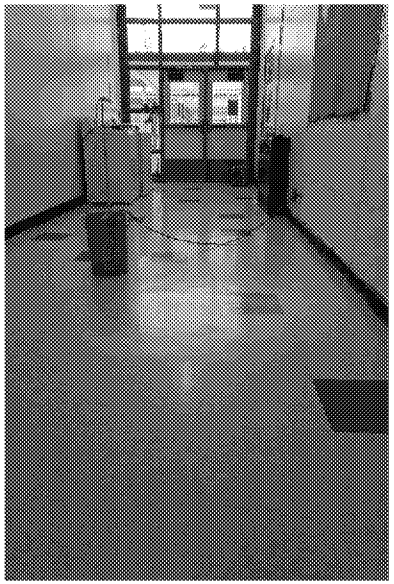
72517-ANX-Ehallway: Annex east hallway.

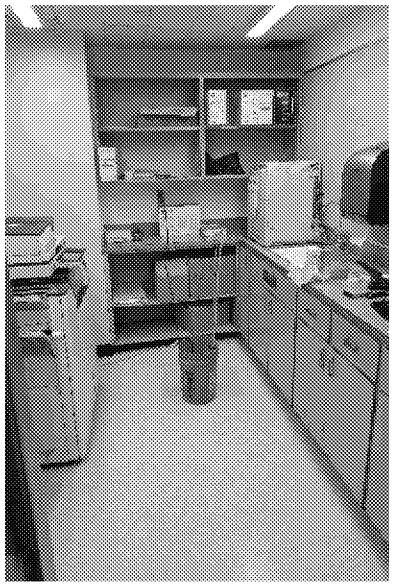
72517-ANX-RM B Office Supplies: Annex room B office supplies.

72517-ANX-Boys bathroom: Annex boys bathroom.

72517-ANX-RMC: annex room C.

72517-ANX-RMD: Annex room D.

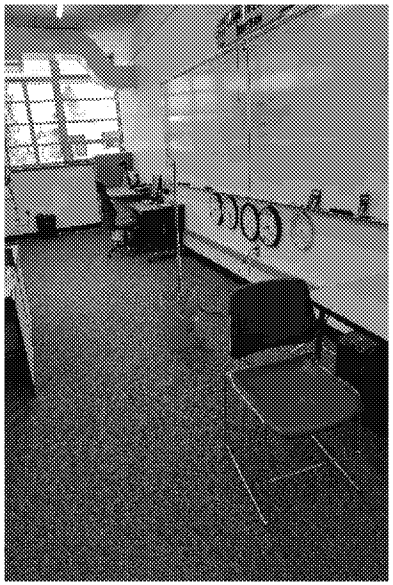
72517-ANX-RME east: Annex room E east.

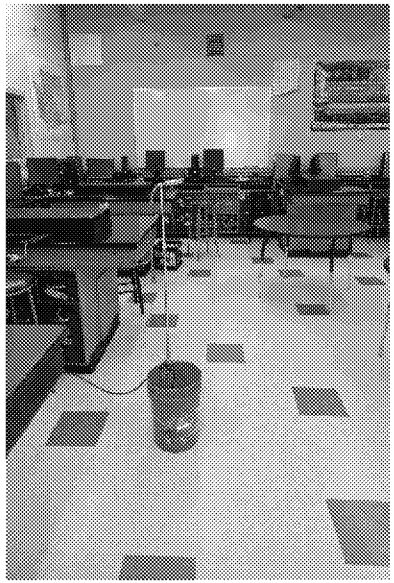
72517-ANX-RMF: Annex room F.

72517-ANX-Nhallway: Annex north hallway.

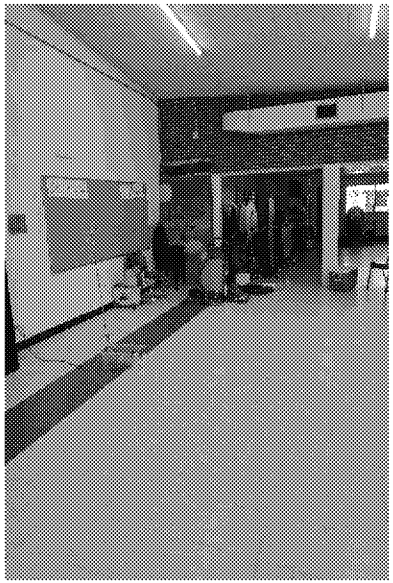
72517-GYM-Gathering: Gymnasium Building gathering room.

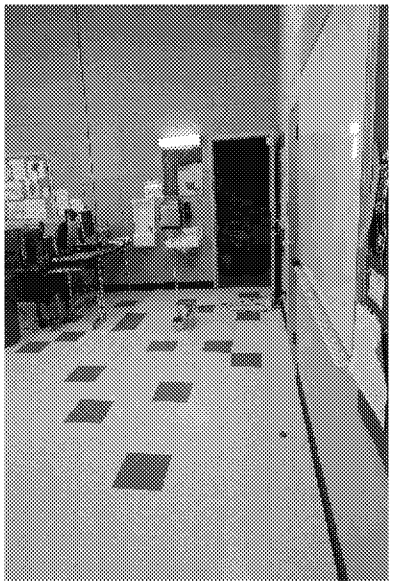
72517-GYM-CTE: Gymnasium Building CTE classroom.

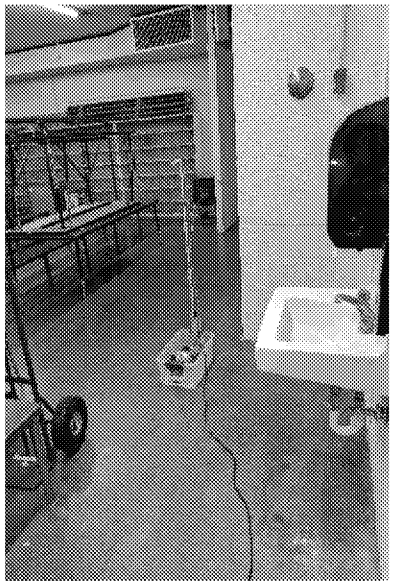
72517-GYM-Girls Lockers: Gymnasium Building girl's lockers.

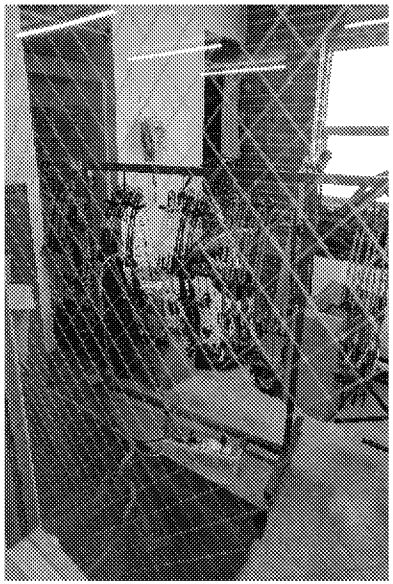
72517-GYM-Girls Lockers Storage: Gymnasium Building girl's lockers storage.

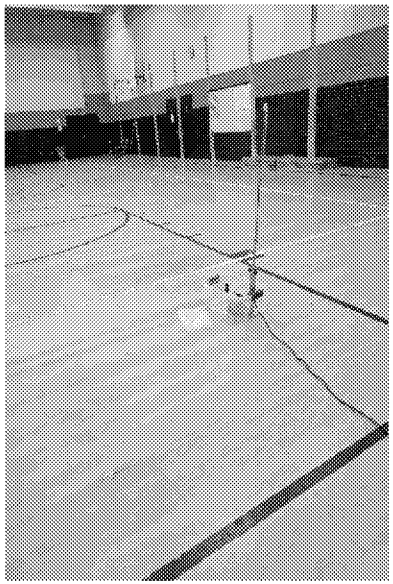
72517-GYM-SmallGym: Gymnasium Building small gymnasium.

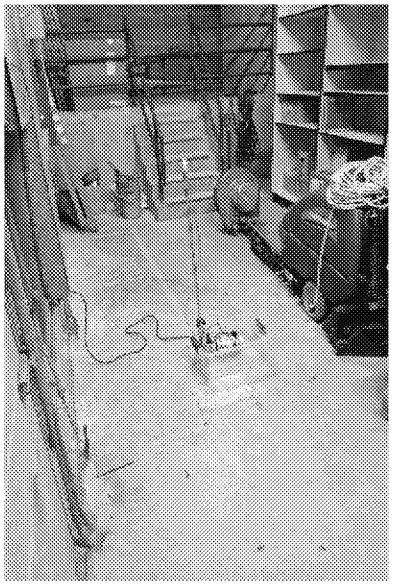
72517-GYM-Electric Room:
small gymnasium electric room.

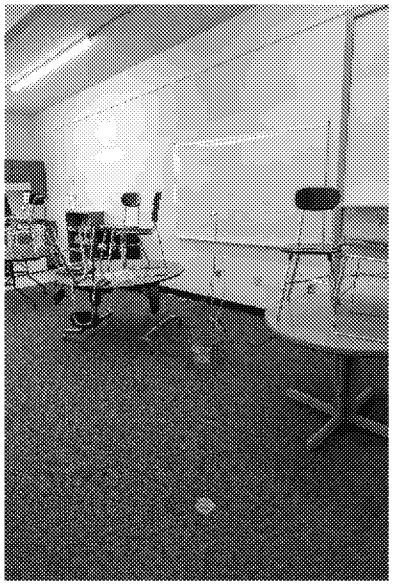
42517-ANX-RME west: Annex
room E west.

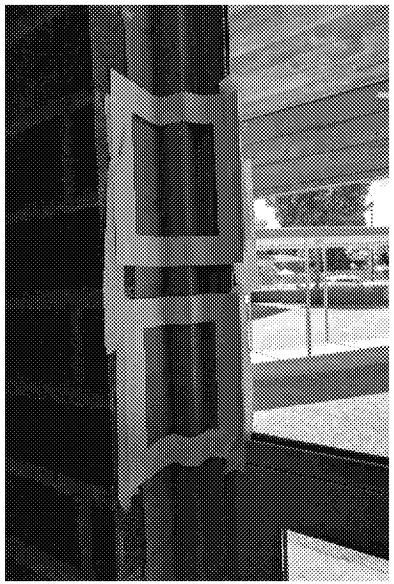
72417-POD-RM20A: POD room 20 on window frame.

72417-POD-RM20B: POD room 20 on window frame.

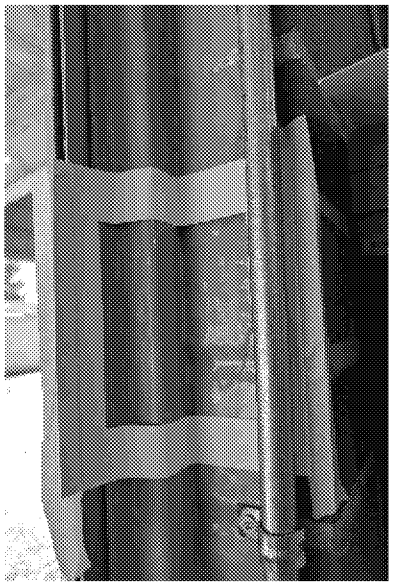
72417-POD-RM17: POD room 17 on window frame.

72417-POD-RM11 – POD room 11 on window frame.

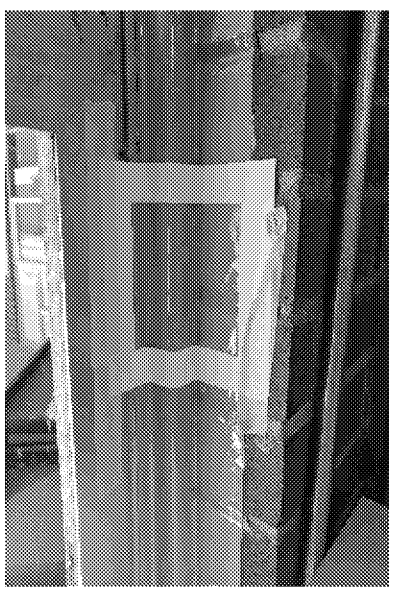
72417-POD-RM08: POD room 8 on window frame.

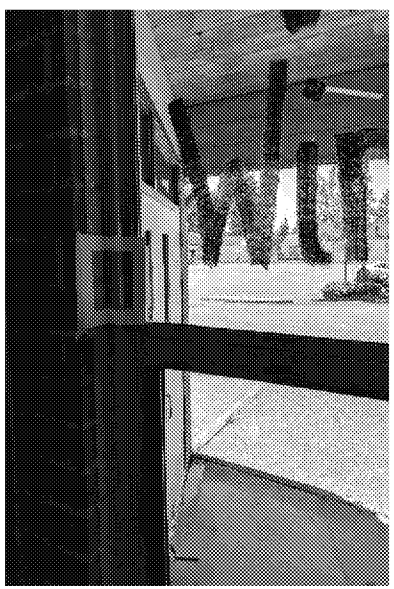
72417-POD-RM03: POD room 3 on window frame.

72417-POD-RM04: POD room 4 on window frame.

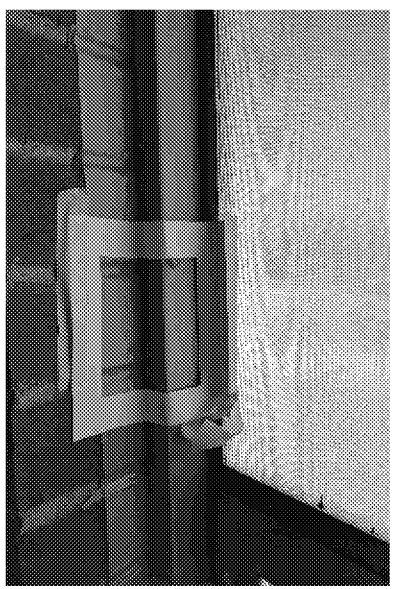
72417-GYM-Girls Locker Storage: girl's locker storage on window frame.

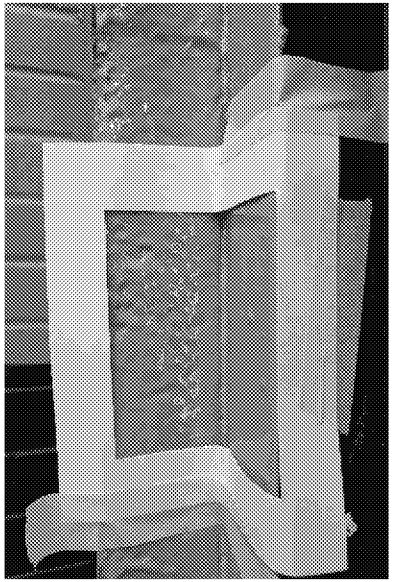
72417-GYM-Small Gym A: northwest door frame in small gymnasium.

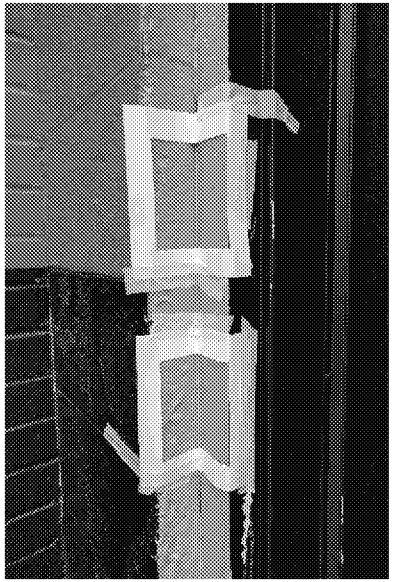
72417-GYM-Small Gym B- northwest door frame in small gymnasium.

72417-ADM-SEoffice – Admin southeast office window frame.

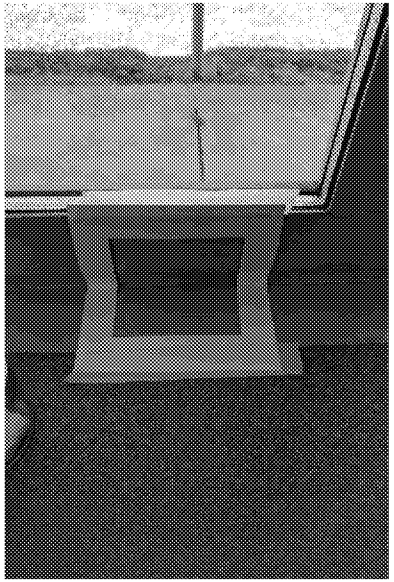
72417-ADM-Woffice: Admin west office window frame.

72417-ANX-RMF: Annex room F on window frame.

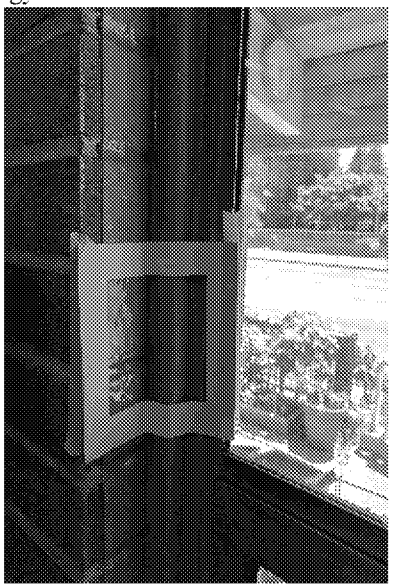
72417-POD-RM14: POD – room 14 on window frame.

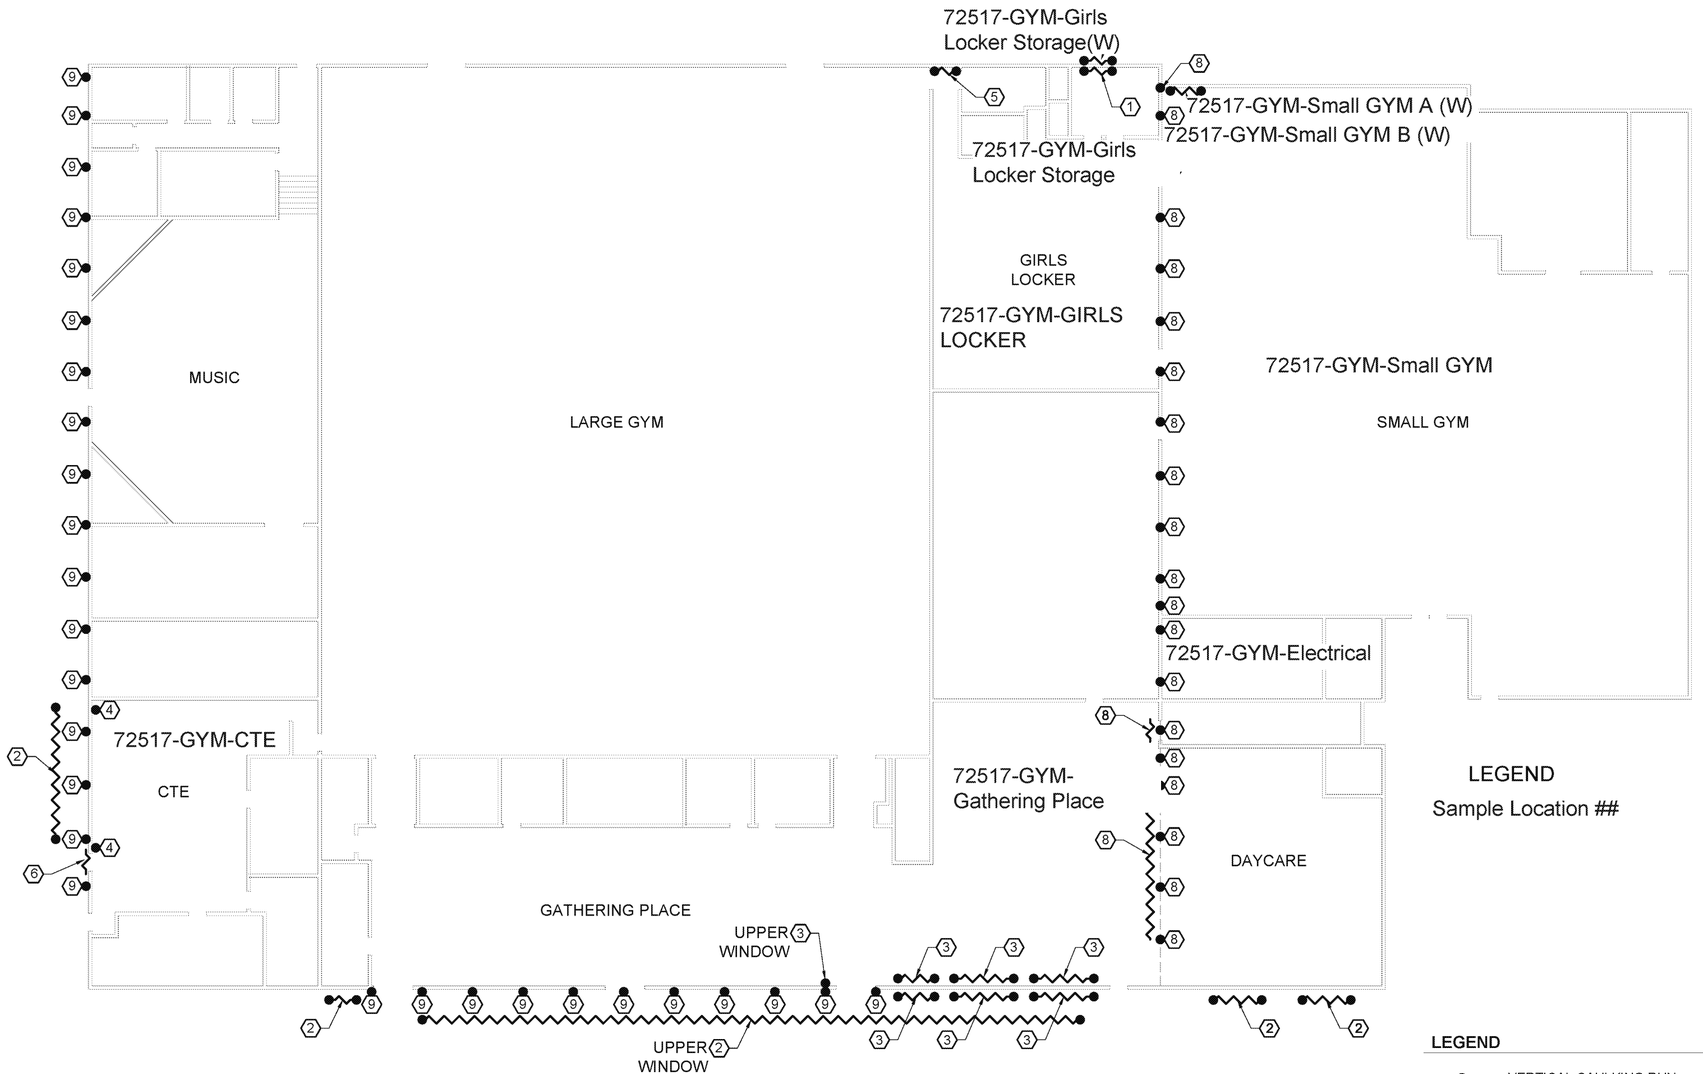
GYM BUILDING

Sample Number	Location	Air/Wipe	Results
72517-GYM-Gathering Place	Gym Gathering Place	Air	<47.6 ng/m³
72517-GYM-CTE	Gym CTE Room	Air	<47.6 ng/m³
72517-GYM-Girls Locker	Gym Girls Locker Room	Air	<47.6 ng/m³
72517-GYM-Girls Locker Storage	Gym Girls Locker Storage	Air	<47.6 ng/m³
72517-GYM-Small Gym	Gym Small Gym	Air	<47.6 ng/m³
72517-GYM-Electrical	Gym Electrical Room	Air	<47.6 ng/m³
72517-GYM-Girls Locker Storage	Gym Girls Locker Room	Wipe	<0.10 µg/cm²
72517-GYM-Small Gym A	Gym - Small Gym	Wipe	<0.10 µg/cm²
72517-GYM-Small Gym B	Gym - Small Gym	Wipe	<0.10 µg/cm²
