FULCRUM environmental consulting

September 5, 2017

RE: Quarterly Air and Wipe Sampling – July 2017
Sky Valley Educational Center, 351 Short Columbia Street, Monroe, Washington

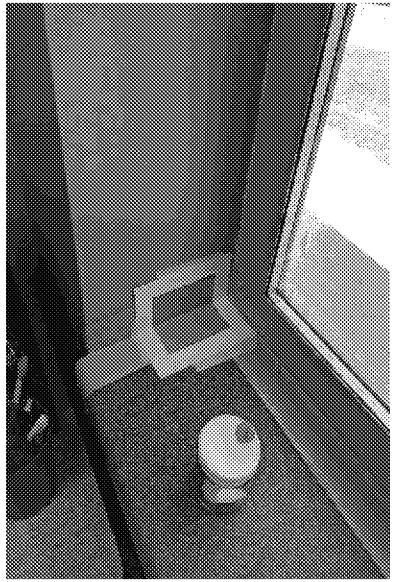
72417-GYM-Small Gym B- northwest door frame in small gymnasium.

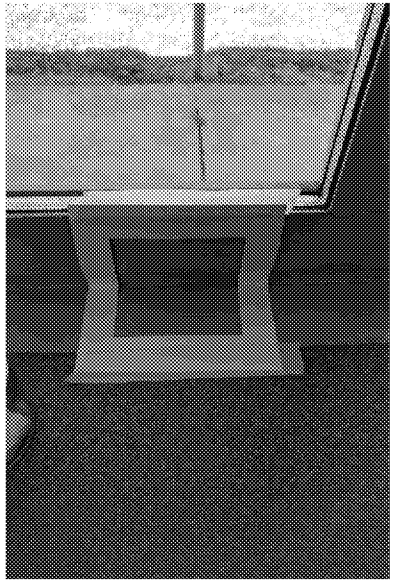
72417-ADM-SEoffice – Admin southeast office window frame.

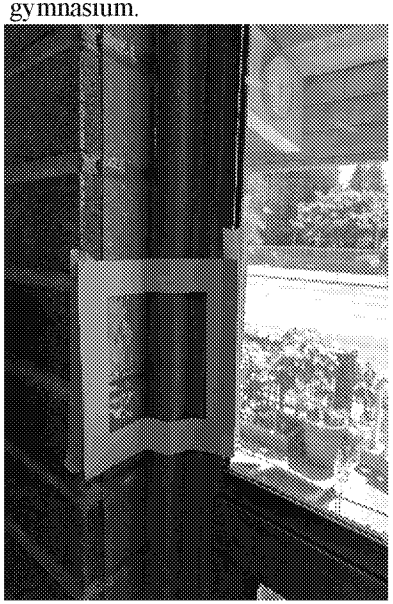
72417-ADM-Woffice: Admin west office window frame.

72417-ANX-RMF: Annex room F on window frame.
