PCB ABATEMENT CLOSEOUT SUMMARY REPORT

SKY VALLEY EDUCATION CENTER
351 Short Columbia Street
Monroe, Washington

June – September 2016

October 2016
PBS Project # 41373.000

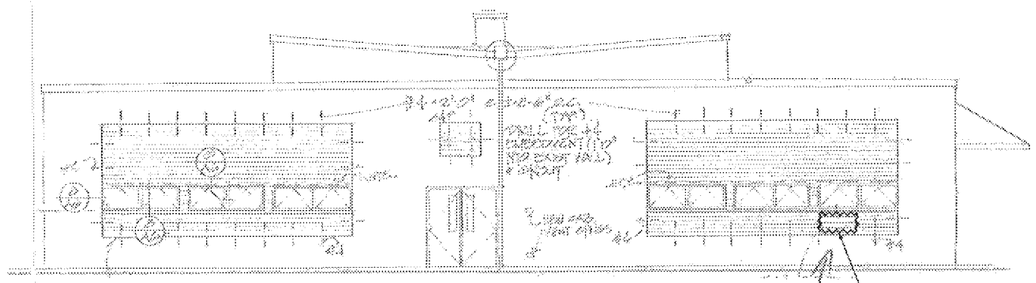
2 TECHNOLOGY BUILDING WEST
NOT TO SCALE

visually cleared 8/30/16
44in x 2 = 88in
21in x 2 = 42in
130 in = 10.8 ft

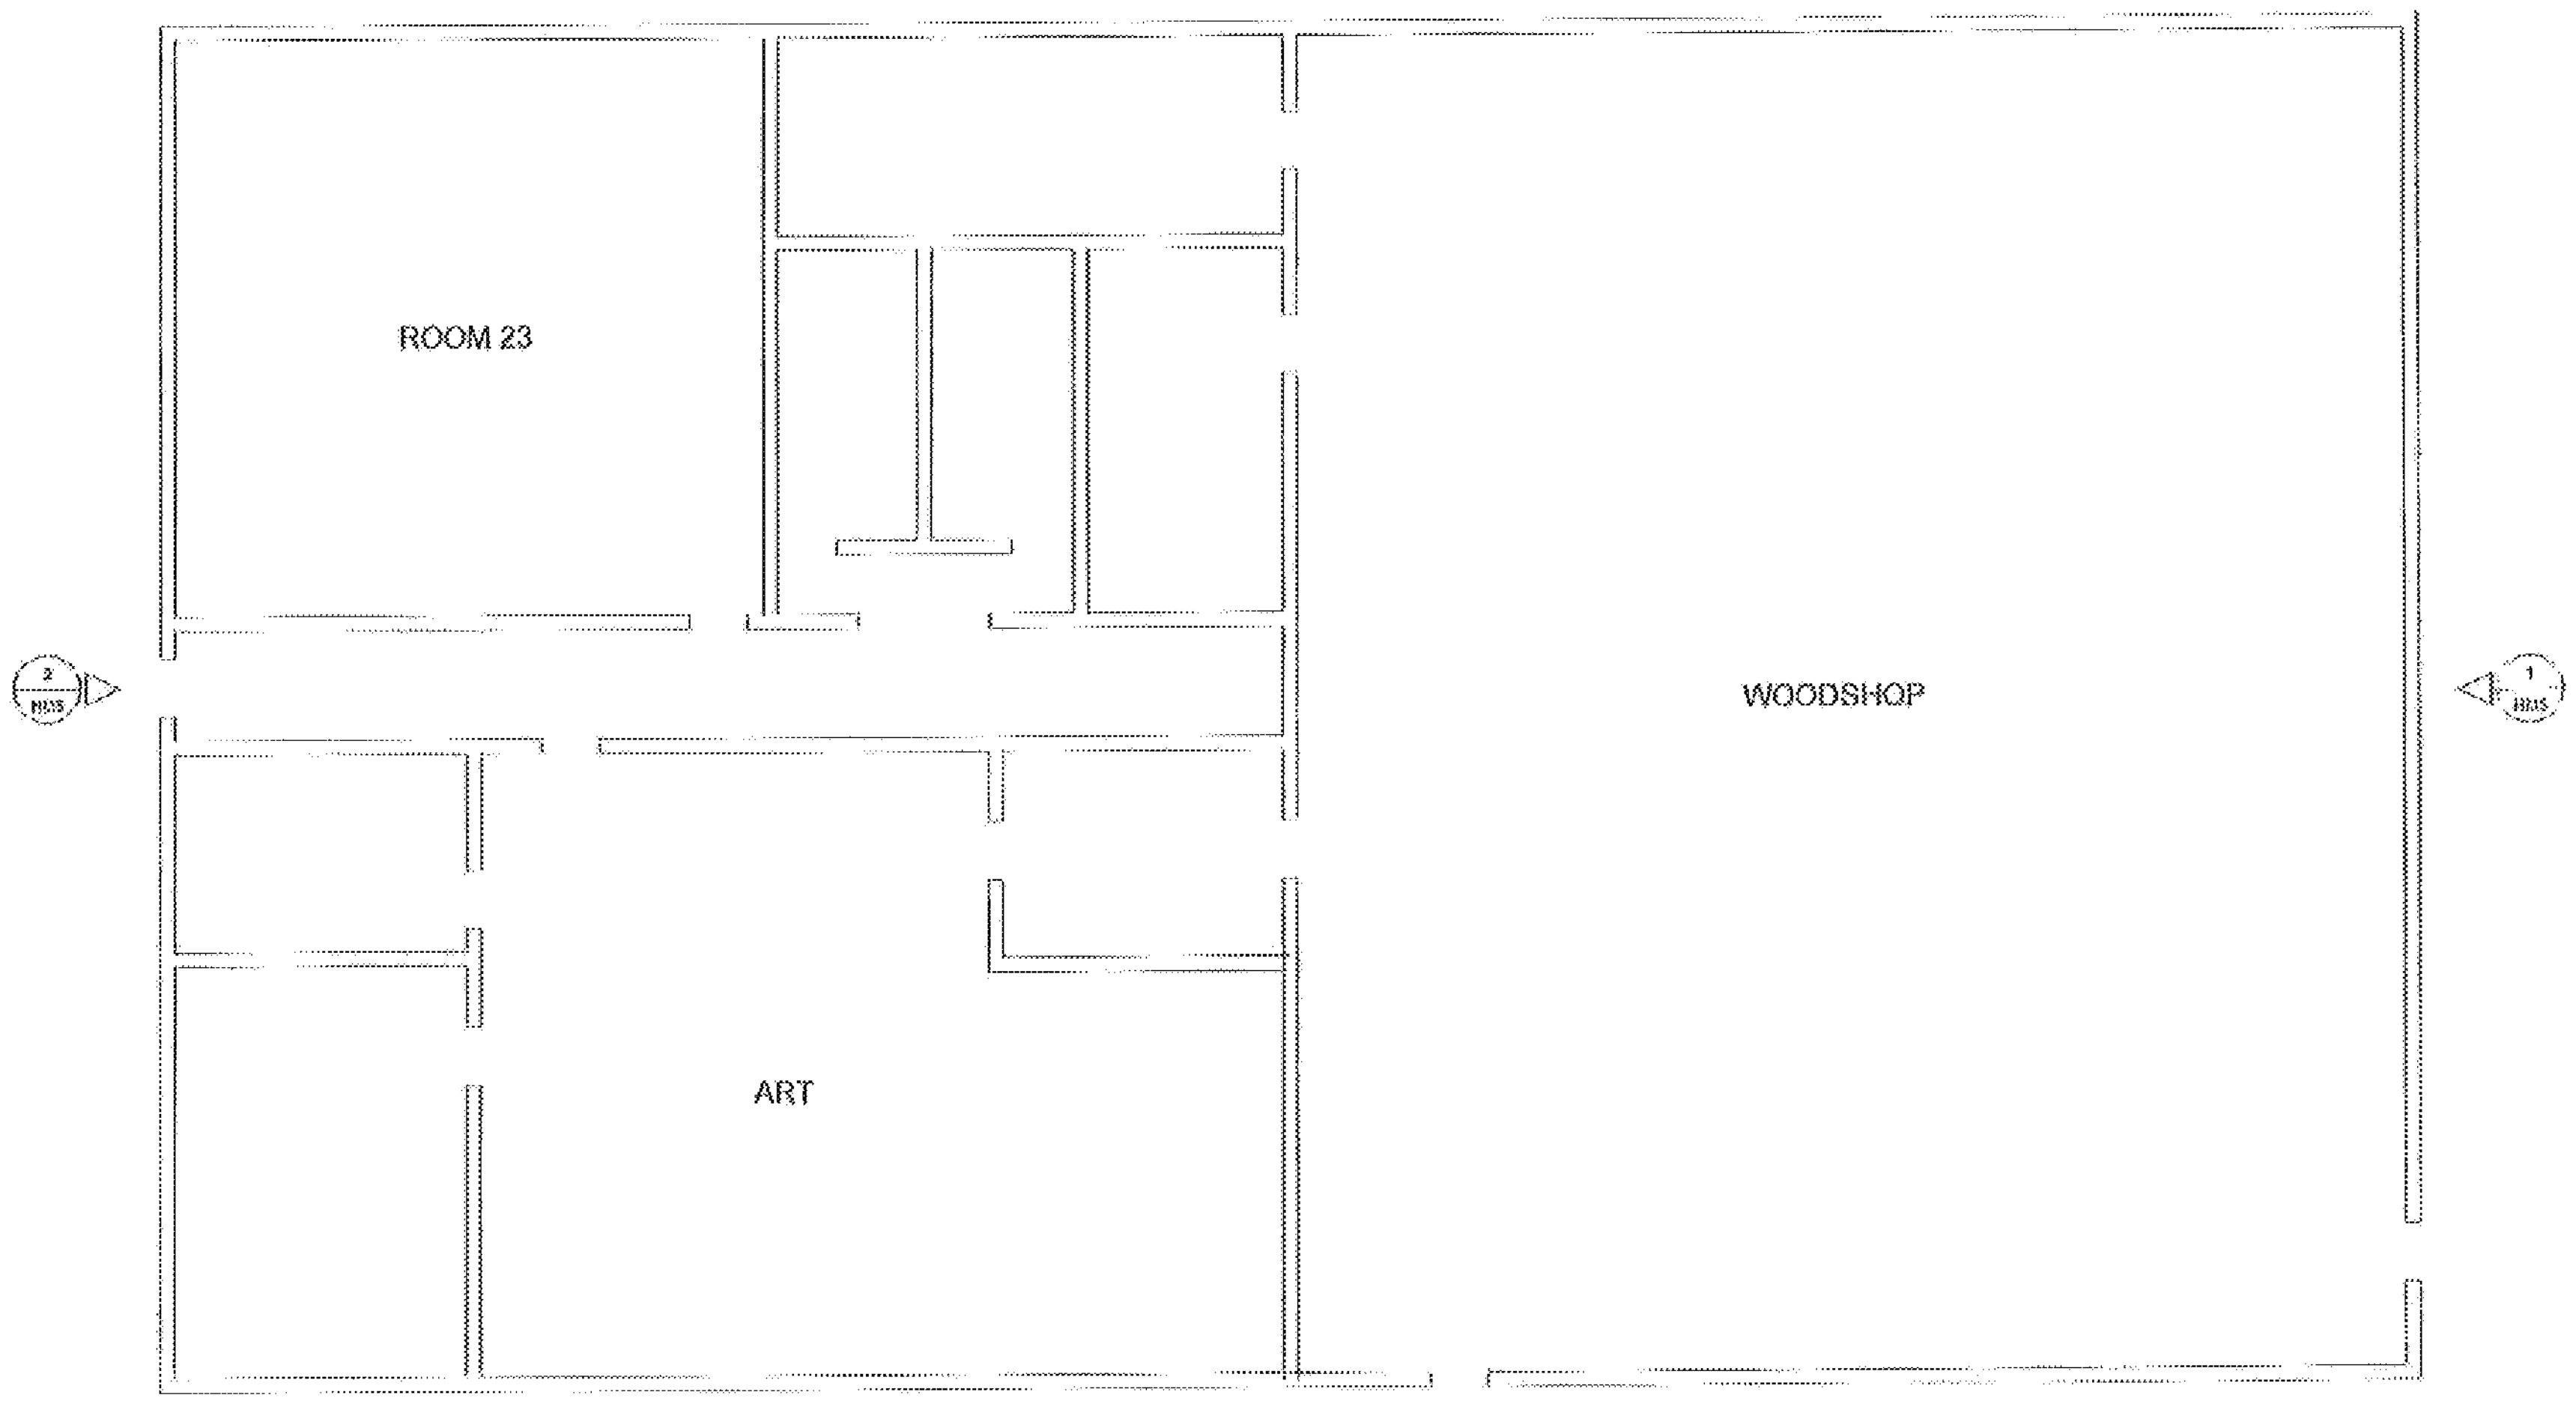
TECHNOLOGY BUILDING
NOT TO SCALE

(4) REMOVE PCB-CONTAINING SOFT GREY CAULKING. SEE DRAWING NOTE 1.

NO INTERIOR PCB CONTAINING CAULK IDENTIFIED
