PCB ABATEMENT CLOSEOUT SUMMARY REPORT

SKY VALLEY EDUCATION CENTER
351 Short Columbia Street
Monroe, Washington

October 2016
PBS Project # 41373.000

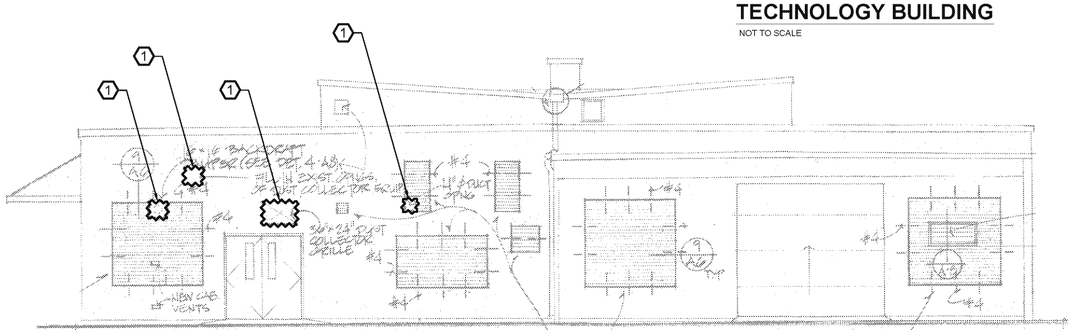
1 HM5 **TECHNOLOGY BUILDING EAST**

1. REMOVE APPROX. 60 LF OF PCB-CONTAINING CAULKING LOCATED ON EXTERIOR LOUVERS, VENTS AND DUCTING ON METAL TRANSITIONS ON THE WEST AND EAST EXTERIOR ELEVATIONS OF THE TECHNOLOGY BUILDING AS SHOWN.

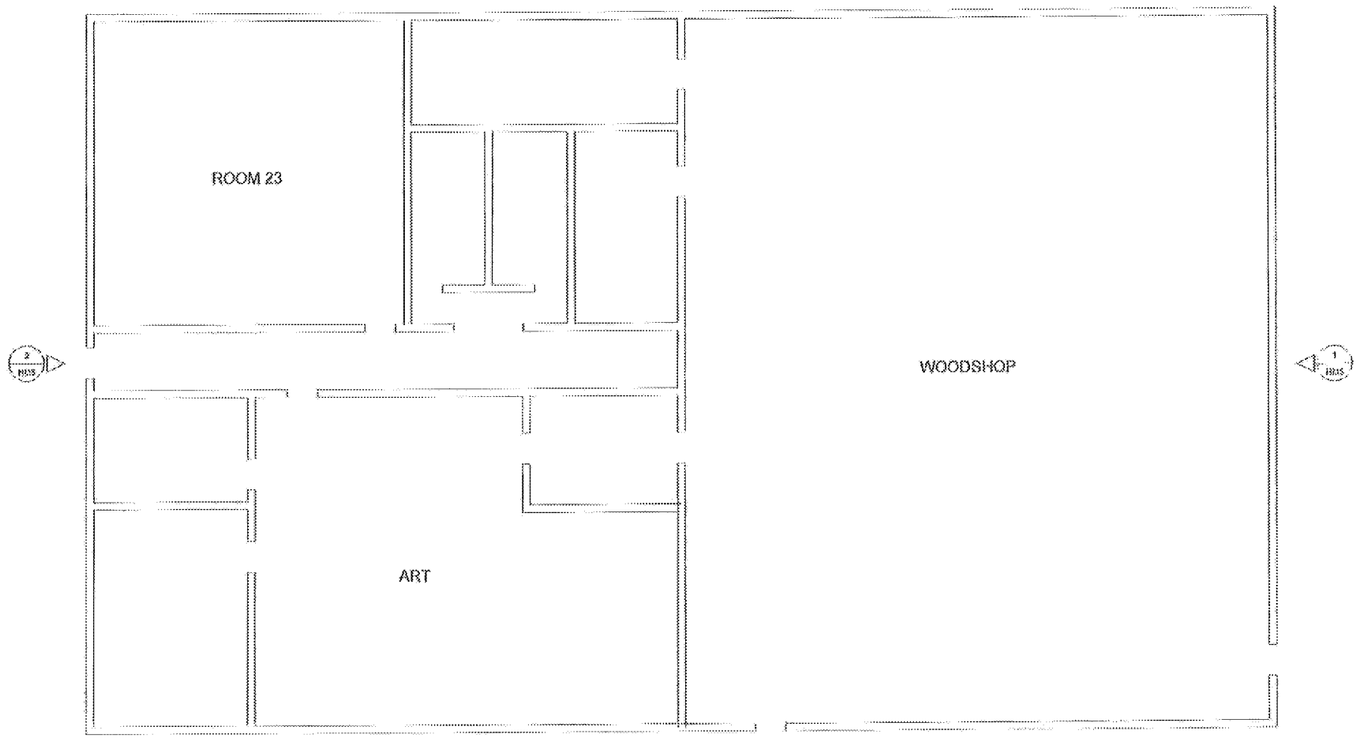
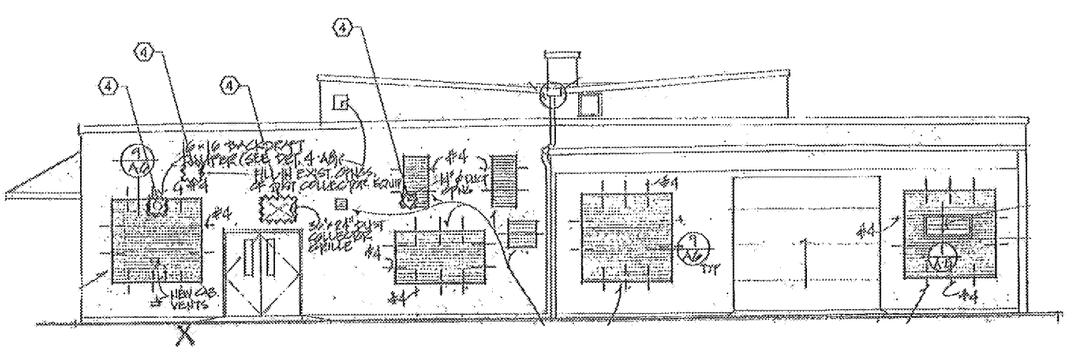
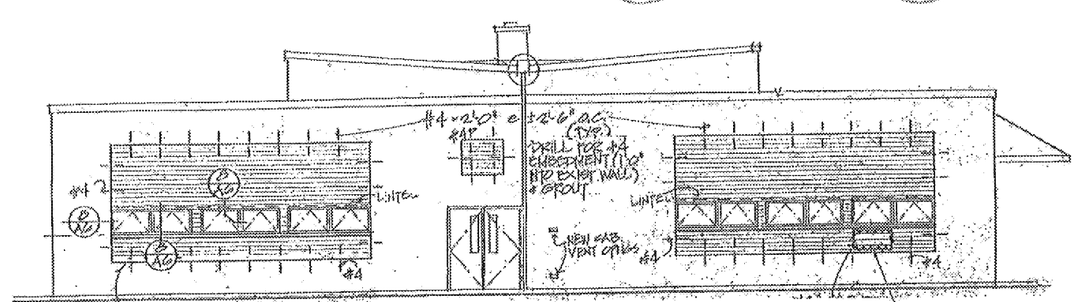
TECHNOLOGY BUILDING
NOT TO SCALE

4 REMOVE PCB-CONTAINING SOFT GREY CAULKING. SEE DRAWING NOTE 1.

NO INTERIOR PCB CONTAINING CAULK IDENTIFIED

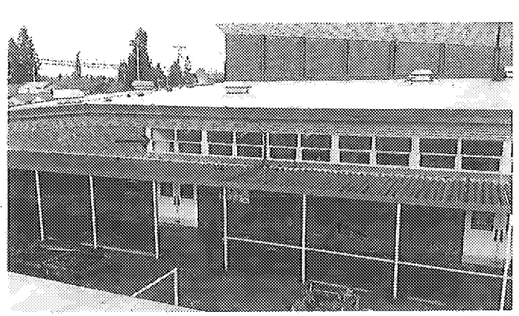
(2)(9) PHOTO DETAIL

(9) REMOVE APPROX. 780 LF OF PCB-CONTAINING CAULKING LOCATED ON ALL EXTERIOR VERTICAL STRUCTURAL METAL COLUMN TRANSITIONS THROUGHOUT THE LOWER WEST AND SOUTH ELEVATIONS OF THE LARGE GYM BUILDING AS SHOWN.

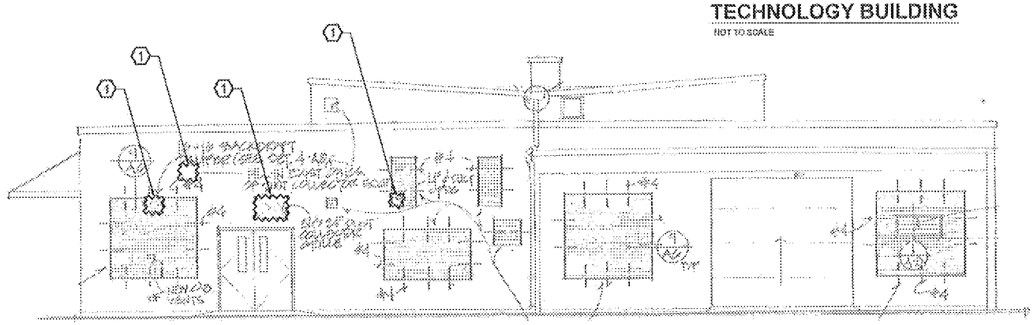
1 TECHNOLOGY BUILDING EAST
NOT TO SCALE

1. REMOVE APPROX. 60 LF OF PCB-CONTAINING CAULKING LOCATED ON EXTERIOR LOUVERS, VENTS AND DUCTING ON METAL TRANSITIONS ON THE WEST AND EAST EXTERIOR ELEVATIONS OF THE TECHNOLOGY BUILDING AS SHOWN.
