CAFO FACILITY INSPECTION REPORT

8365986001 WDID NUMBER	**Pat Carrigan** OWNER NAME	**American Beef Packers** FACILITY NAME
CAG018001 NPDES NUMBER	**Ex. 6 Personal Privacy (PP)** OWNER ADDRESS	FACILITY ADDRESS
R8-2007-0001 RWQCB ORDER NO.	**Chino, CA 91710** OWNER CITY AND STATE	**Ontario, CA 91762** FACILITY CITY AND STATE
03-06-2013 SCHEDULED INSPECTION DATE	**Pat Carrigan** OWNER CONTACT	**Sam Sousa** FACILITY CONTACT
03-06-2013 ACTUAL INSPECTION DATE	**Ex. 6 Personal Privacy (PP)** OWNER PHONE NO.	FACILITY PHONE NO.
Unknown RECEIVING WATER	Ex. 6 Personal Privacy (PP) FACILITY LATITUDE	Ex. 6 Personal Privacy (PP) FACILITY LONGITUDE

On March 6, 2013, a Concentrated Animal Feeding Operation (CAFO) inspection was conducted for Santa Ana Water Board Order No. R8-2007-0001 - 'General Waste Discharge Requirements for Concentrated Animal Feeding Operations (Dairies and Related Facilities) within the Santa Ana Region', NPDES General Permit No. (CAG018001) at American Beef Packers in Ontario, California (refer to Photo 1). The inspectors met with Mr. Sam Sousa (Manager, American Beef Packers) at approximately 9:00 AM on March 6, 2013. Mr. Sousa did not participate in the Facility site v

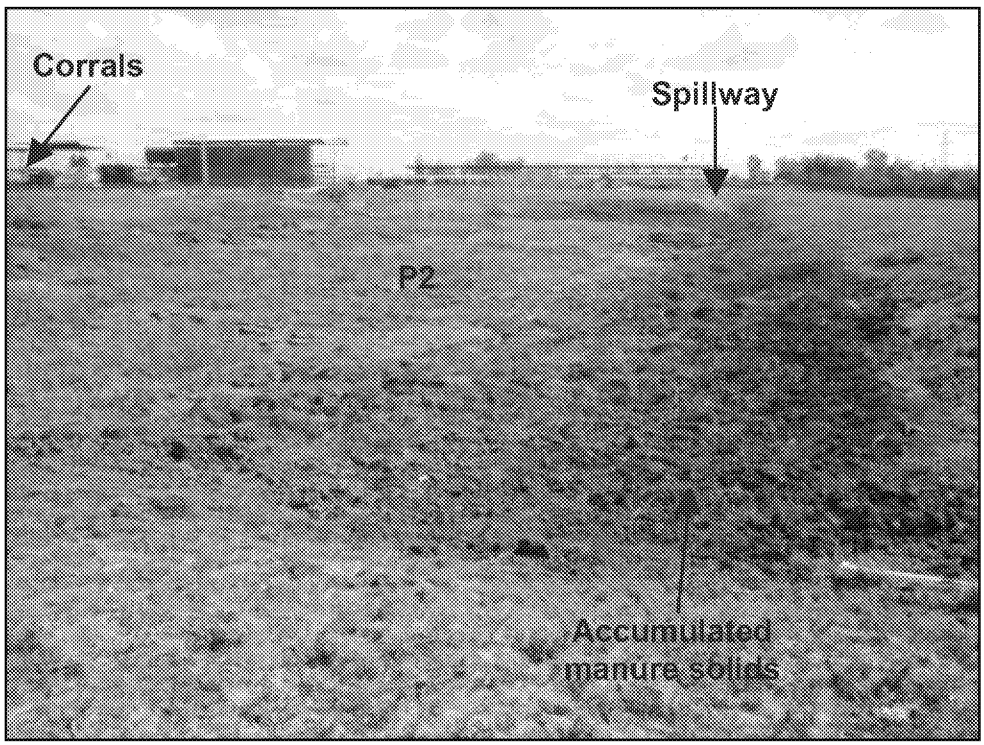
1. Depth markers were not installed in the three storage ponds, P1, P2, and P9, located in the southern and south-western portion of the Facility as required by Permit Attachment B - Monitoring and Reporting Program, Section I.B.1 (refer to Photos 2, 4, and 10). This is a recurring issue identified in a previous inspection conducted on September 24, 2008.

7. Accumulated manure solids and trash/debris were observed in P1 and P2 in the southern portion of the Facility (refer to Photos 2 through 7). The Discharger must design and maintain all containment structures per the EWMP as required by Provision VII.C.3.a of the Permit.

1. The inspectors observed, during the inspection, that depth markers were not installed in the three existing storage ponds, P1, P2, and P9, located in the southern and south-western portion of the Facility as required by Permit Attachment B - Monitoring and Reporting Program, Section I.B.1 (refer to Photos 2, 4, and 10). In addition, accumulated manure solids was observed inside P1 and P2; however, the inspectors could not determine the depth of the solids within each containment structure due to the lack of depth markers. This is a recurring issue identified in a previous inspection conducted on September 24, 2008.

3. The inspectors observed, during the inspection, accumulated manure solids and trash/debris in containment structures P1 and P2 in the southern portion of the Facility (refer to Photos 2 through 7). Mr. Sousa stated that per the Facility lease agreement with San Bernardino County (Owner/Discharger), he is not required to clean the ponds of any solids that accumulate in the bottom and that the ponds had not been cleaned of manure solids since American Beef Packers began operating at the Facility approximately three (3) years prior to the inspection. P1 and P2 did not contain depth markers; therefore, the inspectors were unable to determine the depth of accumulated manure solids in the ponds; however, an out of service floating pump was observed partially buried by the manure solids (refer to Photos 5 and 6). Section V - 'Operation and Maintenance', Item E - 'Solids Removal' states "as soon as practicable following the ending of the wet season, solids shall be removed from the containment basins to restore the minimum required available capacity of the basins prior to the next wet season." The Discharger must design and maintain all containment structures per the EWMP as required by Provision VII.C.3.a of the Permit.

Photograph 2. View facing east of P2 in the southeast portion of the Facility. The pond did not contain a depth marker. Note the accumulated manure solids in the pond.

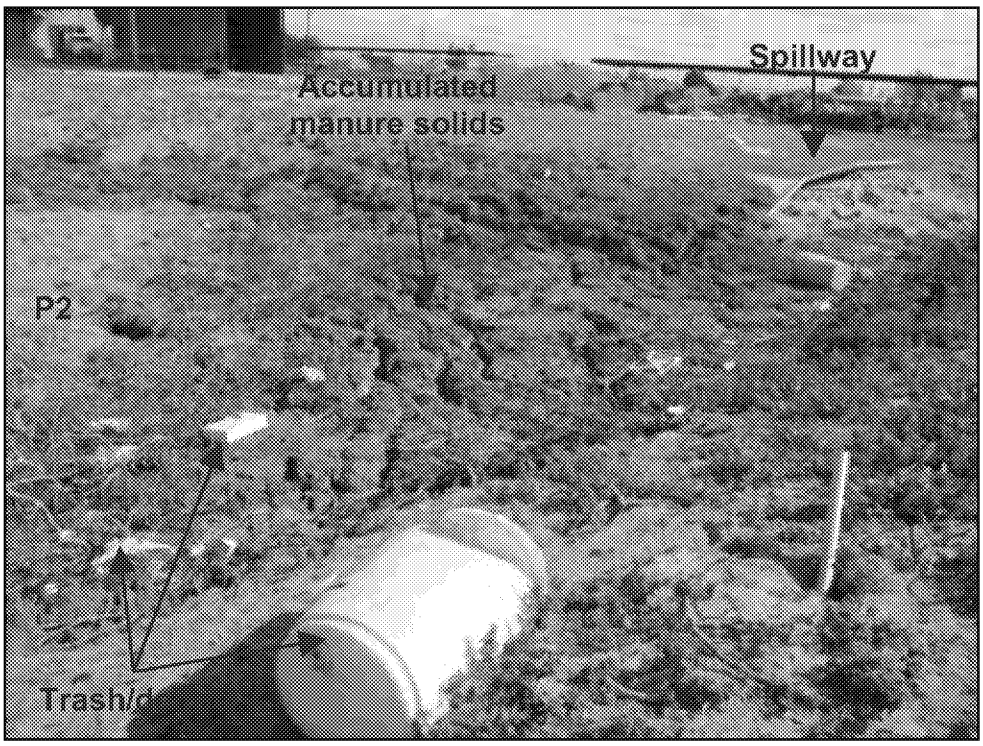
Photograph 3. View facing northeast of P2. Note the accumulated manure solids and trash/debris in the pond.

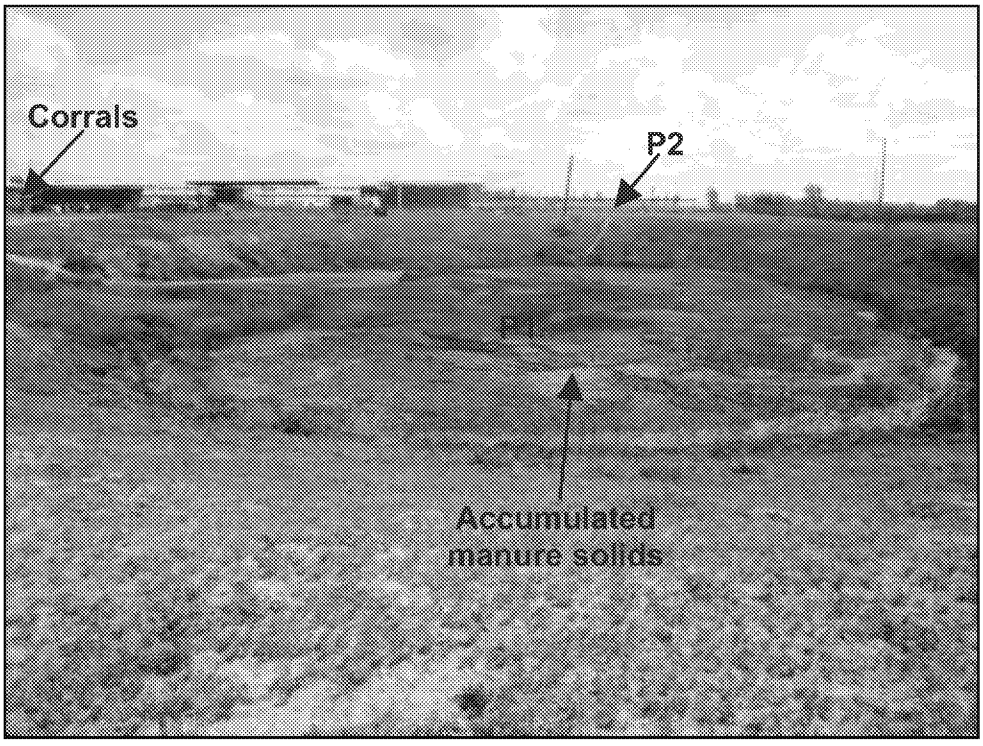
Photograph 4. View facing east of P1. Note the accumulated manure solids and lack of depth marker in the pond.

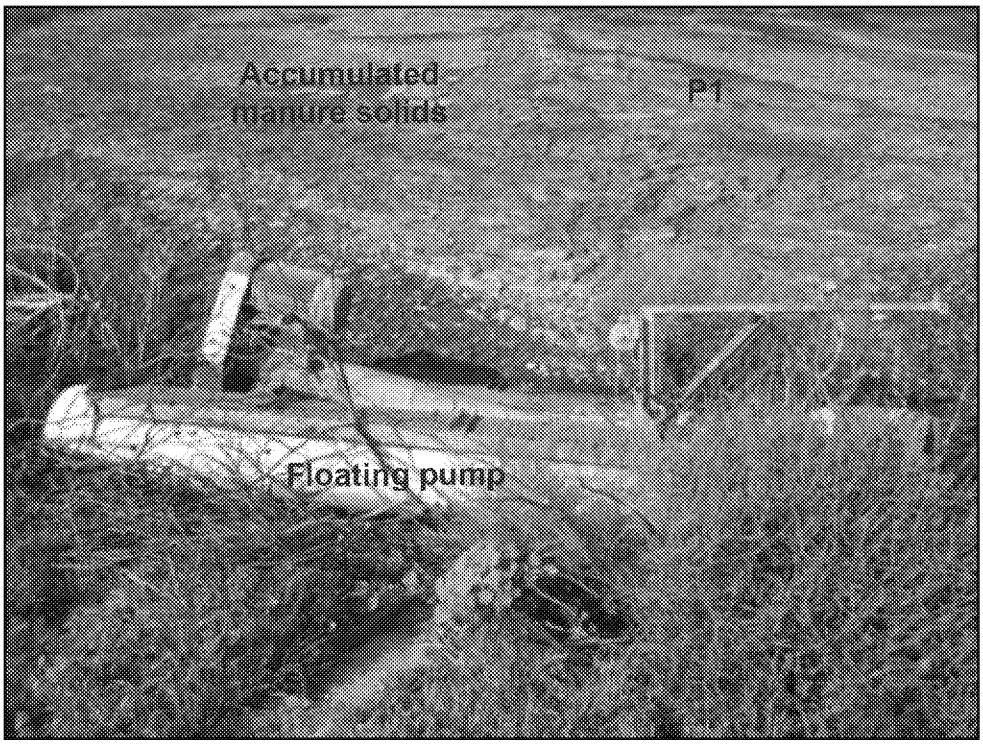
Photograph 6. Additional view of P1. Note the out of service floating pump partially buried in the accumulated manure solids.

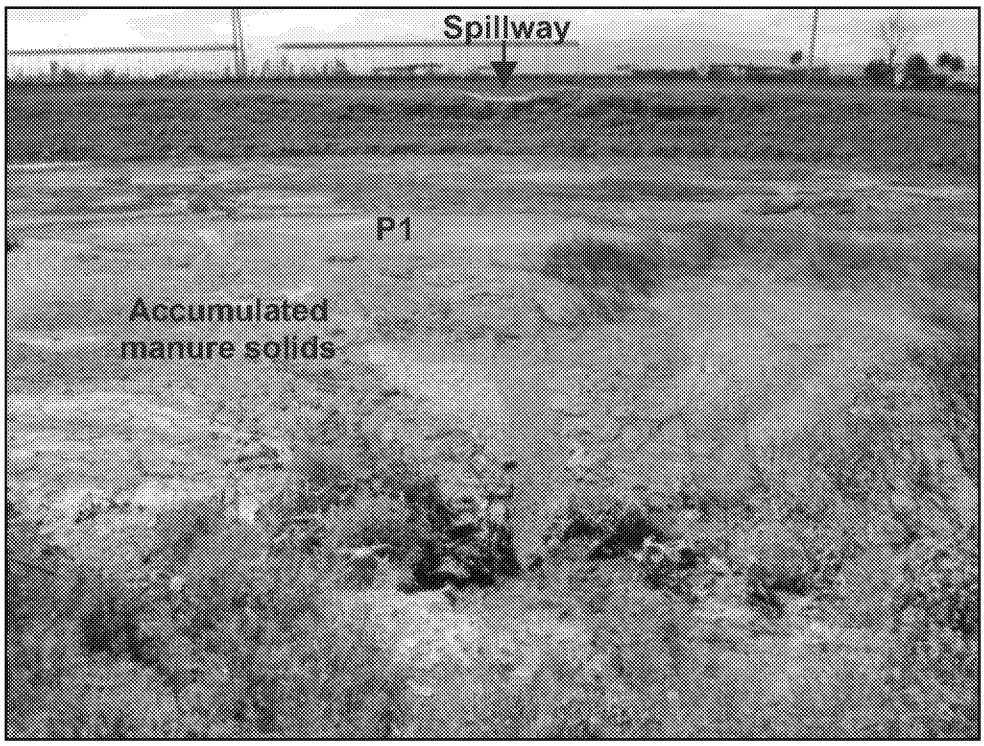
Photograph 7. View facing south of P1. Note the accumulated manure solids in the pond.

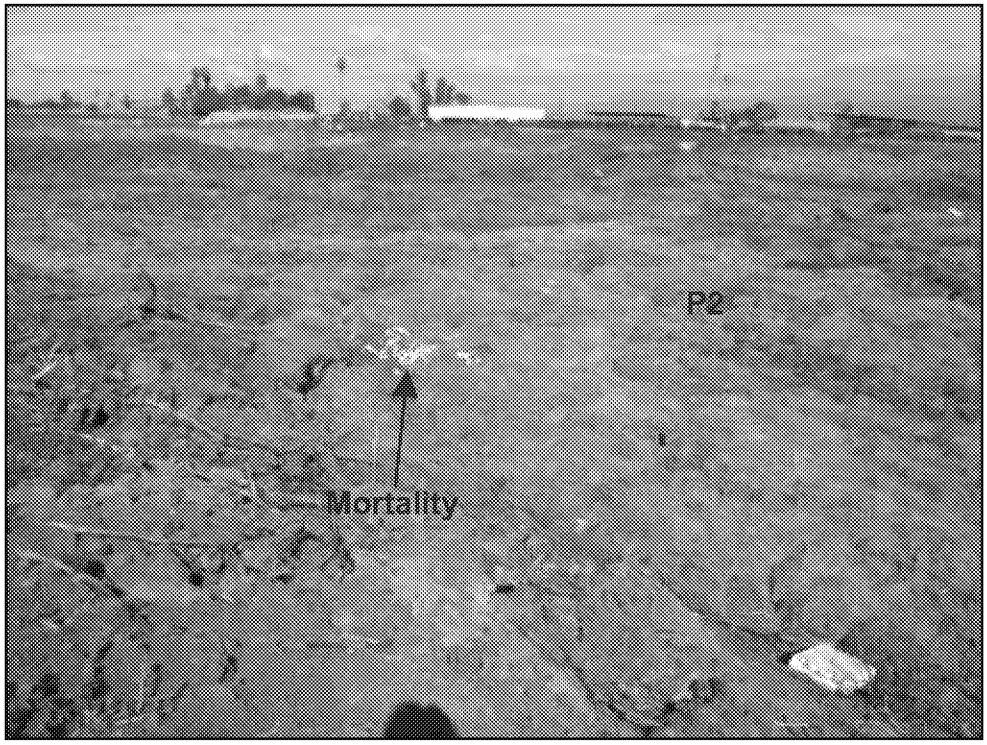
2. Evidence of previous mortality disposal (skeletal remains) was observed on the southern embankment of P2 located in the southern portion of the Facility (refer to Photos 8 and 9). Discharge Prohibition IV.F states that "the disposal of any mortality in any process wastewater system is prohibited."

2. The inspectors observed, during the inspection, evidence of previous mortality disposal (skeletal remains) on the southern embankment of P2 located in the southern portion of the Facility (refer to Photos 8 and 9). Mr. Sousa stated that all mortalities at the Facility are hauled away immediately by Stiles Animal Removal, Inc.; however, this had not been adequately implemented at the Facility. In addition, Mr. Sousa explained that he had not cleaned the ponds since he took operational control over the Facility approximately three (3) years prior to the inspection. Discharge Prohibition IV.F states that "the disposal of any mortality in any process wastewater system is prohibited."

Photograph 8. View facing northwest of P2. Note the evidence of a previous mortality disposal (skeletal remains) on the south side of P2.

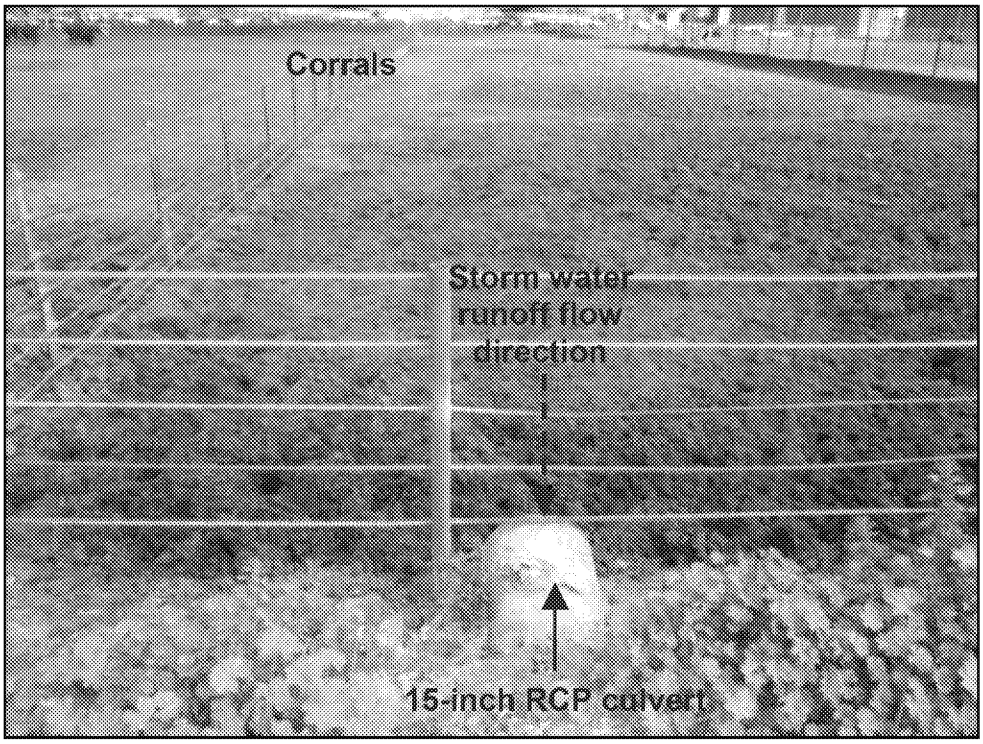
Photograph 12. View facing north of the 15-inch RCP shown in Photograph 11. Note this culvert conveys storm water runoff from the corrals into P2.

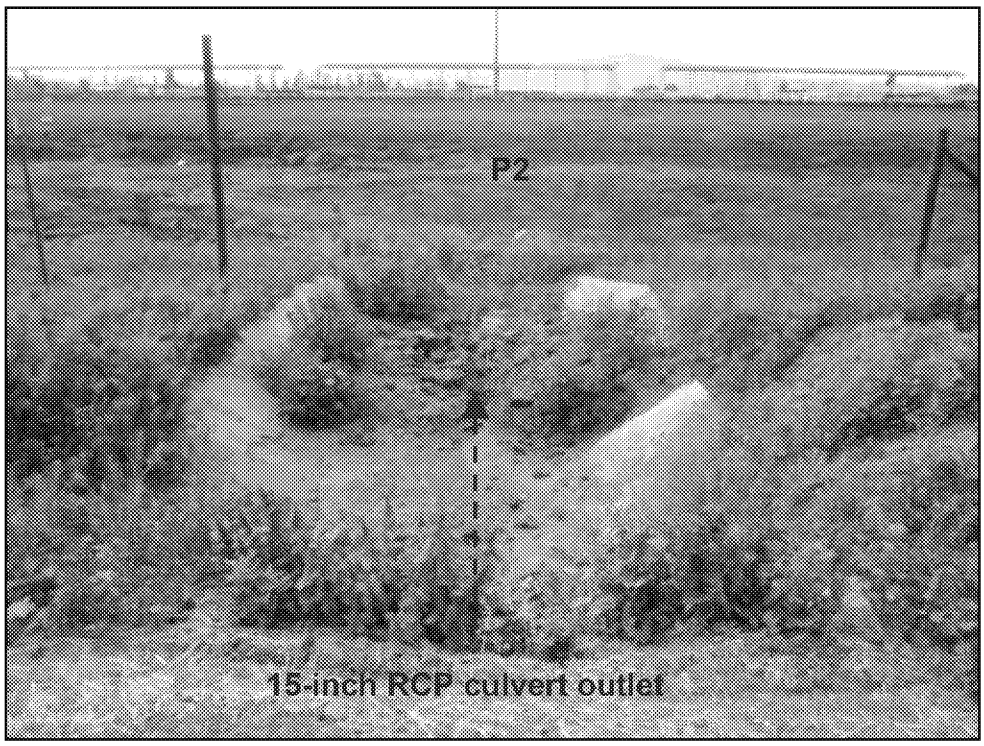
Photograph 13. View facing south of the 15-inch RCP culvert outlet into P2. Note this culvert conveys storm water runoff from the corrals into P2.

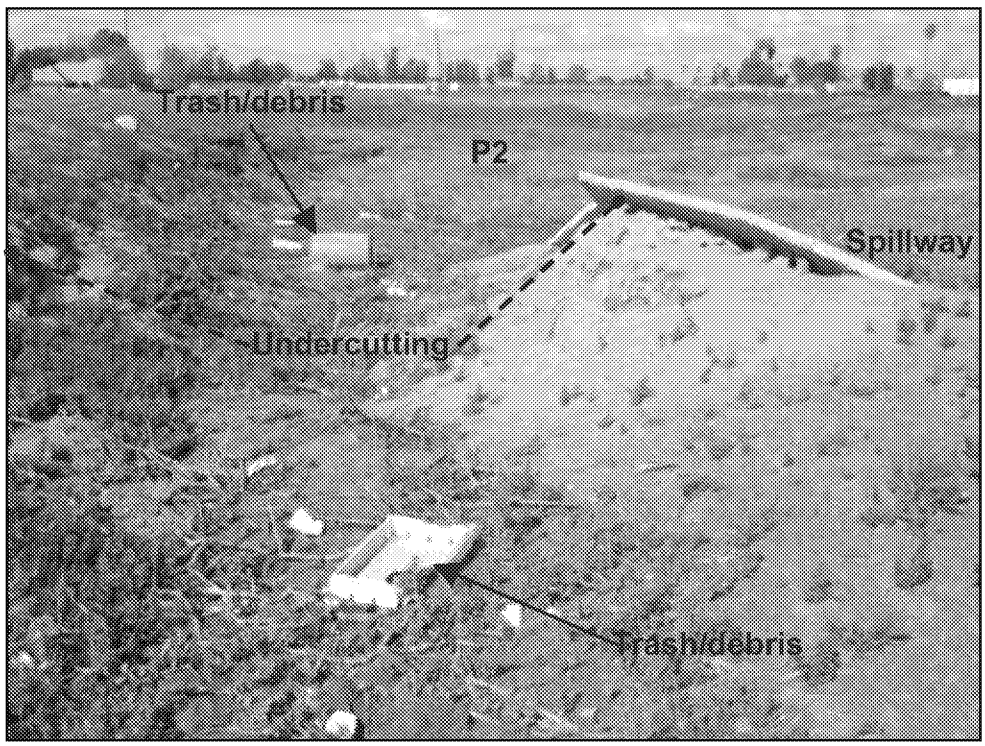
8. The concrete spillway on the east side of P2 was observed deteriorated and undercut (refer to Photos 15 and 16). The Discharger must design and maintain all containment structures per the EWMP as required by Provision VII.C.3.a of the Permit.

4. The inspectors observed, during the inspection, that the concrete spillway on the eastern side of P2 had become deteriorated and undercut, compromising the spillway's flow pathway (refer to Photos 15 and 16). Mr. Sousa stated that per the Facility lease agreement with San Bernardino County, he is not required to maintain the existing ponds in the southern portion of the Facility. As a result, the Discharger was not adequately maintaining all containment structures at the Facility. The Discharger must design and maintain all containment structures to retain all process wastewater and precipitation from a 25-year, 24-hour rainfall event at the Facility, as required by Provision VII.C.3.a of the Permit.

Photograph 16. View facing west of the concrete spillway on the east side of P2. Note the spillway was deteriorated and previous evidence of undercutting was observed. Note the accumulated trash/debris within the pond.

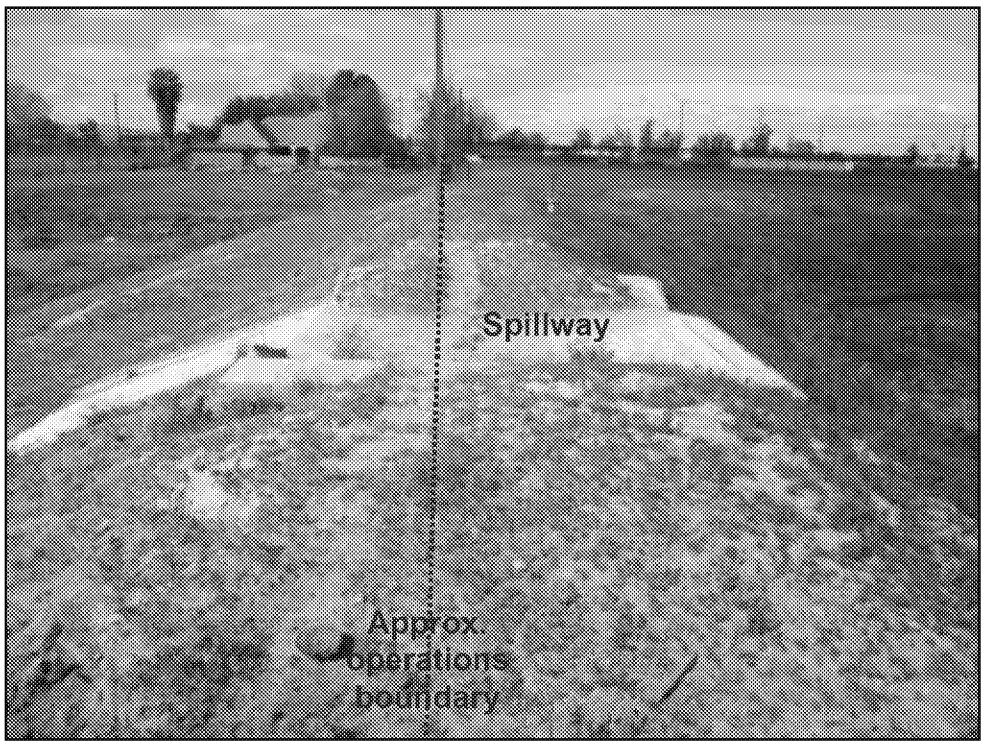
Photograph 17. View facing west of the concrete spillway on the south side of P1.

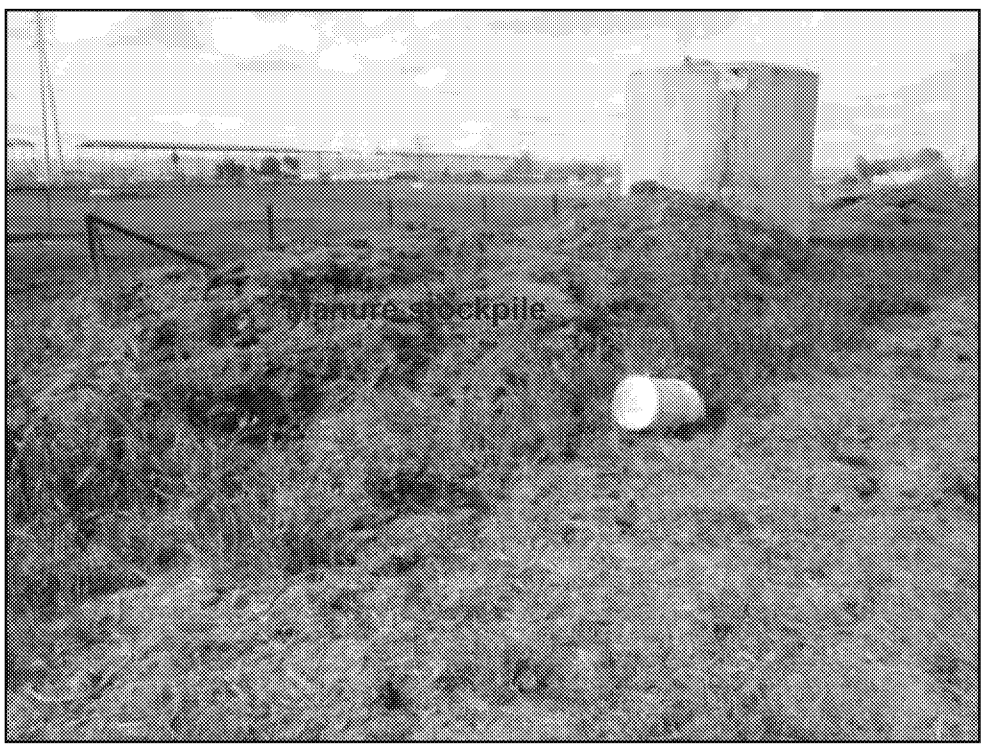
6. Manure stockpiles located in the southern portion of the Facility had not been removed from the Facility within 180 days as required by Provision VII.C.5.e of the Permit (refer to Photos 18 and 19).

1. The inspectors observed, during the inspection, a manure stockpile with vegetation growth located in the southern portion of the Facility, northeast of P2 (refer to Photos 18 and 19). Mr. Sousa stated that the manure stockpile was leftover from the previous tenant and most likely had been stored at that location for multiple years. As a result, the manure stockpile had not been removed from the Facility within 180 days as required by Provision VII.C.5.e of the Permit.

Photograph 18. View facing southwest of an old manure stockpile located in the south-eastern portion of the Facility.
