CAFO FACILITY INSPECTION REPORT

8335286001A WDID NUMBER	**Pete Vanderham** OWNER NAME	**Pete Vanderham Dairy** FACILITY NAME
CAG018001 NPDES NUMBER	**Ex. 6 Personal Privacy (PP)** OWNER ADDRESS	FACILITY ADDRESS
R8-2007-0001 RWQCB ORDER NO.	**Mira Loma, CA 91752** OWNER CITY AND STATE	**Mira Loma, CA 91752** FACILITY CITY AND STATE
03/07/2013 SCHEDULED INSPECTION DATE	**Pete Vanderham** OWNER CONTACT	**Pete Vanderham** FACILITY CONTACT
03/07/2013 ACTUAL INSPECTION DATE	**Ex. 6 Personal Privacy (PP)** OWNER PHONE NO.	FACILITY PHONE NO.
Unknown RECEIVING WATER	Ex. 6 Personal Privacy (PP) FACILITY LATITUDE	Ex. 6 Personal Privacy (PP) FACILITY LONGITUDE

On March 7, 2013, a Concentrated Animal Feeding Operation (CAFO) inspection was conducted for Santa Ana Water Board Order No. R8-2007-0001 - 'General Waste Discharge Requirements for Concentrated Animal Feeding Operations (Dairies and Related Facilities) within the Santa Ana Region', NPDES General Permit No. (CAG018001) at Pete Vanderham Dairy in Mira Loma, California (refer to Photo 1). The inspector met with Mr. Pete Vanderham (Owner, Pete Vanderham Dairy) at approximately 8:30 AM on March 7, 2013. Mr. Vanderham accompanied the inspe

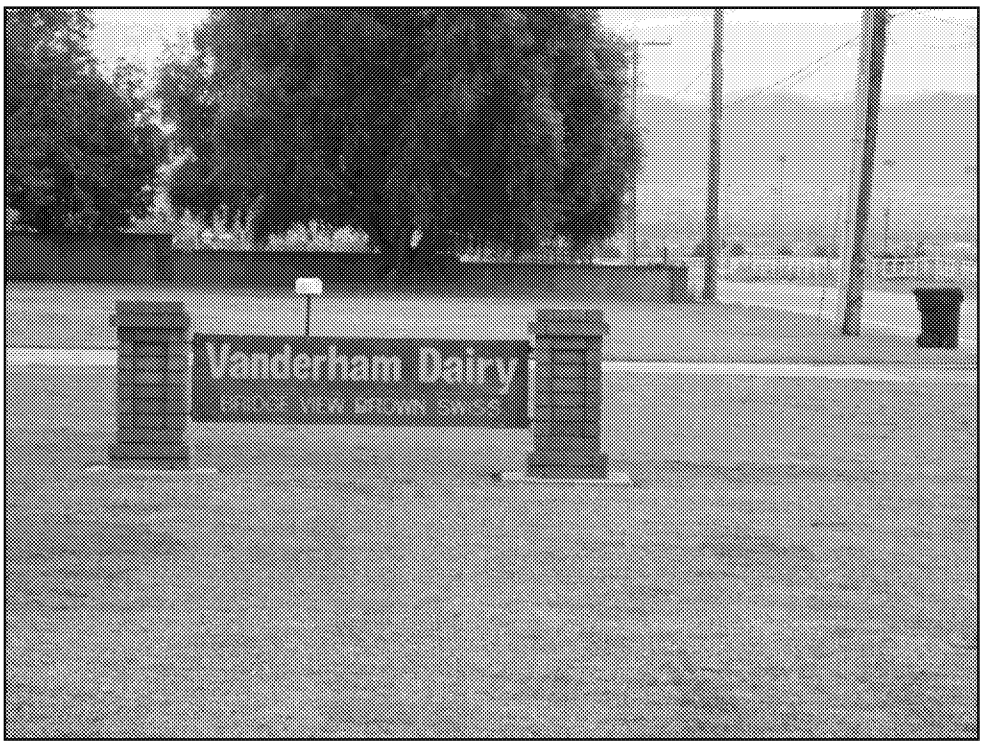
Photograph 1. Pete Vanderham Dairy Facility sign.

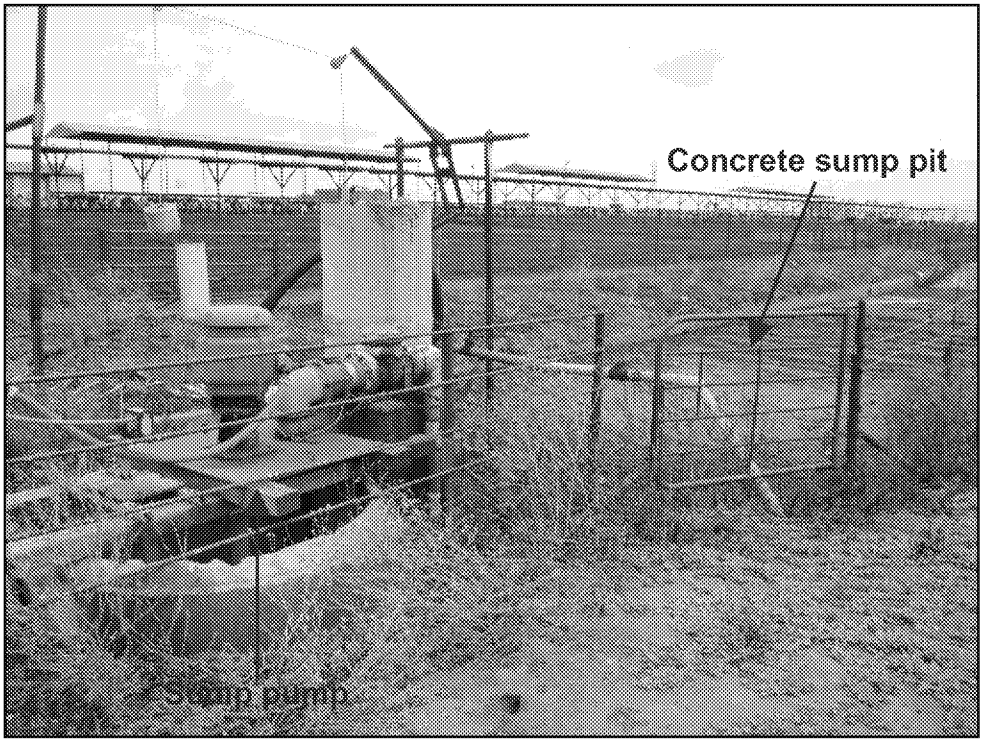
Photograph 2. View facing northwest of the concrete sump pit located in the central-west portion of the Facility.

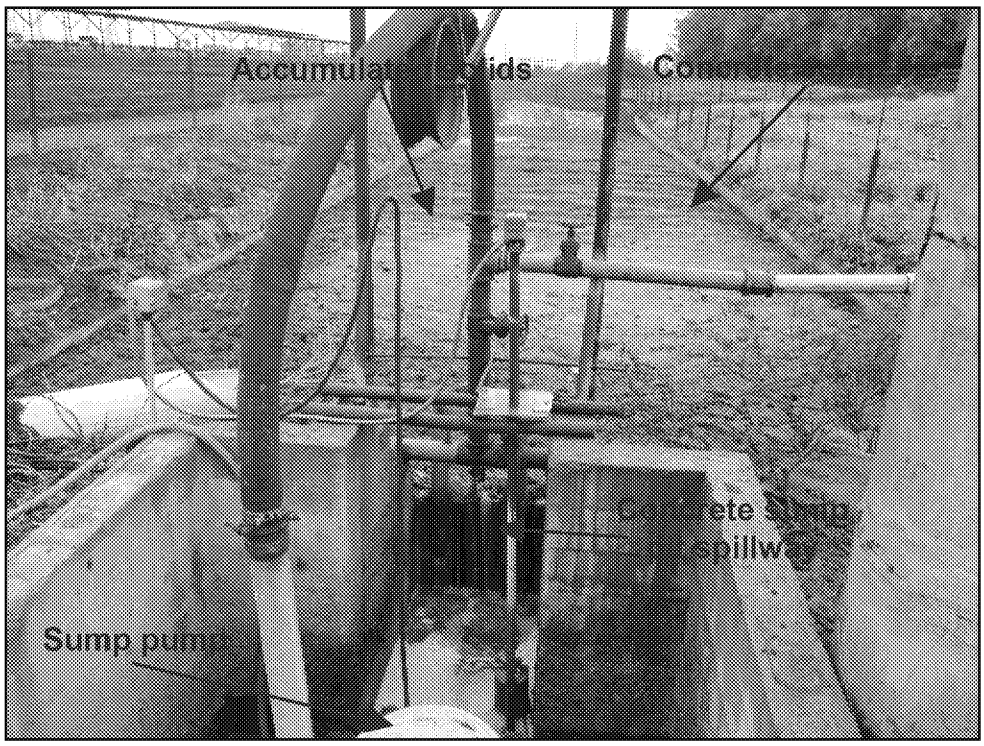
Photograph 3. View facing north of the concrete sump pit located in the central-west portion of the Facility, shown in Photograph 2.

Photograph 4. View facing southeast of basin D. Note the basin did not contain a depth marker. Also note accumulated solids were observed in the basin. A concrete spillway was located in the southwest corner of the basin.

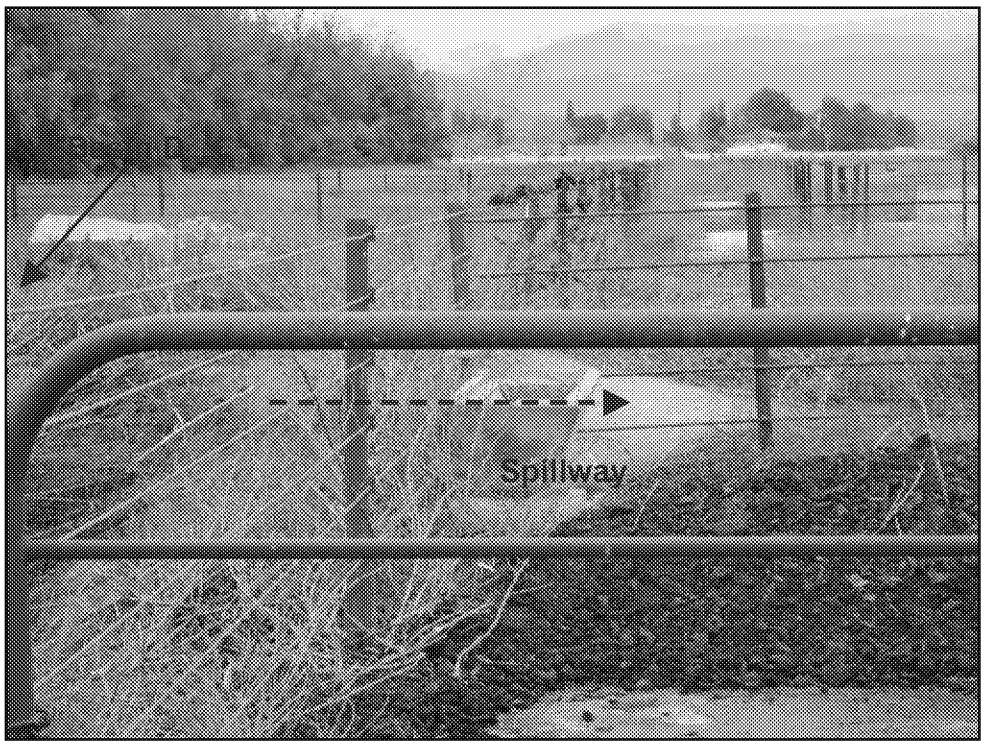
Photograph 5. View facing south of the concrete spillway located in the southwest corner of basin D.

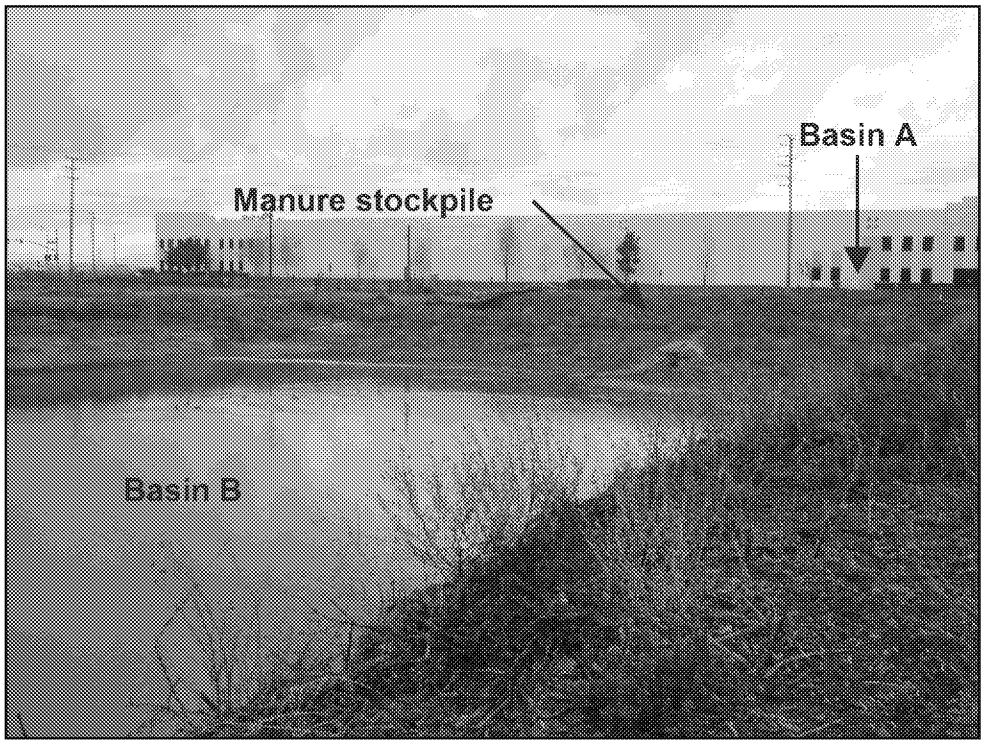
1. Depth markers were not installed in basins A, B, and C, located in the northern portion of the Facility, or in basin D located in the southeastern portion of the Facility, as required by Permit Attachment B - Monitoring and Reporting Program, Section I.B.1 (refer to Photos 4, 6, 9, 10, and 12). This is a recurring issue identified in a previous inspection conducted on December 9, 2011.

1. The inspector observed, during the inspection, that depth markers had not been not installed in basins A, B, and C located in the northern portion of the Facility, and in basin D located in the southeastern portion of the Facility as required by the Permit (refer to Photos 4, 6, 9, 10, and 12). Permit Attachment B - Monitoring and Reporting Program, Section I.B.1 states that "a marker shall be placed within each pond or impoundment to indicate the

6. The inspector observed, during the inspection, that pond solids/manure had been stockpiled on the exisiting berms on the western side of basin C, the northern side of basin B, and the southwestern side of basin A (refer to Photos 6 through 9, 11, and 13). Provision VII.C.5.c of the Permit states "no containment structures shall be constructed of manure, and manure shall not be used to improve or raise existing containment structures." Mr Vanderham informed the inspector that the basins were last cleaned in the summer of 2012.

Photograph 6. View facing north of basin B. Note the basin did not contain a depth marker. Also note a manure stockpile was located on the north side of the basin's berm, immediately south of basin A.

1. Verify basins contain depth markers

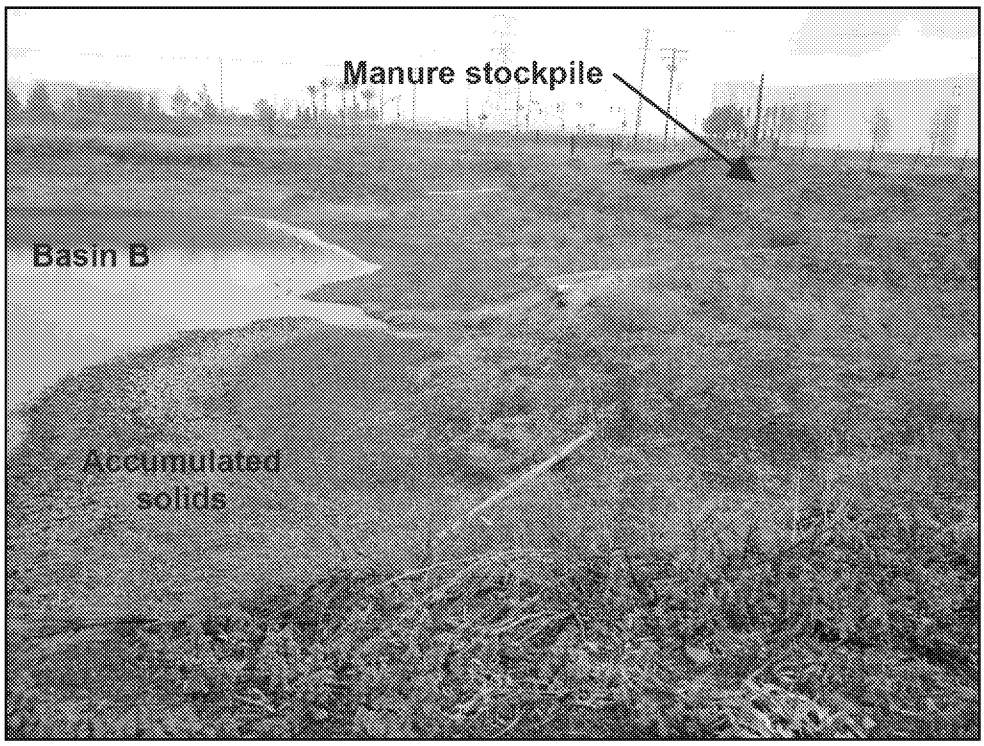
4. The inspector observed, during the inspection, accumulated solids in basins A, B and C in the northern portion of the Facility, and in basin D in the southeast portion of the Facility (refer to Photos 4, 7, 11, and 12). Mr. Vanderham stated that the containment structures at the Facility are typically cleaned every summer, and were last cleaned in the summer of 2012. It should be noted that basins B, C, and D did not contain depth markers; therefore, the inspector was unable to determine the depth of accumulated manure solids in the ponds (refer to Photo 4). Section 1.5.4 - 'Operation and Maintenance Plan' of the approved EWMP states "prior to the wet cycle (beginning Oct. 15), accumulated solids and manure shall be removed from the holding ponds to reestablish the design capacity." As a result, the overall capacity of the basins at the Facility may be diminished. Provision VII.C.3.a of the Permit states that "the discharger shall design, construct, and maintain containment structures to retain all wastewater within the facility, including all process wastewater and all precipitation on, and drainage through, manured areas resulting from rainfall up to and including a 25-year, 24-hour rainfall event." The Discharger must design and maintain all containment structures per the approved EWMP as required by Provision VII.C.3.a of the Permit. This is a recurring issue identified in a previous inspection conducted on December 9, 2011.

Photograph 7. View facing northwest of basin B, shown in Photograph 6. Note a manure stockpile was located on the north side of the basin's berm, immediately south of basin A. Note accumulated solids was observed in basin B.

Photograph 8. Close-up view facing west of the manure stockpile located on the north side of basin B berm, shown in Photograph 6 and 7.

5. Verify basins are maintained and free of accumulated solids and vegetation

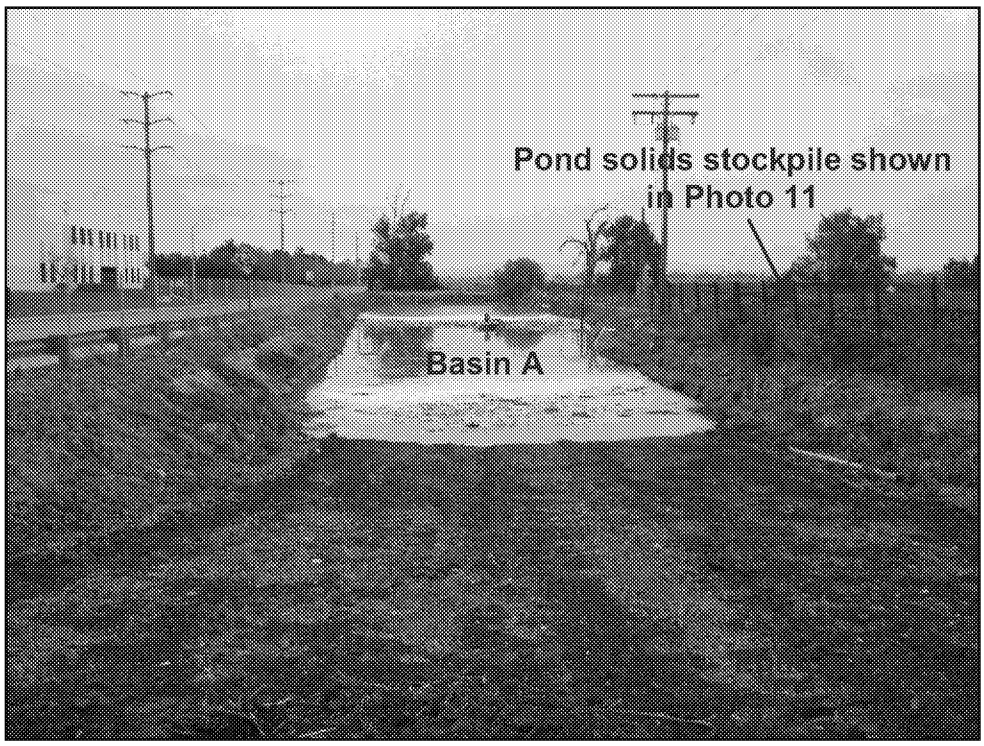
Photograph 9. View facing east of basin A. Note the basin did not contain a depth marker. Also note a manure stockpile and/or removed pond solids was located immediately south of the basin.

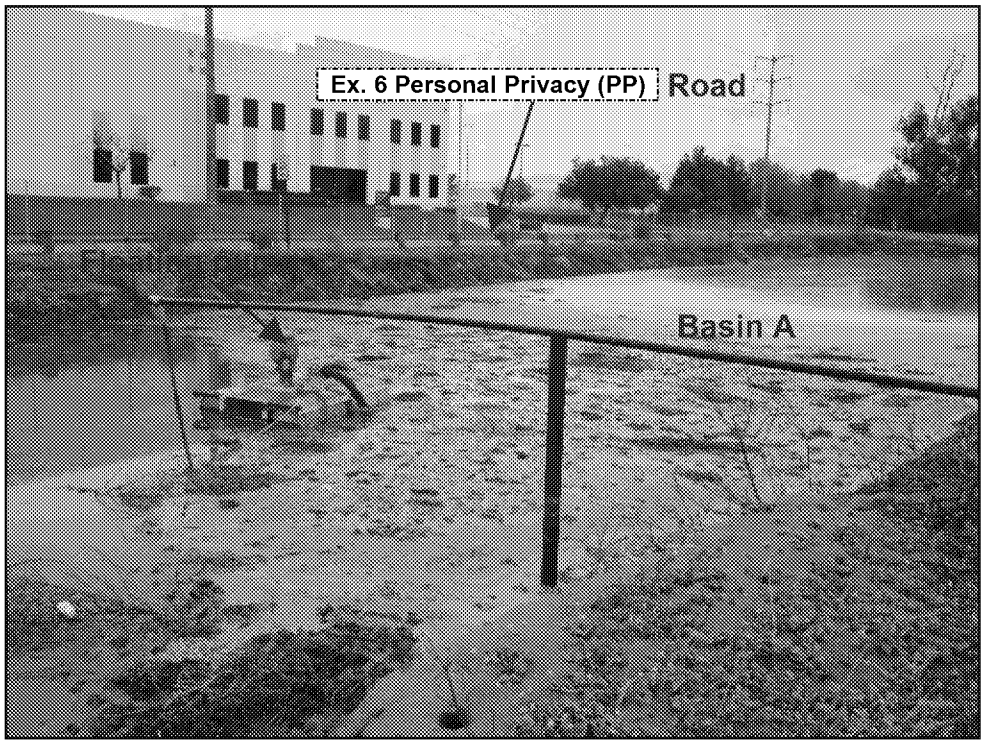
Photograph 10. View facing northeast of basin A, shown in Photograph 9. Note the basin did not contain a depth marker.

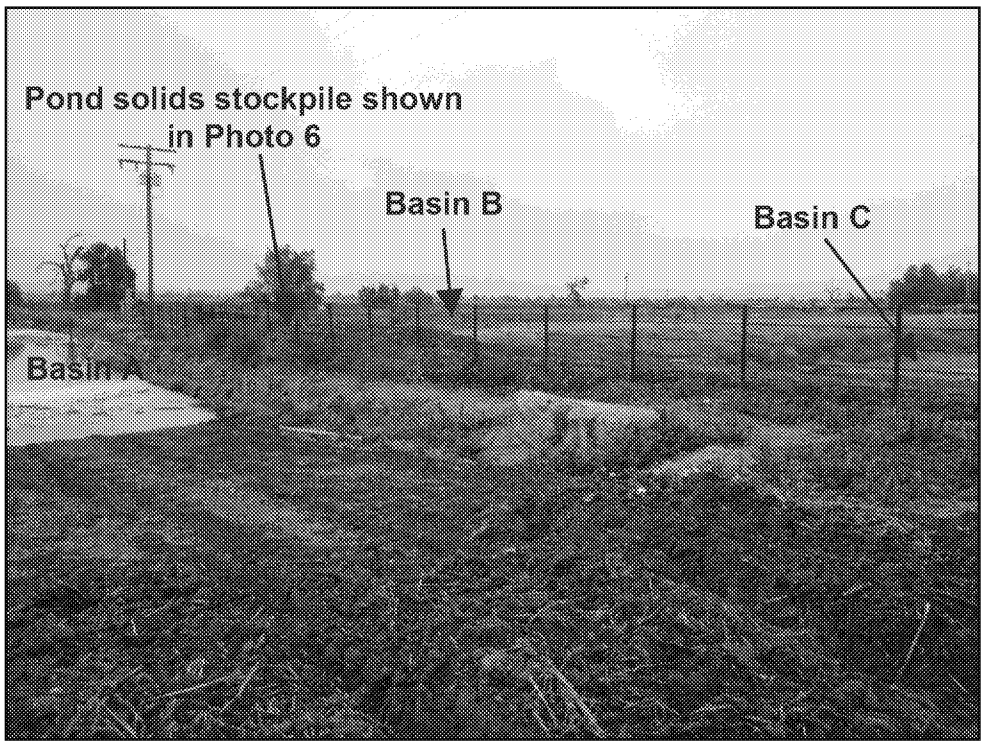
Photograph 11. View facing southeast of pond solids stored in the southwest corner of basin A and south of basin A.

7. Verify manure is not being used to enhance or raise berms throughout the Facility

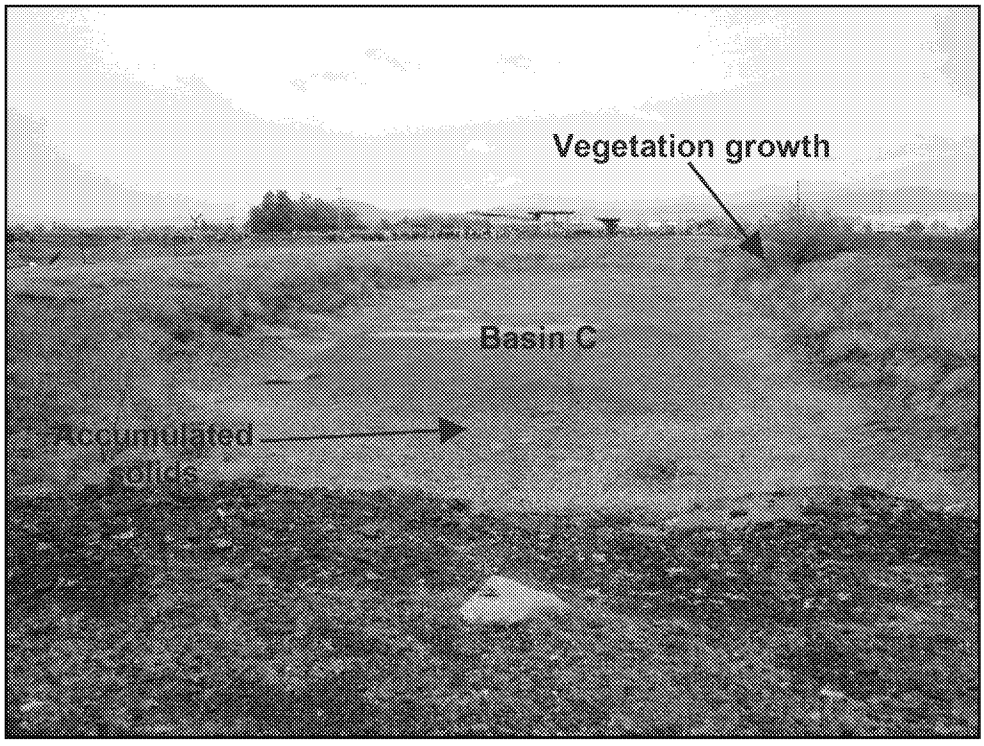
5. The inspector observed, during the inspection, that vegetation growth potentially affecting the containment structure capacity was present in basin C located in the northern portion of the Facility (refer to Photos 12 and 13). Section 1.5.4 - 'Operation and Maintenance' of the approved EWMP states that the Discharger shall "maintain weed control at the top and inside of the pond embankments. As a result, the overall capacity of the basin at the Facility may be diminished. Provision VII.C.3.a of the Permit states that "the discharger shall design, construct, and maintain containment structures to retain all wastewater within the facility, including all process wastewater and all precipitation on, and drainage through, manured areas resulting from rainfall up to and including a 25-year, 24-hour rainfall event." The Discharger must design and maintain all containment structures per the approved EWMP as required by Provision VII.C.3.a of the Permit. This is a recurring issue identified in a previous inspection conducted on December 9, 2011.

Photograph 12. View facing south of basin C. Note the basin did not contain a depth marker. Also note accumulated solids and vegetation growth was observed in the basin.

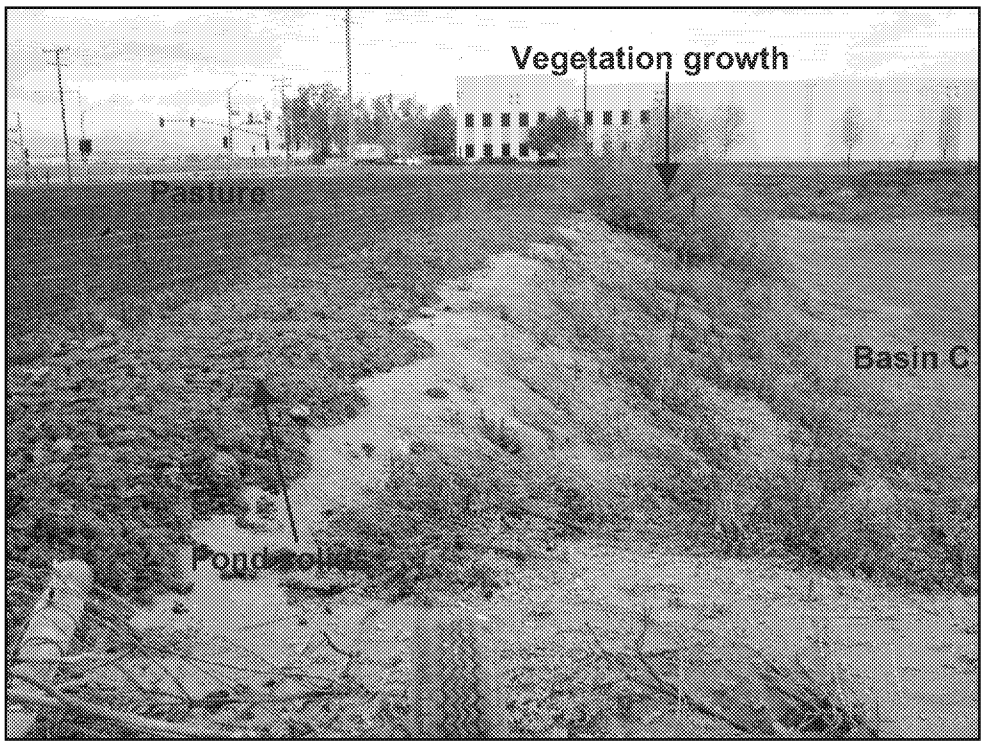
Photograph 13. View facing north of pond solids stored on the west berm of basin C. Also note the basin did not contain a depth marker, and was observed with accumulated solids and vegetation growth.

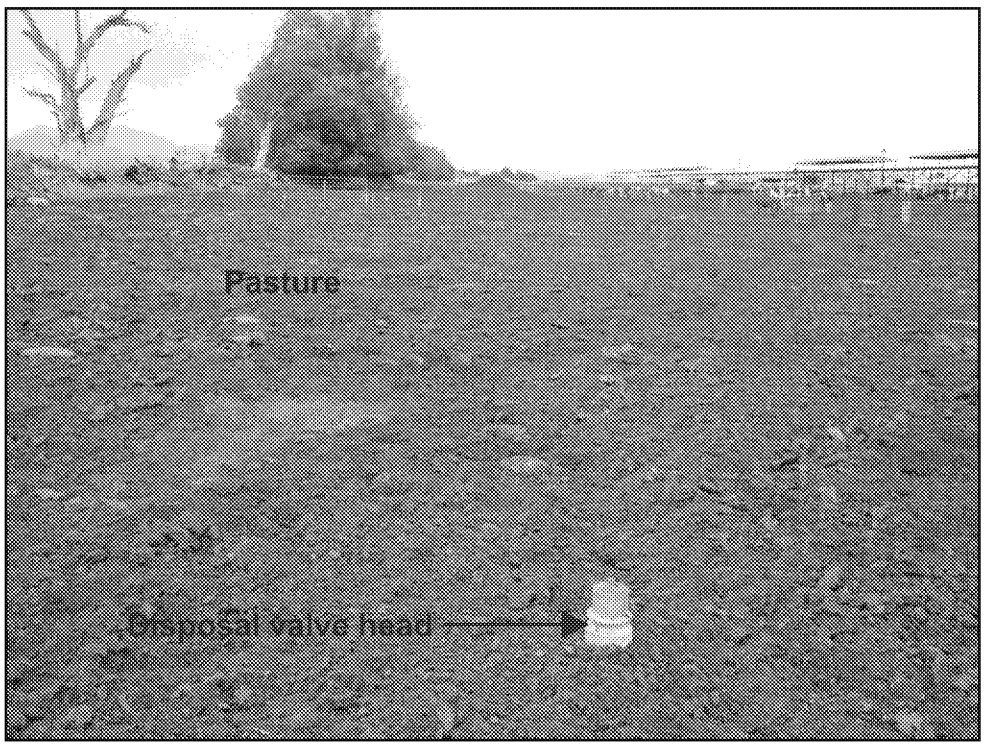
Photograph 14. View facing south of a process wastewater disposal valve head located in the pasture in the northeast portion of the Facility.

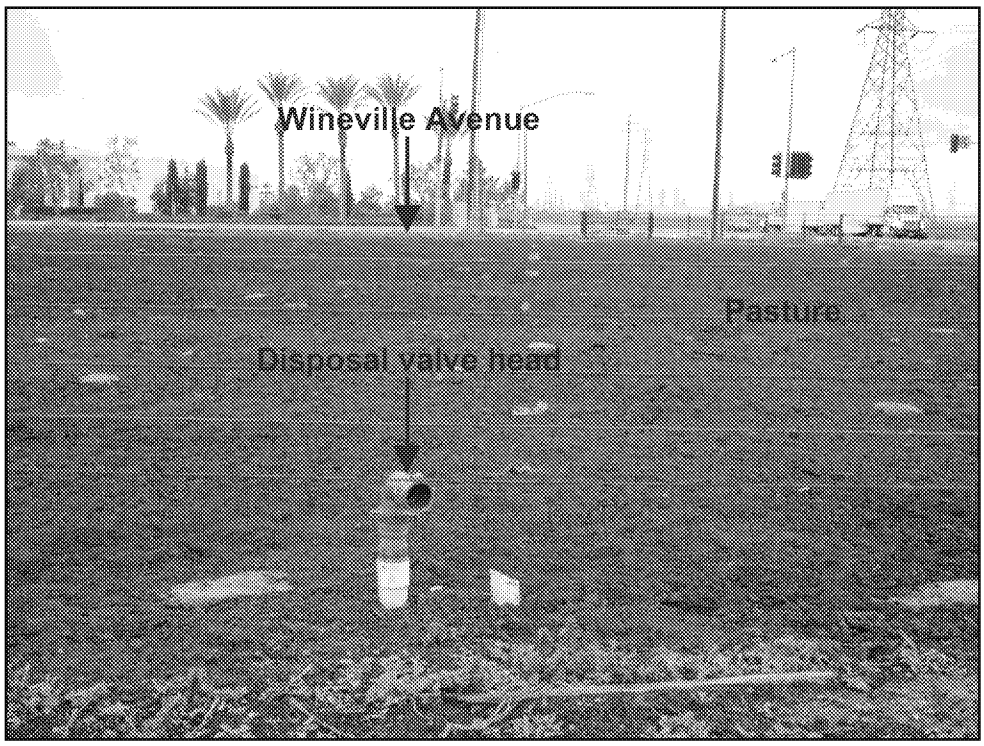
Photograph 15. View facing west of a process wastewater disposal valve head located in the pasture in the northwest portion of the Facility, adjacent to Wineville Avenue.

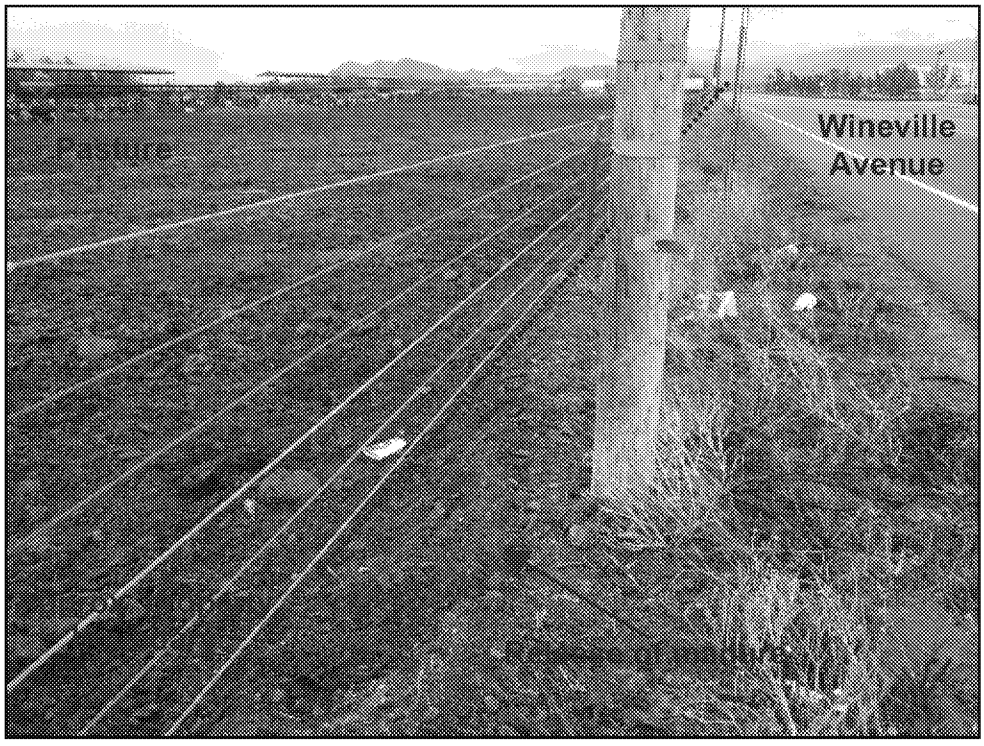
4. A release of manure offsite onto Wineville Avenue right-of-way was observed along the western Facility perimeter originating from the northwestern pastures and public manure stockpile (refer to Photos 16 through 19). A release of manure offsite to land and property not owned or controlled by the Discharger is prohibited by Discharge Prohibitions IV.A-B of the Permit.

1. The inspector observed, during the inspection, a release of manure offsite onto Wineville Avenue right-of-way along the western Facility perimeter (refer to Photos 16 through 19). Manure was released offsite from the pastures in the northwest portion of the Facility (refer to Photos 16 and 17) and from the public manure stockpile located along the central-west Facility perimeter (refer to Photos 18 and 19). The inspector did not receive any information regarding the offsite release of manure from the Facility representative. It should be noted that an adequate contiguous containment berm had not been implemented along the western Facility perimeter. Discharge Prohibition IV.B of the Permit states "disposal of manure to land is prohibited." In addition, Effluent Limitations and Discharge Specification V.1.a of the Permit specifies that pollutants may be discharged from the Facility if "the production area is designed, constructed, operated, and maintained to contain all manure, litter, and process wastewater including the runoff and the direct precipitation from a 25-year, 24-hour rainfall event. " This is a recurring issue identified in a previous inspection conducted on December 9, 2011.

Photograph 16. View facing south of a previous release of manure offsite from the northwest pasture onto the Wineville Avenue right-of-way.

6. Verify manure is not being released offsite from the pastures and public manure stockpile and that an adequate berm has been constructed along the western perimeter

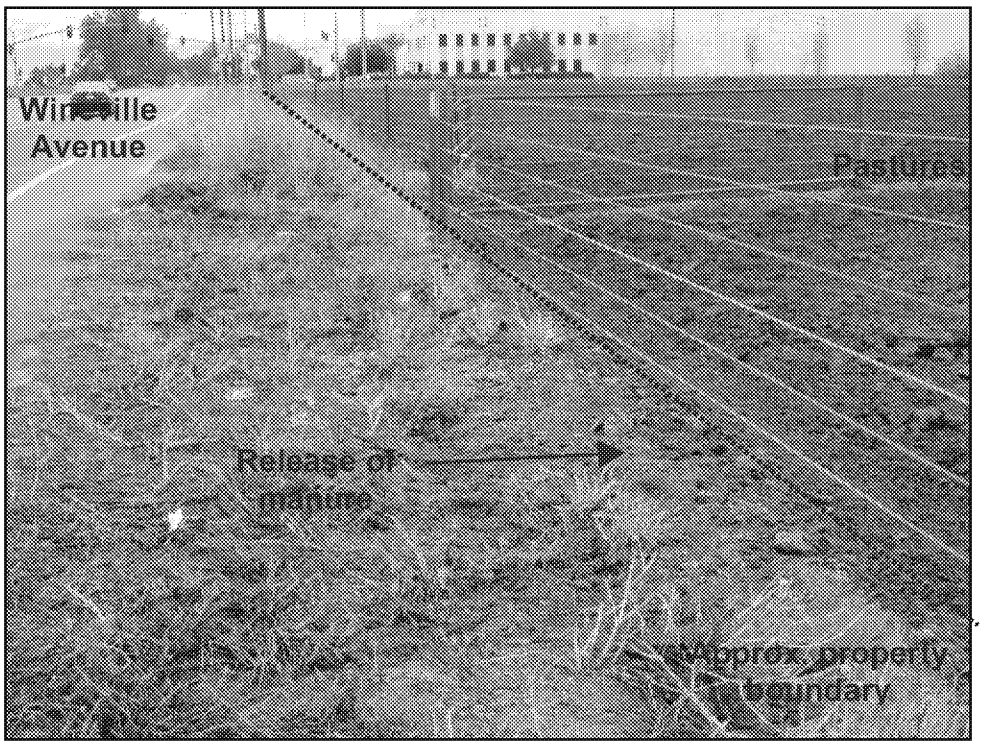
Photograph 17. View facing north of a previous release of manure offsite from the northwest pasture onto the Wineville Avenue right-of-way.

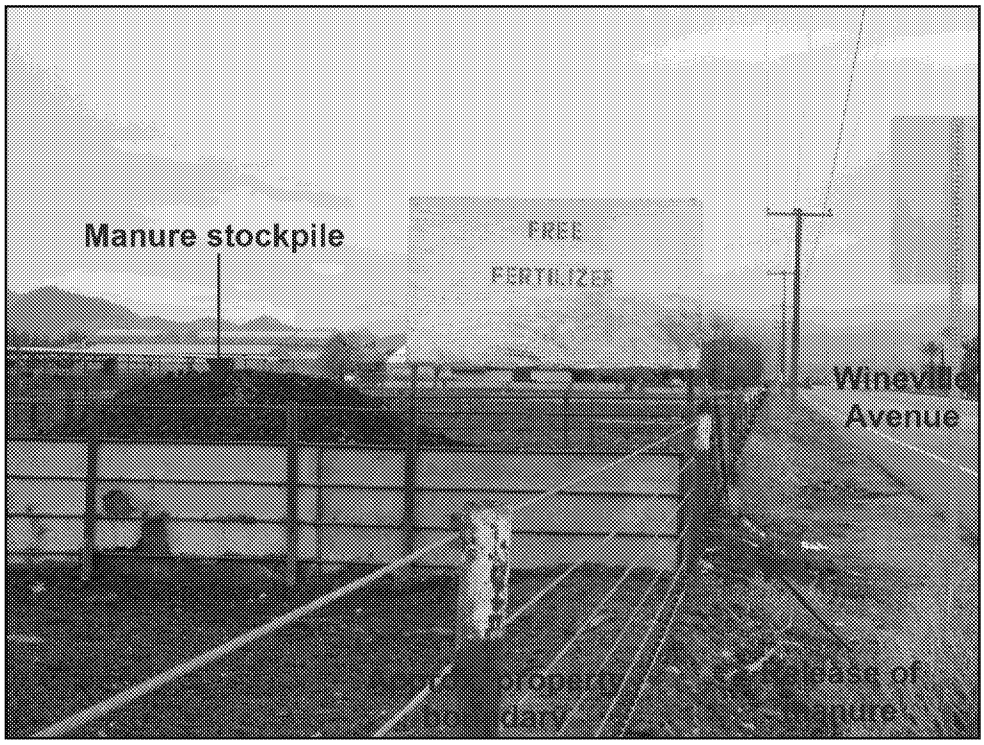
Photograph 18. View facing south of a previous release of manure offsite onto the Wineville Avenue right-of-way from the public manure stockpile located along the central-west perimeter of the Facility.

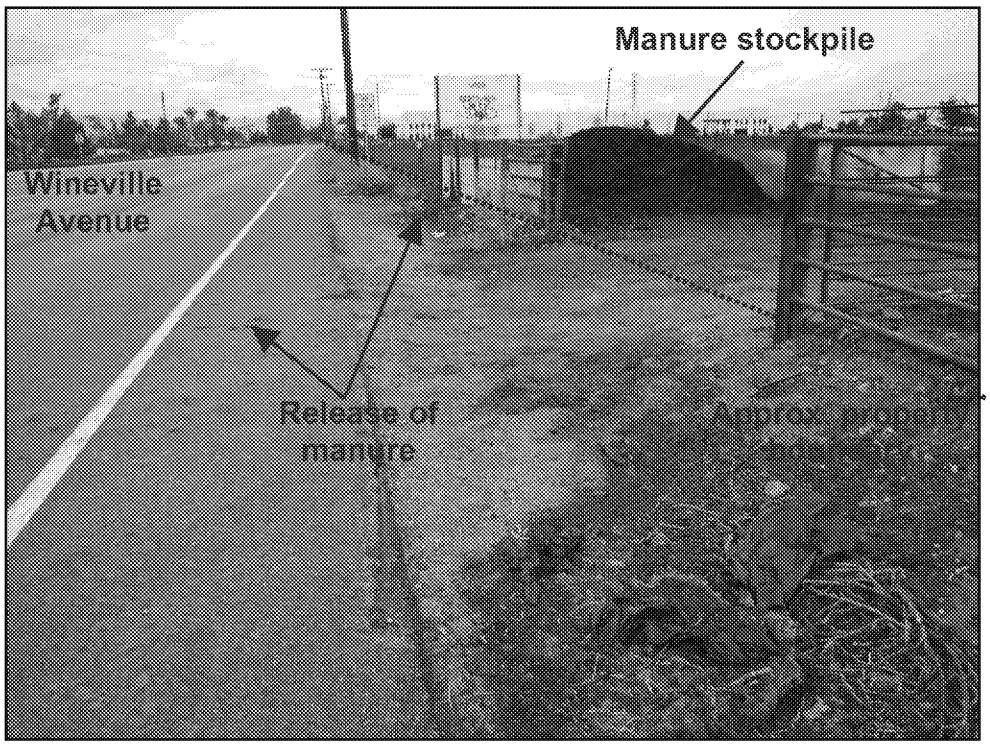
2. The inspector observed, during the inspection, a release of manure out of the west side of the Calf Shelter corral onto an onsite roadway in the southwest portion of the Facility (refer to Photo 20). Corrals (i.e., animal confinement areas) must be designed and maintained to contain all manure, litter, and process wastewater as required by Effluent Limitations and Discharge Specification V.A.1.a of the Permit.

Photograph 19. View facing north of a previous release of manure offsite onto the Wineville Avenue right-of-way from the public manure stockpile located along the central-west perimeter of the Facility, shown in Photograph 18.

Photograph 20. View facing south of a previous release of manure out of the calf shelter corral onto an onsite Facility roadway.

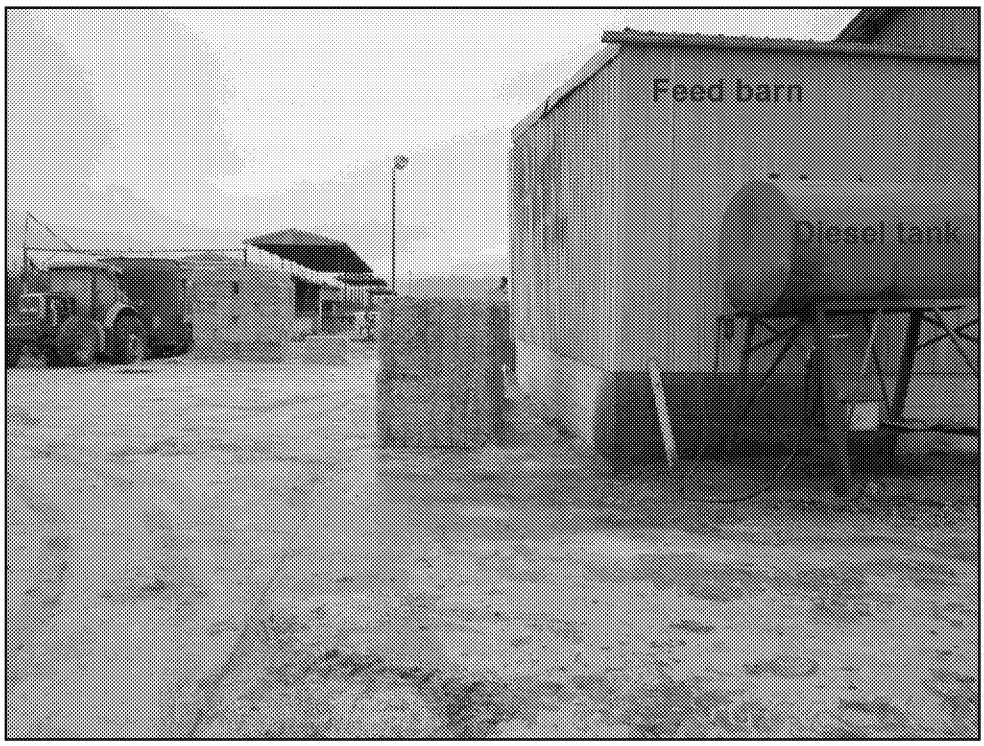
3. The inspector observed, during the inspection, that secondary containment was not provided for an elevated fuel storage tank on the northeast side of the Feed Barn (refer to Photo 21). Fuel product staining was observed on the impervious surface below (refer to Photo 22). Provision VII.C.5.h of the Permit states that "chemicals and other contaminants handled on-site shall not be disposed of in any manure, littler, process wastewater, or storm water storage or treatment systems." The inspector did not observe a disposal of chemical into any of the areas outlined above; however, the lack of secondary containment and staining creates a potential for chemicals to be spilled and/or contribute pollutants to storm water runoff on the impervious roadway.

Photograph 21. View facing south of a diesel fuel tank located on the northeast side of the feed barn. Note the tank did not contain secondary containment and diesel fuel product was observed on the impervious surface below.

8. Verify diesel fuel is properly stored and handled onsite

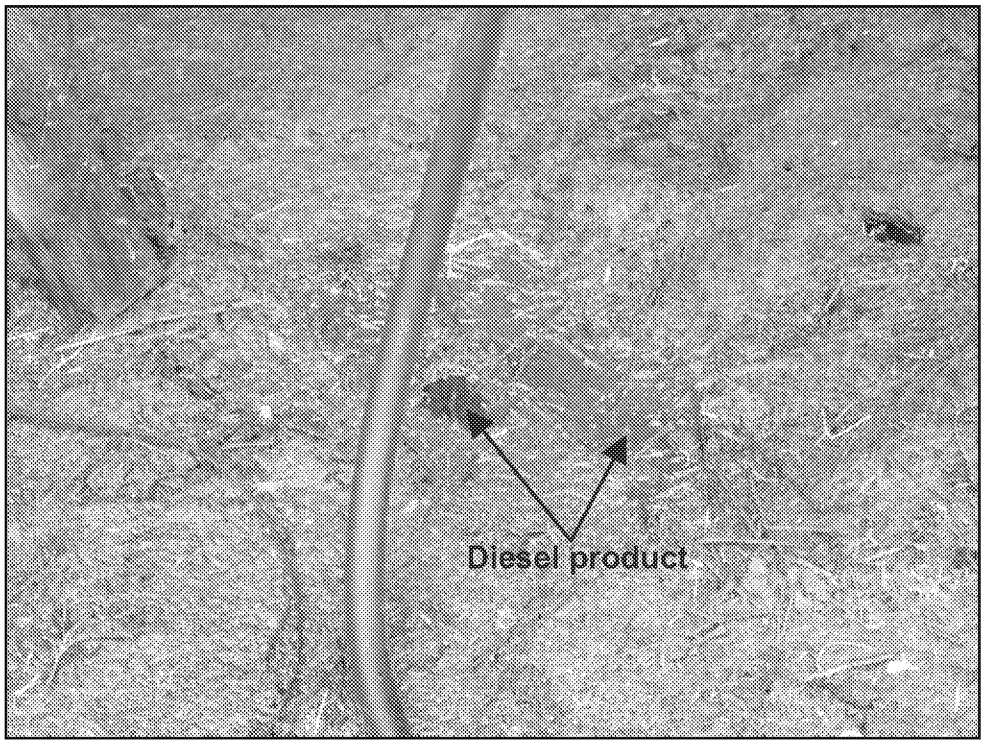
Photograph 22. Close-up view of the diesel fuel product on the impervious surface below the diesel fuel tank, shown in Photograph 21.
