OFFICE NO: PCA SYSTEM TASK NO:

8365964001 WDID NUMBER	**Gerben Hettinga** OWNER NAME	**GH Dairy No. 2** FACILITY NAME
CAG018001 NPDES NUMBER	**Ex. 6 Personal Privacy (PP)** OWNER ADDRESS	FACILITY ADDRESS
R8-2007-0001 RWQCB ORDER NO.	**Ontario, CA 91762** OWNER CITY AND STATE	**Ontario, CA 91762** FACILITY CITY AND STATE
03/07/2013 SCHEDULED INSPECTION DATE	**Gerben Hettinga** OWNER CONTACT	**Gerben Hettinga** FACILITY CONTACT
03/07/2013 ACTUAL INSPECTION DATE	**Ex. 6 Personal Privacy (PP)** OWNER PHONE NO.	FACILITY PHONE NO.
Unknown RECEIVING WATER	Ex. 6 Personal Privacy (PP) FACILITY LATITUDE	Ex. 6 Personal Privacy (PP) FACILITY LONGITUDE

INSPECTION SUMMARY

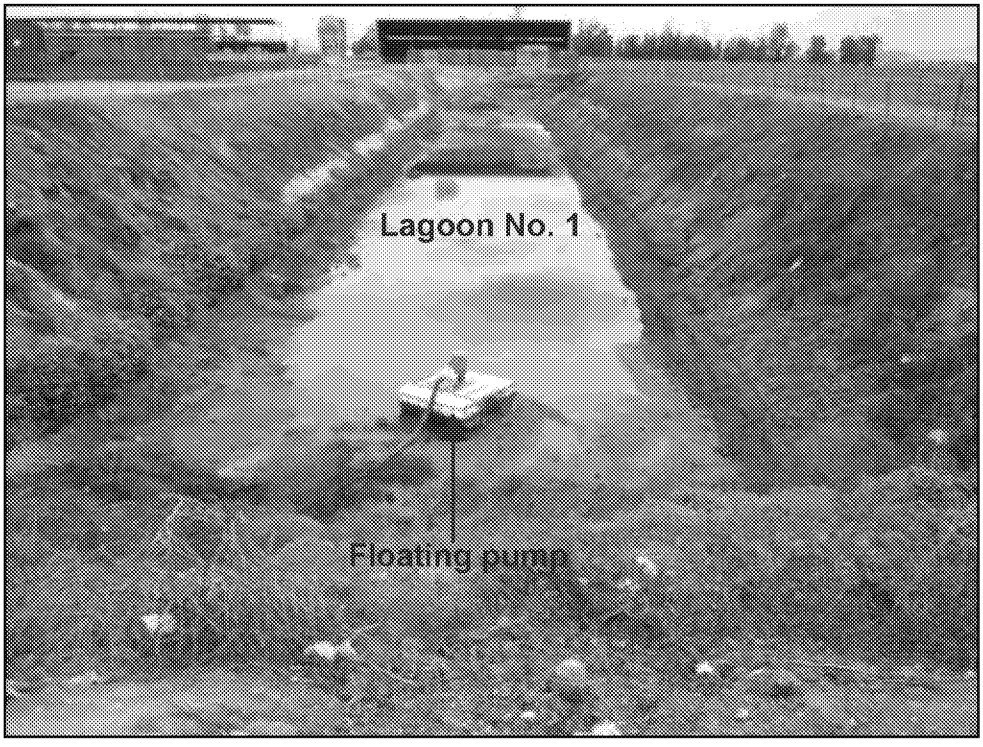
1. A depth marker was not installed in lagoon No. 1, located in the central portion of the Facility as required by Permit Attachment B - Monitoring and Reporting Program, Section I.B.1 (refer to Photo 2). This is a recurring issue identified in a previous inspection conducted on October 23, 2008.

4. The EWMP was not fully implemented onsite at the Facility at the time of the inspection, as required by Provision VII.C.3.b of the Permit (refer to Photos 2 through 7).

1. The inspector observed, during the inspection, that a depth marker was not installed in lagoon No. 1 located in the central portion of the Facility as required by the Permit (refer to Photo 2). This is a recurring issue identified in a previous inspection conducted on October 23, 2008. Permit Attachment B - Monitoring and Reporting Program, Section I.B.1 states that "a marker shall be placed within each pond or impoundment to indicate the minimum capacity necessary to contain the runoff and direct precipitationof the 25-year, 24-hour rainfall event."

Photograph 2. View facing east of lagoon No. 1 located in the central portion of the Facility. Note the lagoon did not contain a depth marker.

1. Verify whether a depth marker has been installed in lagoon No. 1
2. Verify whether the EWMP is retained onsite
3. Verify if weekly (and daily) storm water management structure visual inspections are conducted at the Facility
4. Verify whether the EWMP has been fully implemented onsite

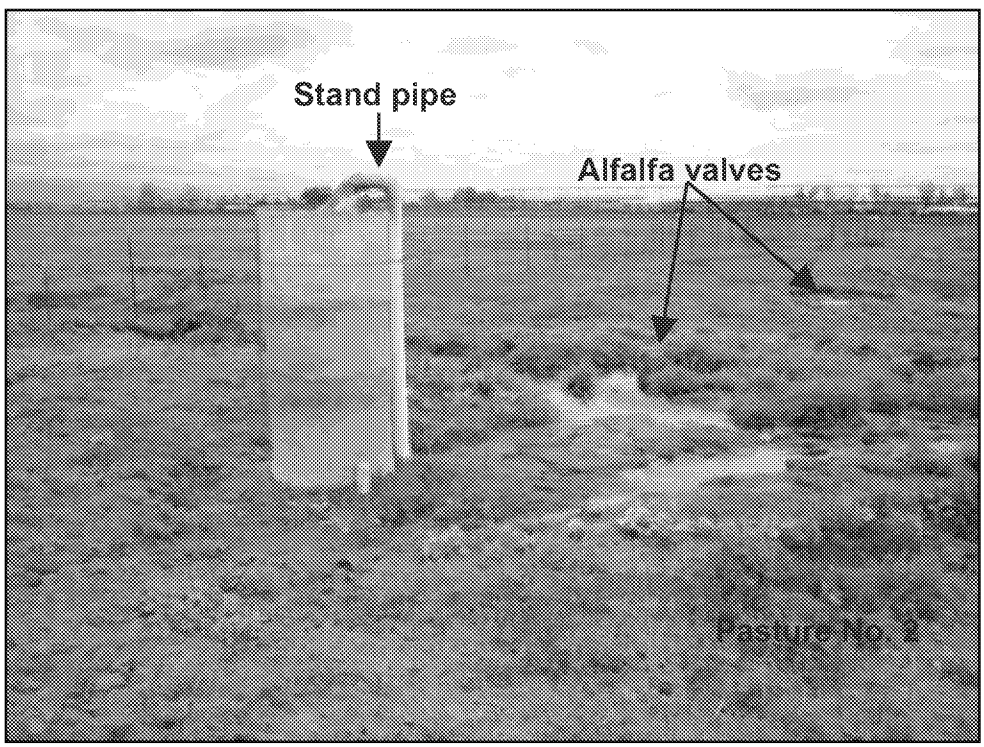
3. The EWMP was not fully implemented onsite at the Facility as required by the Permit. Section V - 'Operation and Maintenance' of the EWMP requires that the Discharger "disc percolation areas (fields) to about 18 inches to assure maximum percolation during wet seasons…All of the disposal areas should be disked at least once each year." Specifically, Mr. Romero informed the inspector that the disposal pastures are not disked or plowed to promote percolation and infiltration. Provision VII.C.3.b of the Permit states that "the discharger shall develop and fully implement an Engineered Waste Management Plan (EWMP) acceptable to the Executive Officer." As a result, the Discharger was not fully implementing the approved EWMP. The Discharger shall fully implement the EWMP as required by Provision VII.C.3.b of the Permit.

Photograph 3. View facing south of a stand pipe located in the northeast corner of pasture No. 1. All process wastewater flows from the milking barn sump may be piped to standpipes in pastures Nos. 1, 2, and 3.

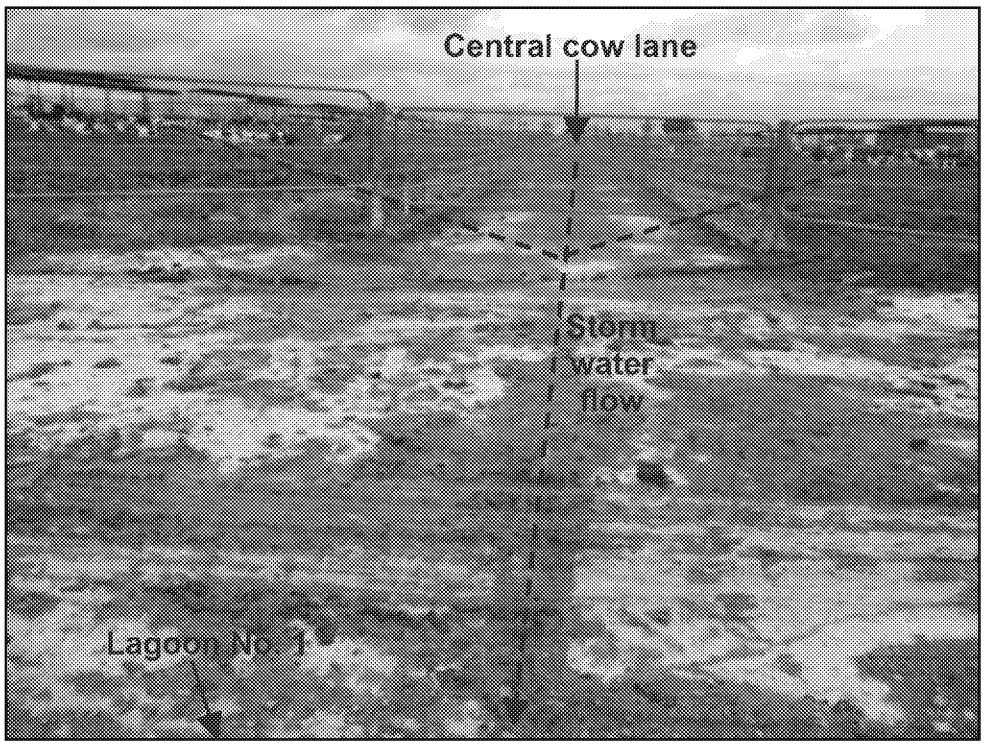
Photograph 10. View facing west of the storm water flow pathway from the corrals into lagoon No. 1. Note all storm water runoff from the corrals enters the lagoon via sheet flow through the central cow lane.

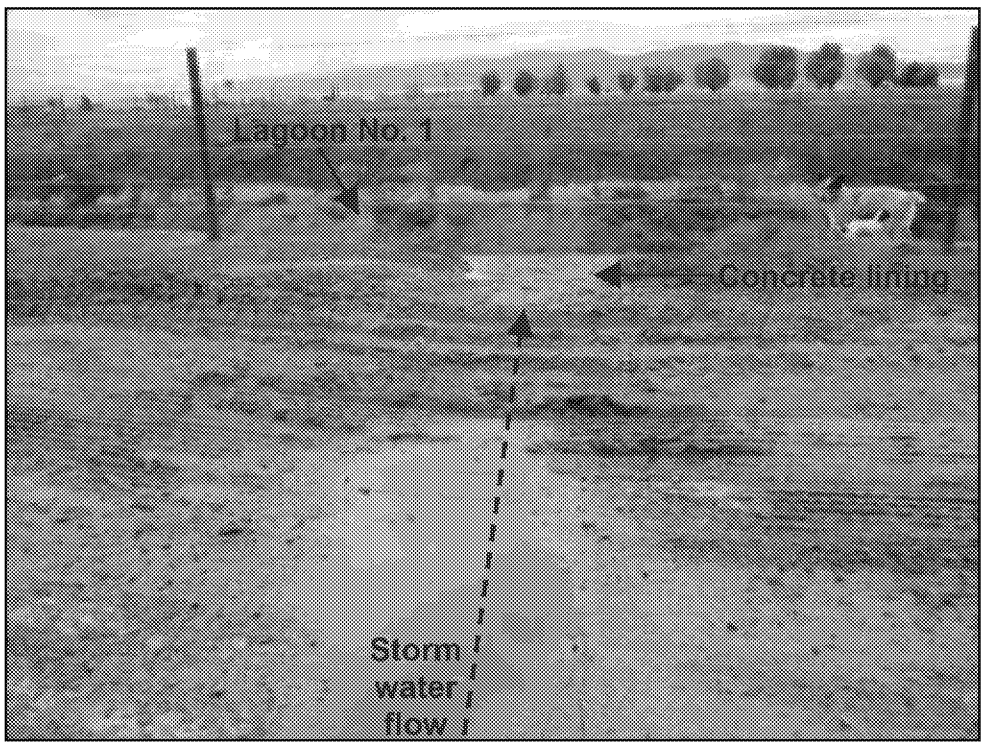
Photograph 11. View facing north of the central cow lane, north of lagoon No. 1. Note all storm water runoff from the corrals flows into the central cow lane, then south into lagoon No. 1.

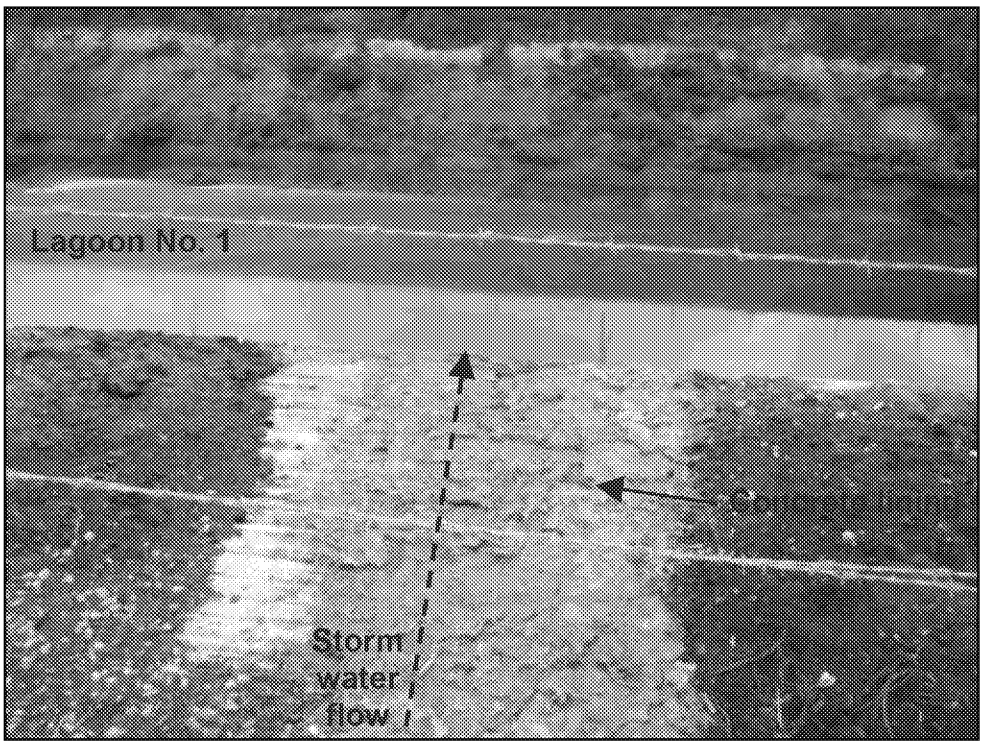
Photograph 12. View facing south of the storm water flow pathway from the corrals into lagoon No. 1. Note the storm water runoff entrance location on the north-central side of lagoon No. 1 was lined with concrete to prevent erosion from occurring on the embankment.
