# CAFO FACILITY INSPECTION REPORT

INSPECTOR(S): Jared Richardson (PG Environmental, LLC) and Anthony D'Angelo (PG Environmental, LLC)

| **8365978001**<br>WDID NUMBER | **James Jongsma**<br>OWNER NAME | **James & John Jongsma Dairy**<br>FACILITY NAME |
| **03/06/2013**<br>ACTUAL INSPECTION DATE | **Ex. 6 Personal Privacy (PP)**<br>OWNER PHONE NO. | FACILITY PHONE NO. |

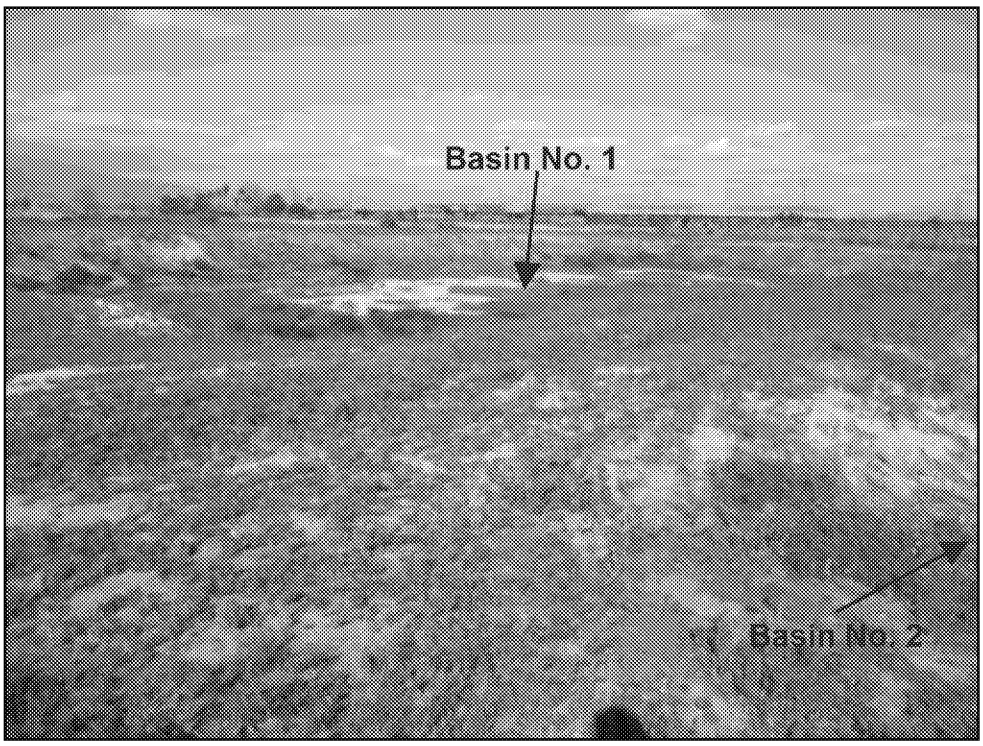
1. Depth markers were not installed in basin Nos. 1 and 2 as required by Permit Attachment B - Monitoring and Reporting Program, Section I.B.1 (refer to Photos 2 and 3).

1. The inspectors observed, during the inspection, that depth markers had not been installed in basin Nos. 1 and 2 located in the northeast, and central-east portion of the Facility to indicate the minimum capacity necessary to contain the runoff and direct precipitation of the 25-year, 24-hour rainfall event, as required by Permit Attachment B - Monitoring and Reporting Program, Section I.B.1 (refer to Photos 2 and 3).

**Photograph 2.** View facing east of basin No. 2. Note the basin did not contain a depth marker.

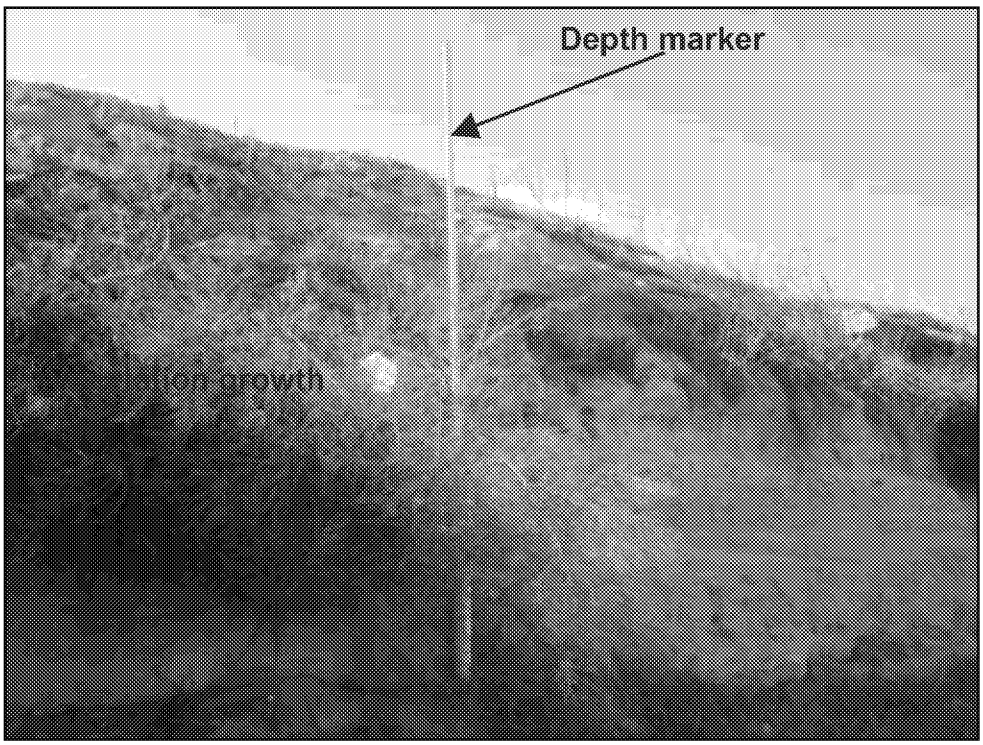
4. Vegetation growth was observed in lagoon No. 1 in the central-west portion of the Facility (refer to Photos 4 through 7). The Discharger must design and maintain all containment structures per the EWMP as required by Provision VII.C.3.a of the Permit.

2. The inspectors observed, during the inspection, that the depth marker installed in lagoon No. 1 did not have measurement markings on the depth marker pole to clearly identify lagoon depth and freeboard (refer to Photos 4 through 7). Mr. Jongsma stated that the lagoon No. 1 depth marker should have depth measurement markings. In addition, he stated that he would evaluate and repair the depth marker to clearly identify depth measurement markings following the inspection.

1. The inspectors observed, during the inspection, that vegetation growth potentially affecting the containment structure capacity was present in lagoon No. 1 (refer to Photos 4 through 7). The 'Operation and Maintenance' section of the EWMP states that "weed abatement measures such as pesticides and clearing and grubbing should be used to control weeds in fields, lagoons, wastewater transport channels, and wastewater access paths." As a result, the overall capacity of lagoon No. 1 at the Facility may be diminished. Provision VII.C.3.a of the Permit states that "the discharger shall design, construct, and maintain containment structures to retain all wastewater within the facility, including all process wastewater and all precipitation on, and drainage through, manured areas resulting from rainfall up to and including a 25-year, 24-hour rainfall event." The Discharger must design and maintain all containment structures per the EWMP as required by Provision VII.C.3.a.

**Photograph 4.** View facing north of lagoon No. 1. Note the vegetation growth in the lagoon.

**Photograph 5.** View facing east of the depth marker installed in lagoon No. 1. Note the depth marker did not have depth measurement markings. Also note the vegetative growth in the lagoon.

**Photograph 6.** Close-up view of the vegetative growth and depth marker installed in lagoon No. 1. Note the depth marker did not have depth measurement markings.

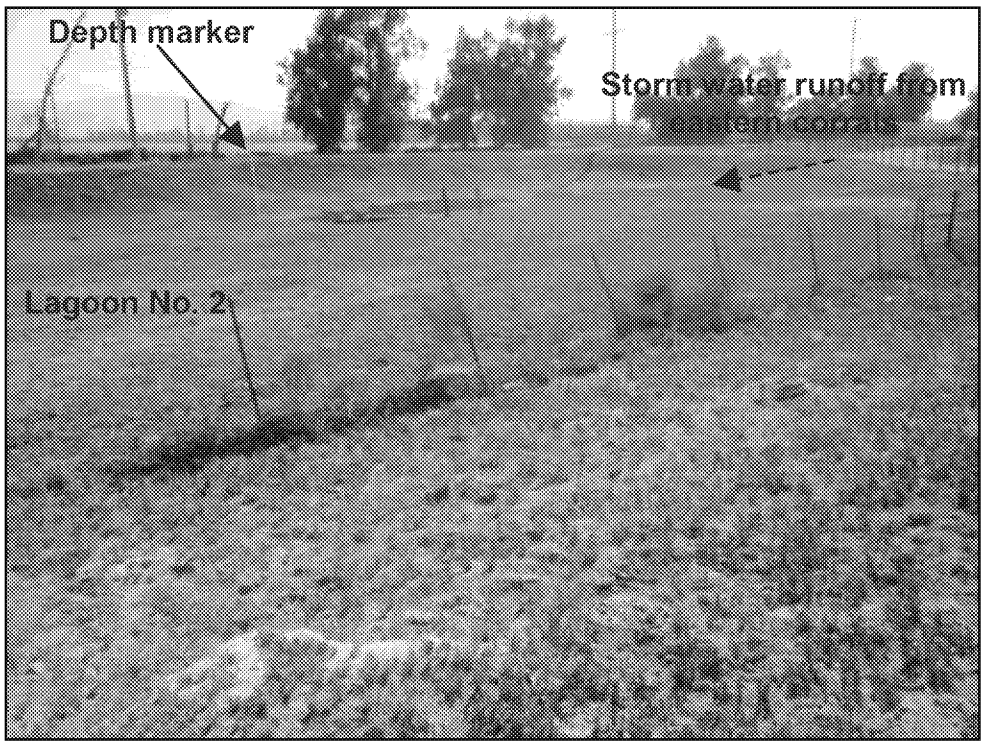
**Photograph 8.** View facing southeast of lagoon No. 2. Note storm water runoff from the eastern corrals enters lagoon No. 2 via a drain pipe from the 'Not Used' corral into the northwestern corner of lagoon No. 2.

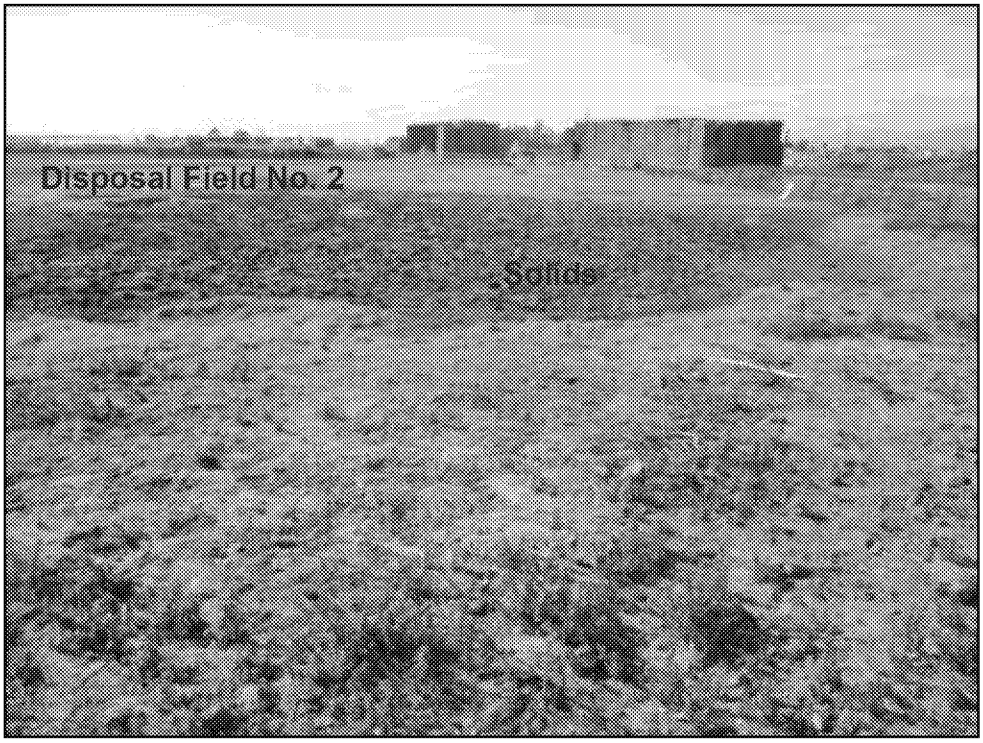
2. The inspectors observed, during the inspection, accumulated manure solids in field No. 2 in the central-east portion of the Facility (refer to Photos 10, 11, and 12). Mr. Jongsma stated that the disposal pipes in disposal field No. 2 are moved every couple of days and that the field is ripped as needed. Mr. Jongsma did not identify a field solids cleaning frequency timeframe; however, field Nos. 1 and 2 were last ripped in December 2012. Section V - 'Operation and Maintenance' of the EWMP identifies the 'removal and disposal of accumulated waste solids" as a routine maintenance item. The Discharger must design and maintain all containment structures per the EWMP as required by Provision VII.C.3.a.

**Photograph 10.** View facing southwest of disposal field No. 2. Note the ponding of process wastewater and accumulated solids were observed on the north side of field No. 2, adjacent to the disposal valves and pipes.

**Photograph 11.** Additional view facing south of disposal field No. 2, shown in Photograph 10.

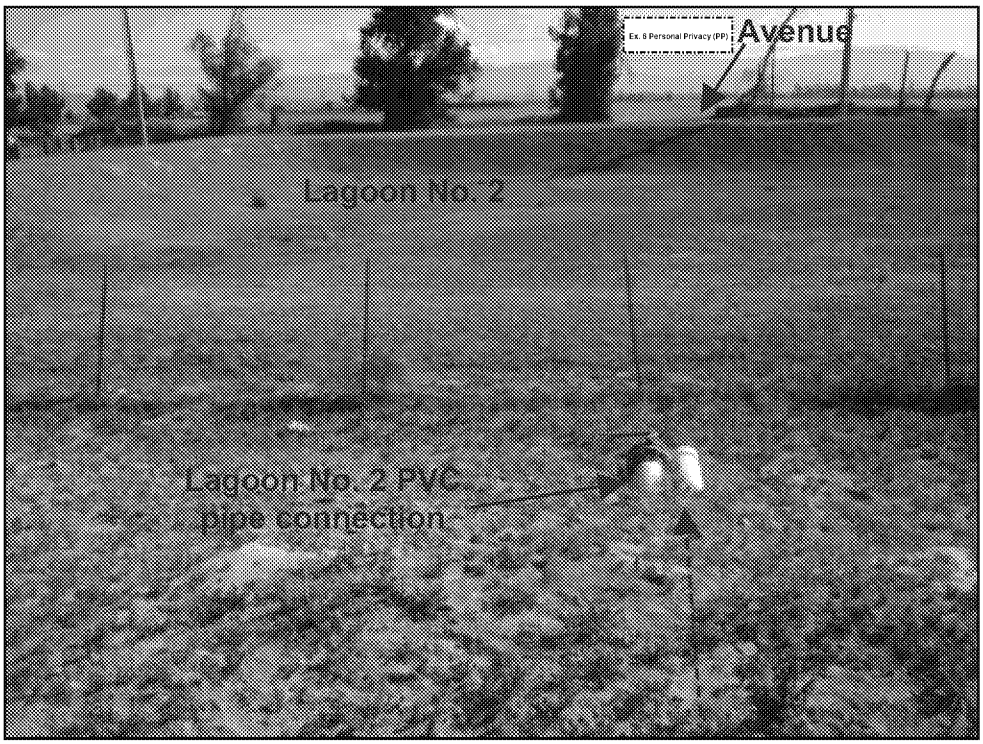
**Photograph 15.** View facing west of standing water on the south side of disposal field No. 2 and basin No. 3, upgradient of the PVC pipe connection which drains into lagoon No. 2.

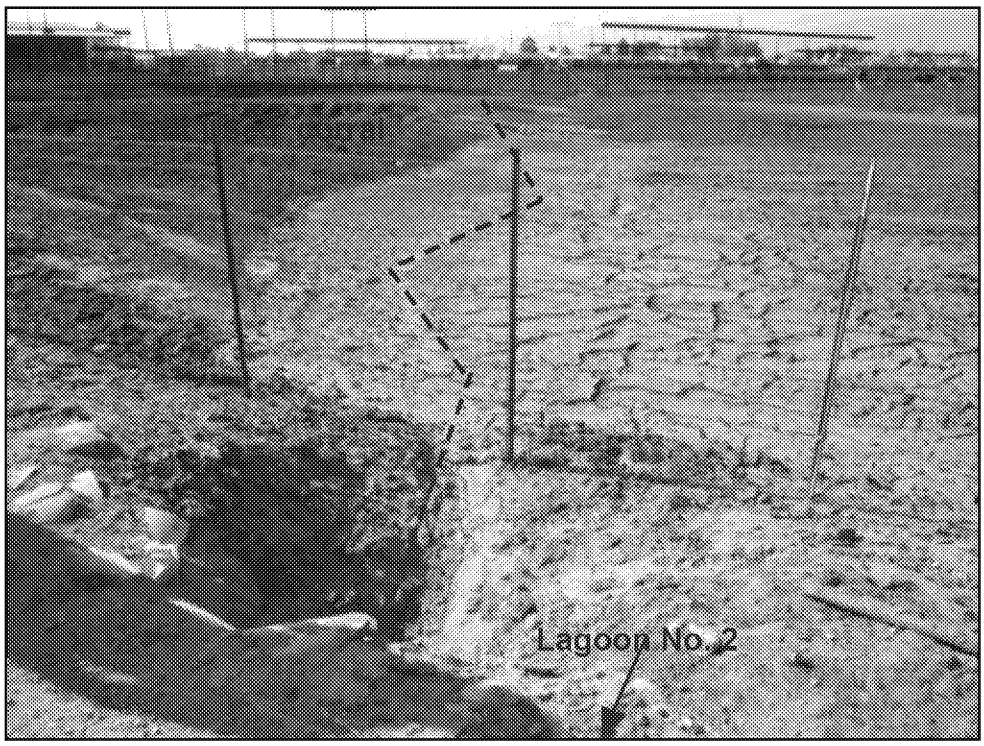
**Photograph 17.** View facing northwest of the 'Not Used' corral, which conveys storm water runoff from the eastern corrals into lagoon No. 2 via a drain pipe.

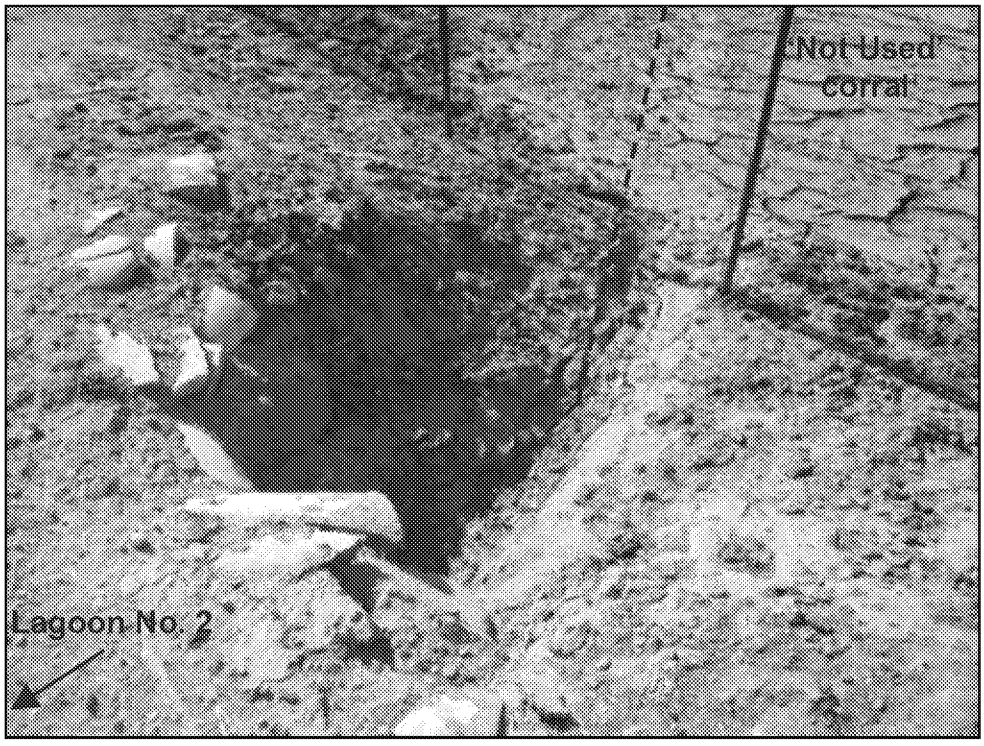
**Photograph 18.** Close-up view of the storm water runoff drain pipe inlet from the 'Not Used' corral into lagoon No. 2.

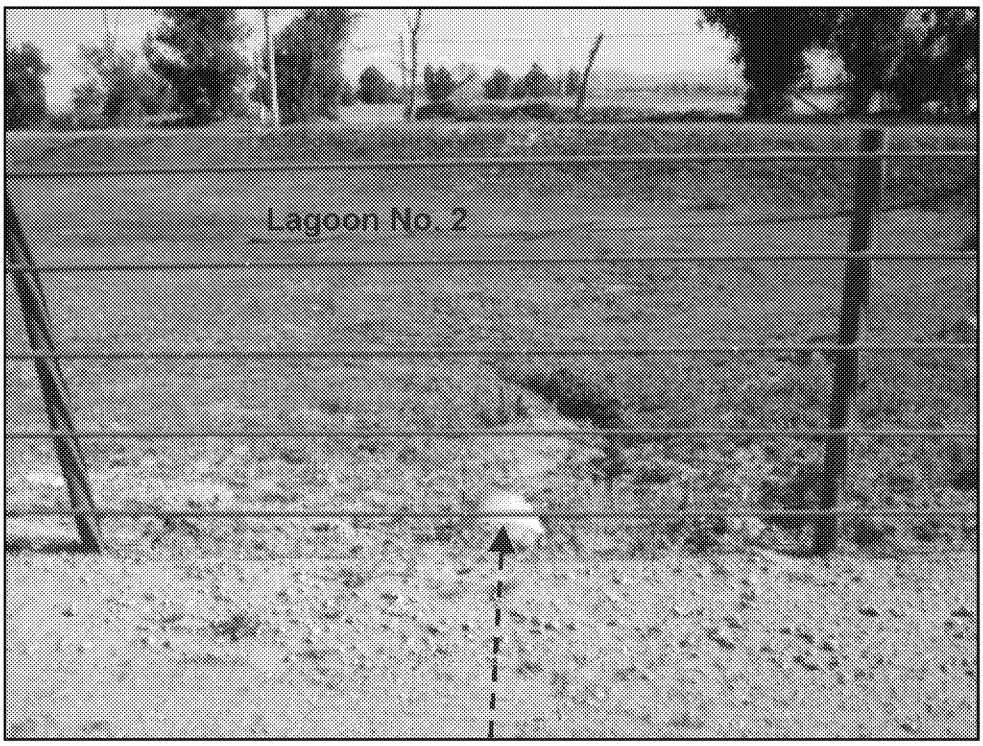
**Photograph 19.** View facing south of the eastern corrals storm water runoff pipe outlet into lagoon No. 2.

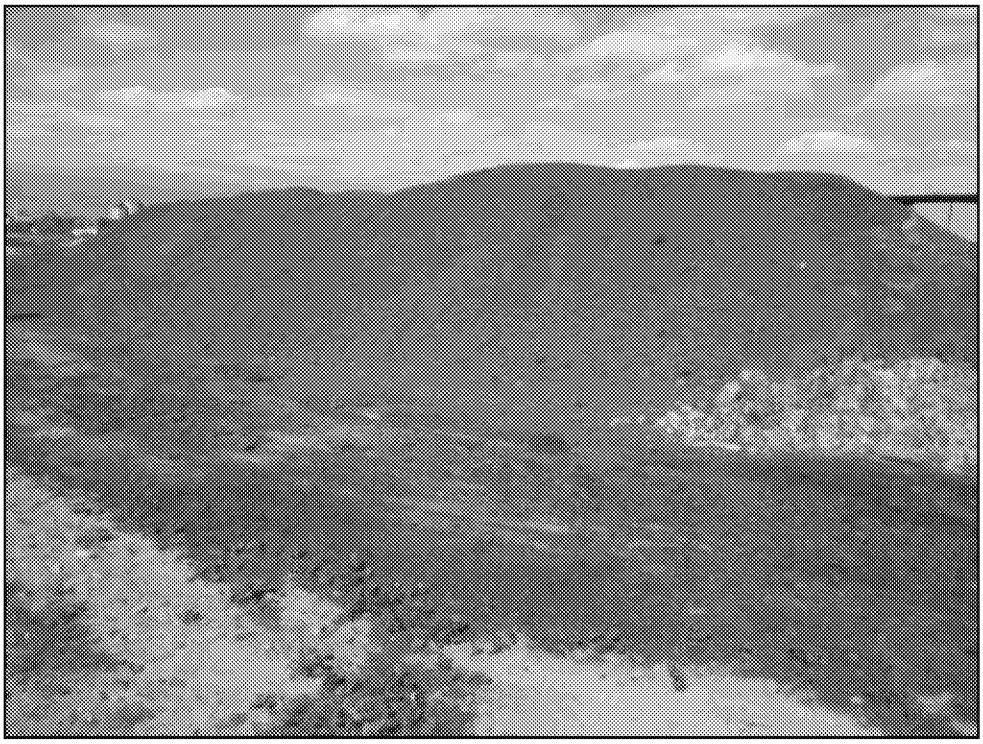
Mr. Jongsma stated that the corrals were last cleaned in Decemeber 2012. A manure stockpile from the most recent corral cleaning event was located in the central-west portion of the Facility, adjacent to disposal field No. 1 (refer to Photo 20). Manure is hauled offsite by multiple trucking companies. The exact disposal location was unknown by Mr. Jongsma at the time of the inspection. Manure tracking manifests are maintained of all haul events at the central Jongsma Dairy office in the California Central Valley. Mr. Jongsma stated that all mortalities are removed from the Facility immediately by Stiles Animal Removal, Inc.

**Photograph 20.** View facing northeast of a manure stockpile located on the central-west portion of the Facility, adjacent to disposal field No. 1.
