CAFO FACILITY INSPECTION REPORT

8335698001 WDID NUMBER	**Ben Slegers** OWNER NAME	**Chino Valley Heifers** FACILITY NAME
CAG018001 NPDES NUMBER	Ex. 6 Personal Privacy (PP) OWNER ADDRESS	FACILITY ADDRESS
R8-2007-0001 RWQCB ORDER NO.	**Bakersfield, CA 93314** OWNER CITY AND STATE	**Corona, CA 92880** FACILITY CITY AND STATE
04/09/2013 SCHEDULED INSPECTION DATE	**Ben Slegers** OWNER CONTACT	**Marty Van Leeuwen** FACILITY CONTACT
04/09/2013 ACTUAL INSPECTION DATE	Ex. 6 Personal Privacy (PP) OWNER PHONE NO.	FACILITY PHONE NO.
Santa Ana River RECEIVING WATER	Ex. 6 Personal Privacy (PP) FACILITY LATITUDE	FACILITY LONGITUDE

On April 9, 2013, a Concentrated Animal Feeding Operation (CAFO) inspection was conducted for Santa Ana Water Board Order No. R8-2007-0001 - 'General Waste Discharge Requirements for Concentrated Animal Feeding Operations (Dairies and Related Facilities) within the Santa Ana Region', NPDES General Permit No. (CAG018001) at Chino Valley Heifers in Corona, California (refer to Photo 1). The inspector provided a phone call to Mr. Ben Slegers (Owner, Chino Valley Dairy No. 2) at 8:20 AM on April 9, 2013. Mr. Slegers informed the inspector that the Facility ceased milking

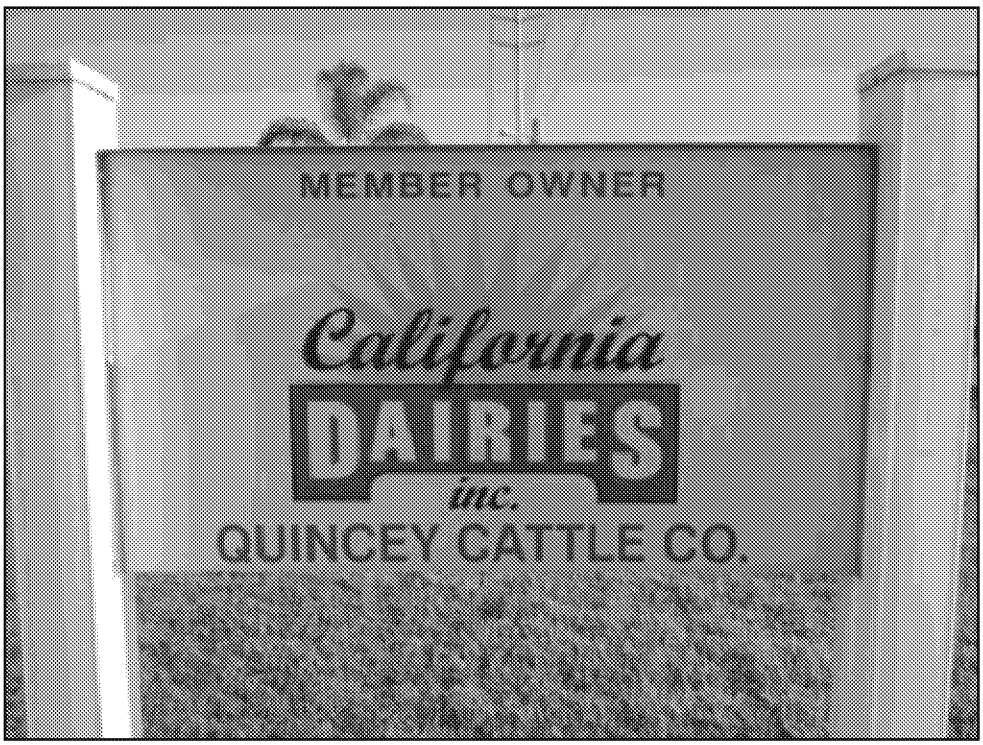
Photograph 1. Chino Valley Heifers (formally Chino Valley Dairy No. 2) Facility sign. Note Quincey Cattle Co. changed to Chino Valley Dairy No. 2 on April 22, 2012.

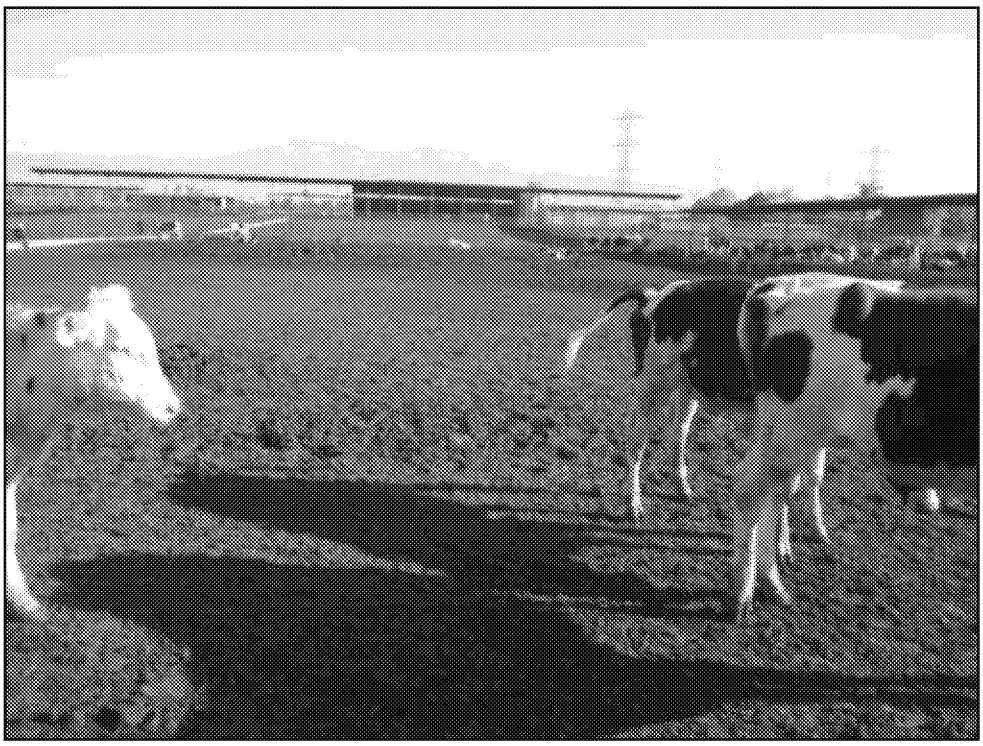
Photograph 3. View facing north of the southern corrals.

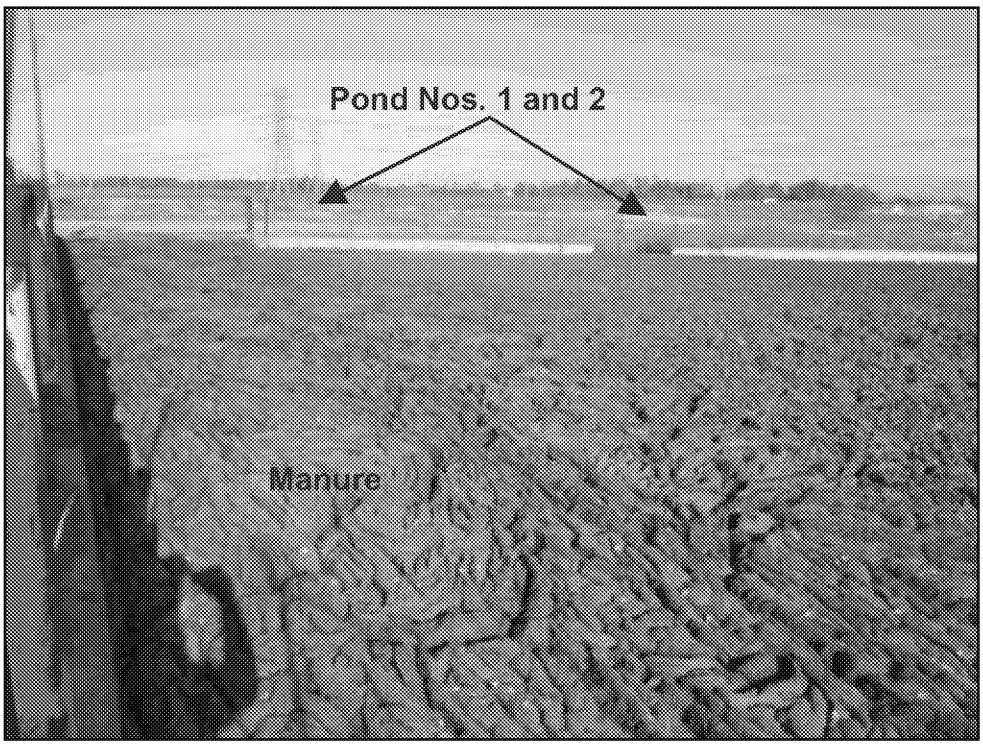
Photograph 5. View facing west of accumulated manure in the southwestern corral, shown in Photograph 4.

Photograph 6. View facing north of the western edge of the corral shown in Photographs 4 and 5. Note storm water runoff from the corrals flows southwest.

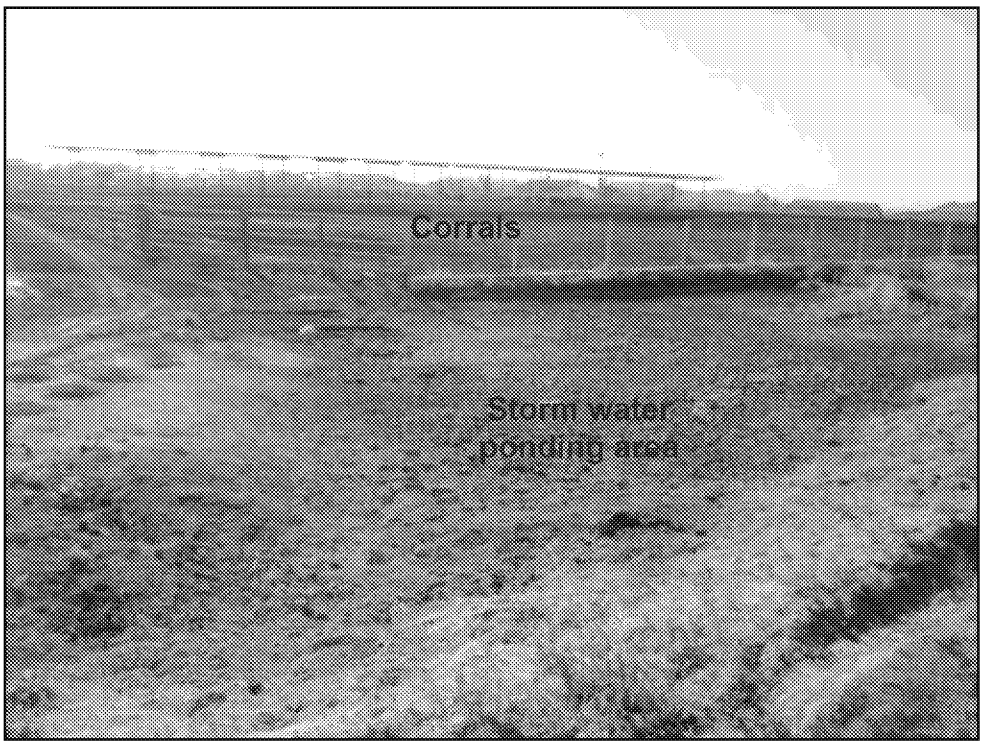
Photograph 7. View facing southeast of a storm water ponding area on the west side of the southern corrals.

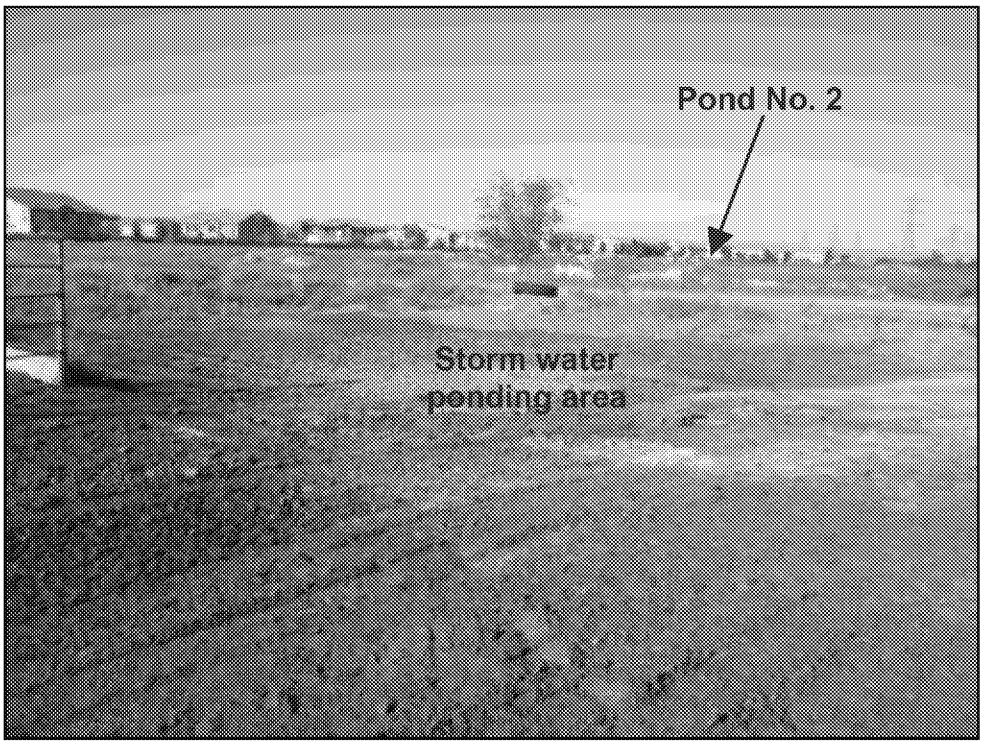
Photograph 8. View facing southwest of a storm water ponding area on the west side of the southern corrals.

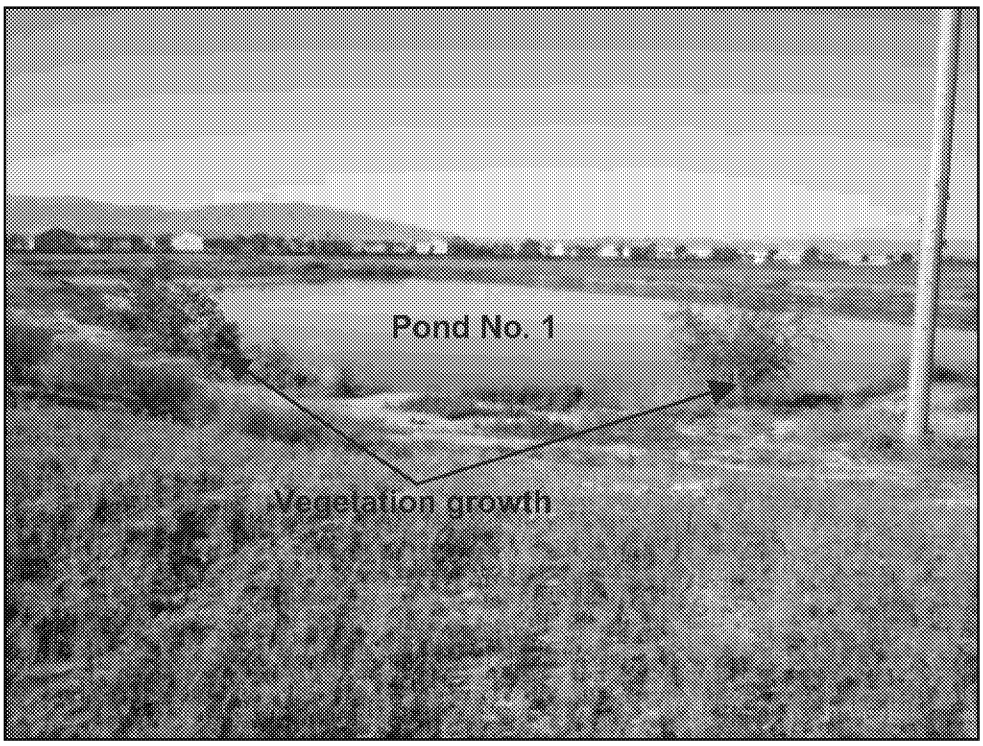
1. Depth markers were not installed in pond Nos. 1 and 2 located in the central portion of the Facility as required by Permit Attachment B - Monitoring and Reporting Program, Section I.B.1 (refer to Photos 9 and 11).

1. The inspector observed, during the inspection, that depth markers had not been not installed in pond Nos. 1 and 2 located in the central portion of the Facility as required by the Permit (refer to Photos 9 and 11). Mr. Van Leeuwen stated that depth markers were not installed in the ponds because depth markers were not present in the ponds when the Discharger took operation control of the Facility on April 22, 2012. Permit Attachment B - Monitoring and Reporting Program, Section I.B.1 states that "a marker shall be placed within each pond or impoundment to indicate the minimum capacity necessary to contain the runoff and direct precipitationof the 25-year, 24-hour rainfall event."

3. The inspector observed, during the inspection, that vegetation growth potentially affecting the containment structure capacity was observed on all pond embankments of pond No. 1 and along the earthen berm between pond Nos. 1 and 2 located in the central portion of the Facility (refer to Photos 9, 10, 14, and 15). Mr. Van Leeuwen stated that the ponds were in poor condition and had not been adequately maintained when the Discharger took operational control of the Facility on April 22, 2012. In addition, he stated that the ponds had not been cleaned or maintained since. As a result, the overall capacity of the containment structures at the Facility may be diminished. Provision VII.C.3.a of the Permit states that "the discharger shall design, construct and maintain containment structures to retain all wastewater within the facility,including all process wastewater and all precipitation on, and drainage through, manured areas resulting from rainfall up to and including a 25-year, 24-hour rainfall event." The Discharger must design and maintain all containment structures per the EWMP as required by Provisions VII.C.3.a of the Permit.

Photograph 9. View facing southwest of pond No. 1 located in the central portion of the Facility. Note vegetation growth was observed on the pond embankments. Also note the pond did not contain a depth marker.

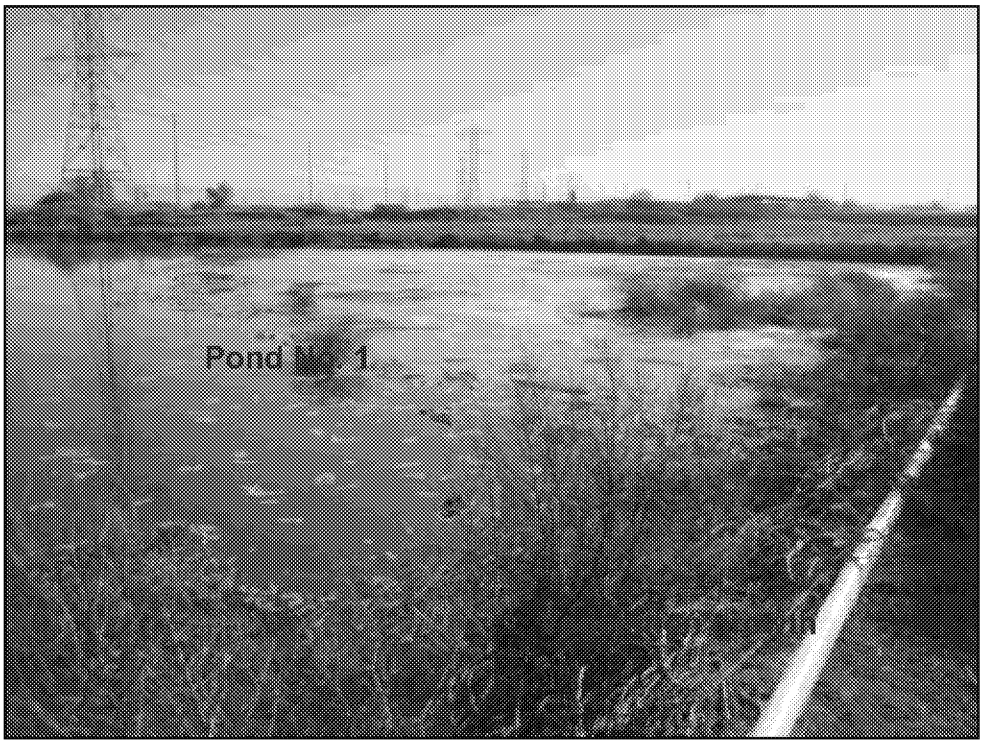
2. The inspector observed, during the inspection, accumulated solids in pond No. 2 in the southcentral portion of the Facility (refer to Photos 11 and 12). Mr. Van Leeuwen stated that the ponds were in poor condition and had not been adequately maintained when the Discharger took operational control of the Facility on April 22, 2012. In addition, he stated that the ponds had not been cleaned or maintained since and most likely would not be cleaned or maintained prior to the Discharger leaving the Facility. Furthermore, he stated that the land owner, Richland Homes, is responsible for cleaning the ponds once the Discharger leaves the Facility in July 2013. As a result, the overall capacity of the containment structures at the Facility may be diminished. Provision VII.C.3.a of the Permit states that "the discharger shall design, construct and maintain containment structures to retain all wastewater within the facility,including all process wastewater and all precipitation on, and drainage through, manured areas resulting from rainfall up to and including a 25-year, 24-hour rainfall event." The Discharger must design and maintain all containment structures per the EWMP as required by Provisions VII.C.3.a of the Permit.

Photograph 10. View facing northeast of pond No. 1. Note vegetation growth was observed on the earthen berm between pond Nos. 1 and 2.

Photograph 11. View facing southwest of pond No. 2. Note the accumulated solids in the pond. Also note the pond did not contain a depth marker.

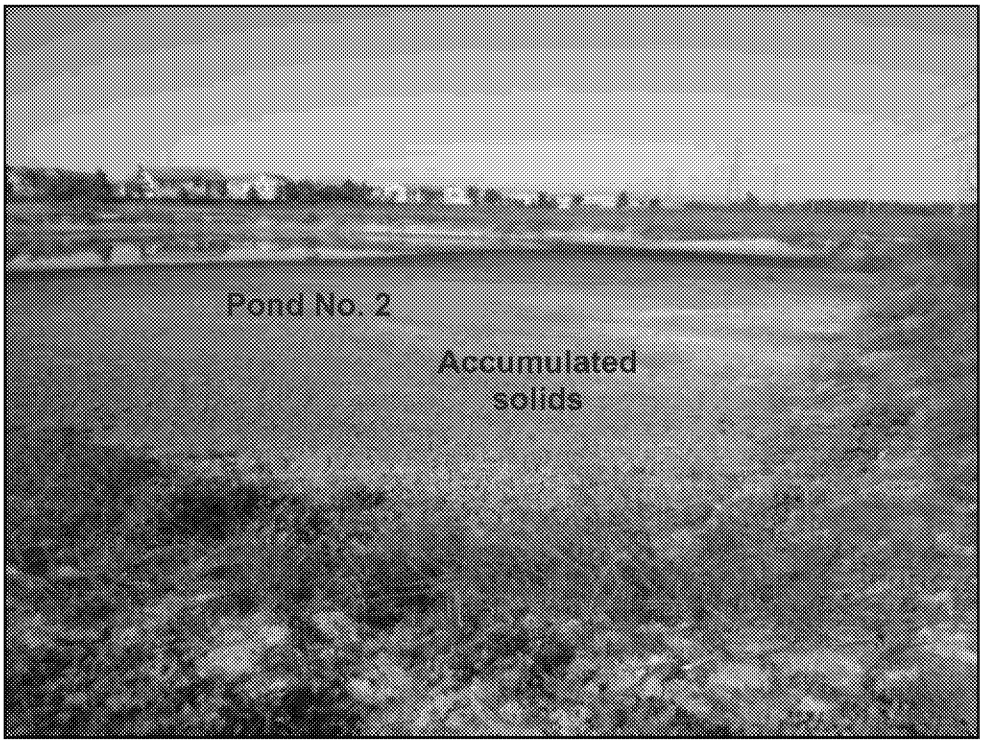
Photograph 12. Close-up view of the accumulated solids in pond No 2, shown in Photograph 11.

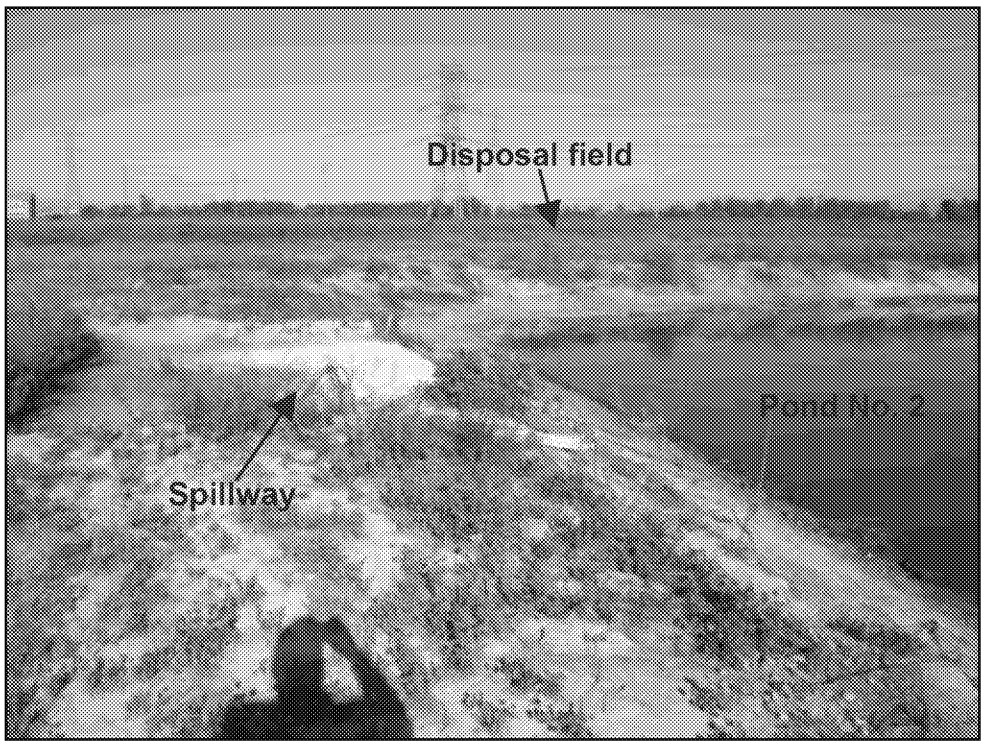
Photograph 13. View facing west of the concrete spillway located on the southwest side of pond No. 2.

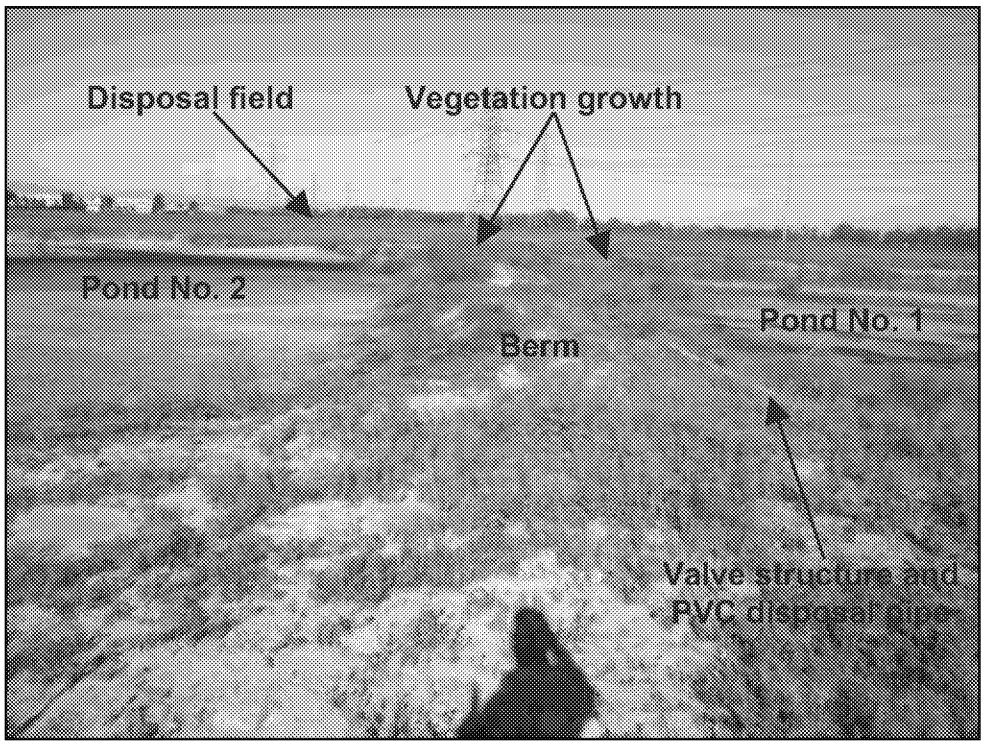
3. The EWMP was not fully implemented onsite and the containment structures had not been adequately maintained at the Facility as required by the Permit. Item No. 9 of the 'Operation and Maintenance' section of the EWMP states that "excessive vegetation growth around containment structures will be controlled with mowing." Mr. Van Leeuwen stated that the ponds were in poor condition and had not been adequately maintained when the Discharger took operational control of the Facility on April 22, 2012. In addition, he stated that the ponds had not been cleaned or maintained since. Vegetation growth was observed on all pond embankments of pond No. 1 and along the earthen berm between the pond Nos. 1 and 2 (refer to Photos 9, 10, 14, and 15). As a result, the Discharger was not fully implementing the EWMP onsite at the Facility, and the capacity of containment

Photograph 14. View facing west of vegetation growth on the earthen berm between pond Nos. 1 and 2 and the process wastewater valve structure location and PVC disposal pipe. Note the PVC disposal pipe was leading to a disposal area not identified in the EWMP or Site Plan (refer to Exhibit 2).

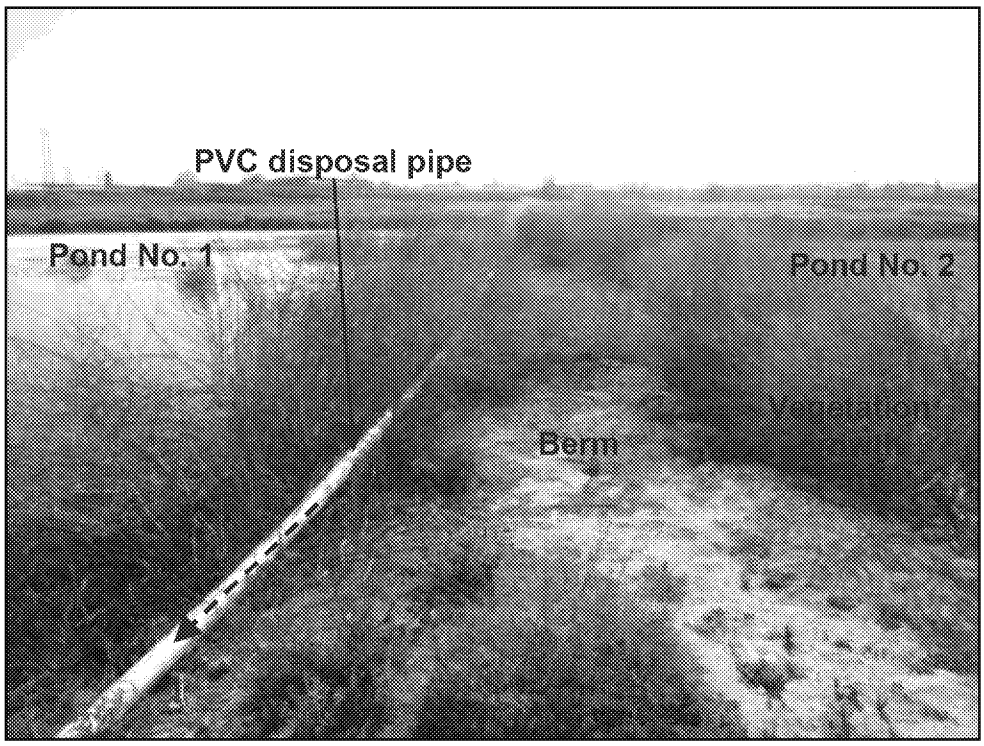
4. The EWMP was not representative of current Facility conditions at the time of the inspection as required by the Permit. Specifically, the EWMP Site Plan identifies process wastewater will be conveyed and land applied via a polyvinyl chloride (PVC) discharge pipe equipped with nine (9) disposal valves along the east side of the field area, located between the corrals and pond Nos. 1 and 2 (refer to Photo 17). A pump, shown in pond No. 2 on the EWMP Site Plan, allows process wastewater "to be reintroduced to the field for additional infiltration," (refer to Exhibit 2). The inspector did not observe a pump in pond No. 2; however, he did observe a PVC pipe from a valve structure adjacent to pond Nos. 1 and 2 extending west across the pond separation berm and into a disposal field west of the ponds (refer to Photos 14 and 15). Mr. Van Leeuwen stated that when the valve is closed, process wastewater is diverted into pond No. 1. The EWMP does not identify a process wastewater disposal field west of the ponds, or identify the conveyance of process wastewater from the valve structure west to the disposal field (refer to Exhibit 2). As a result, the Discharger was not fully implementing the approved EWMP. Provision VII.C.3.b of the Permit states that "the discharger shall develop and fully implement an Engineered Waste Management Plan (EWMP) acceptable to the Executive Officer." The Discharger shall fully implement the EWMP as required by Provision VII.C.3.b of the Permit.

Photograph 15. View facing east of vegetation growth on the earthen berm between pond Nos. 1 and 2 and the PVC disposal pipe.

Photograph 16. View facing west of the disposal field located on the west side of the Facility. Note this disposal area is not identified on the EWMP or Site Plan.

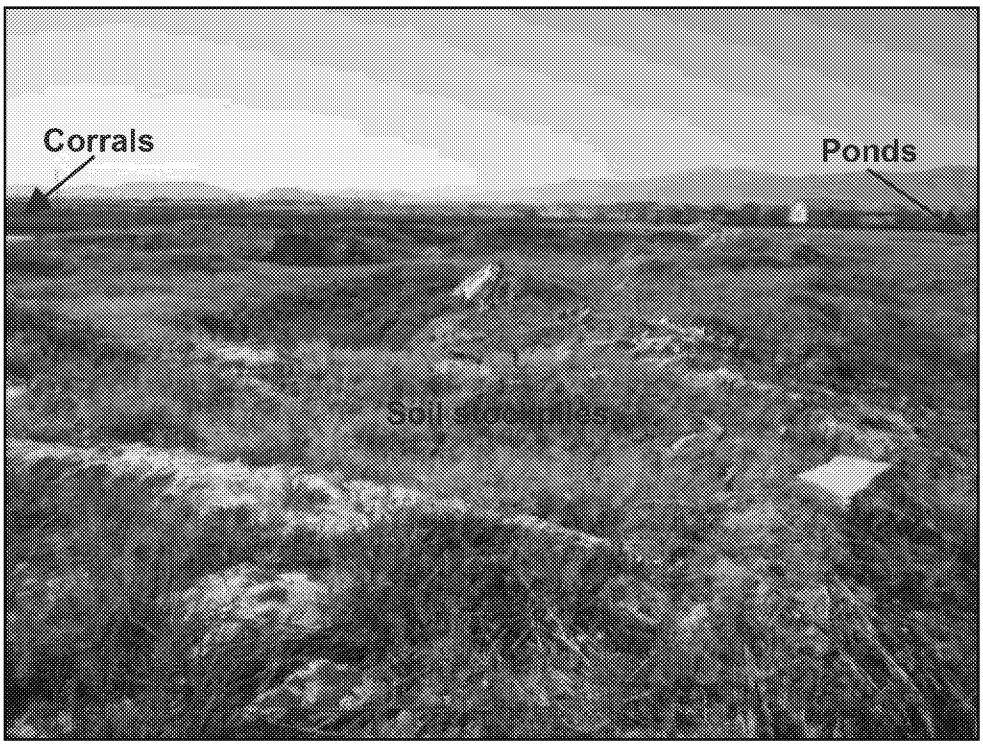
1. The inspector observed, during the inspection, that accumulated manure solids were present in the soil stockpile area located in the central portion of the Facility, west of the corrals (refer to Photos 17, 18, and 19). Mr. Van

Leeuwen stated that the soil stockpile area and manure was left over from the previous operator. It appeared to the inspector that the soil stockpile area was leftover material from the eight (8) containment structures that were previously installed at the Facility. The manure solids appeared to be at the bottom of a previous containment structure. As a result, the manure solids had not been removed from the Facility within 180 days as required by Provision VII.C.5.e of the Permit.

Photograph 17. View facing south of soil stockpiles located between the corrals and the ponds. Note the stockpiles appeared to impede storm water runoff from the corrals from reaching the containment ponds. Also note the EWMP Site Plan identifies this area as a disposal field.

Photograph 18. View facing west of manure solids located in the soil stockpile area shown in Photograph 17. Note the area shown above appears to be an old containment structure.

Photograph 19. Close-up view of the manure solids shown in Photograph 18.
