SANTA ANA REGIONAL WATER QUALITY CONTROL BOARD
INSPECTION REPORT

8365368001	Paul Huizenga	Paul Huizenga Dairy
WDID No.	OWNER NAME	FACILITY NAME
CAG018001	7587 Edison Avenue	7587 Edison Avenue
NPDES No.	OWNER ADDRESS	FACILITY ADDRESS
	Ontario, CA 91762	Ontario, CA 91762
Sched Date	OWNER CITY, STATE & ZIP	FACILITY CITY, STATE & ZIP
Aug 8, 2012	Paul Huizenga	Paul Huizenga
Actual Date Inspected	OWNER CONTACT	FACILITY CONTACT
	909-597-4695	909-597-4695
	OWNER PHONE NO.	FACILITY PHONE NO.

INSPECTION SUMMARY

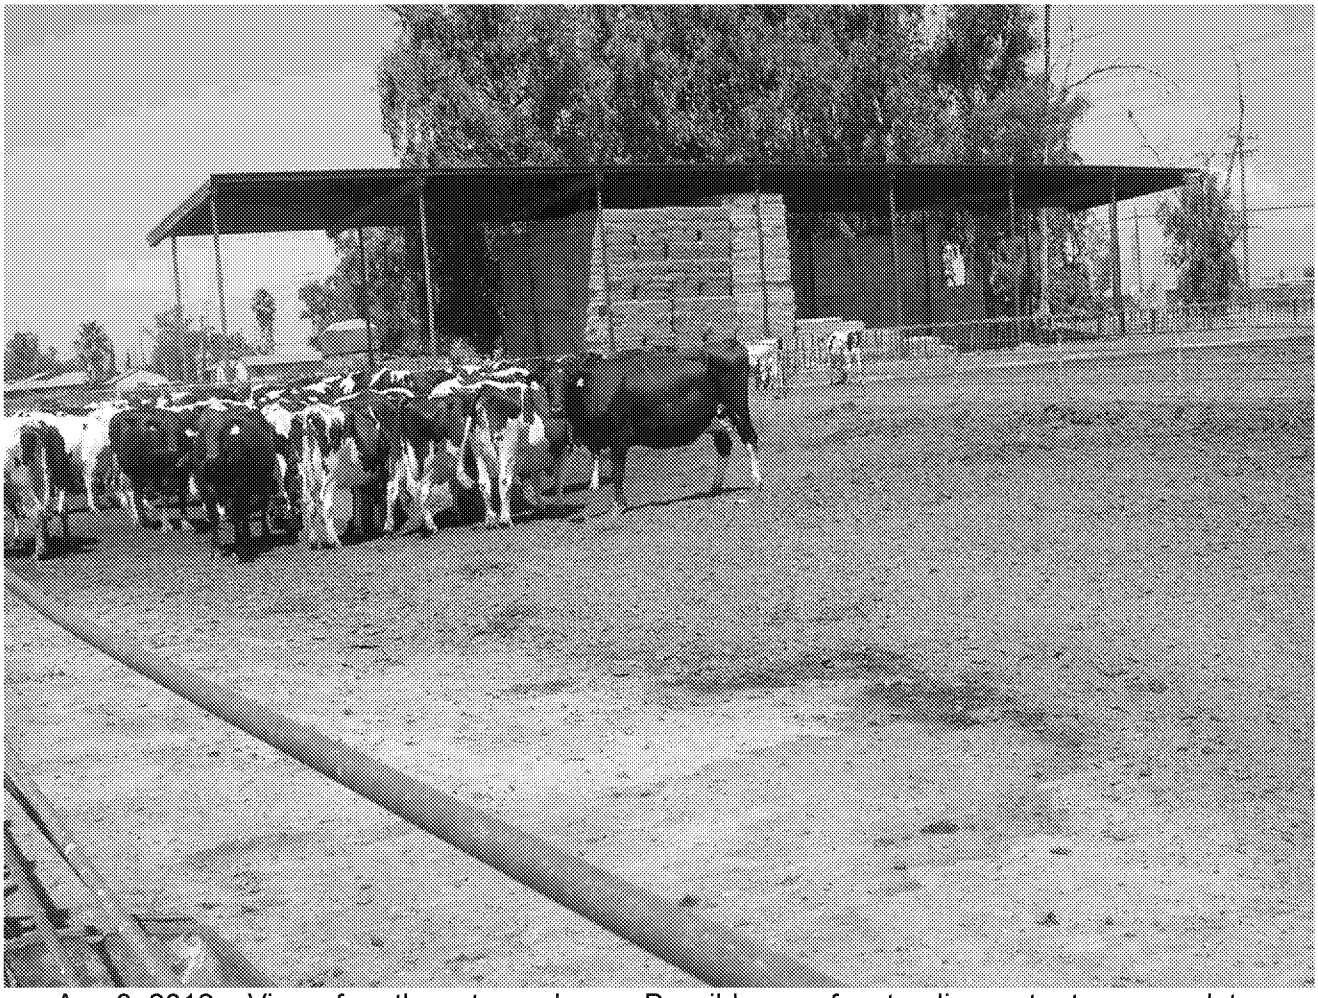
Aug 8, 2012 View of northern corral area. Manure stock pile to be removed. Corral manure ~~ 1-2 inches.
