U.S. ENVIRONMENTAL PROTECTION AGENCY

NPDES Permittee:	Robert Camozzi (unpermitted facility)
Facility:	Willow Creek Jerseys Ex. 6 Personal Privacy (PP) (Conditional Waiver of Waste Discharge Requirements Order R1-2012-0003)
Receiving Water:	Estero Americano tributaries
Date of Inspection:	April 17, 2014; 8:30 a.m.
Inspection Participants:	
U.S. EPA:	Glenn Sakamoto, CWA Compliance Office, (415) 972 - 3556 Becky Mitschele, NPDES Office, (415) 972 - 3492
California Regional Board:	Cherie Blatt, North Coast Regional Water Quality Control Board (707) 576 - 2755
Western United Dairymen:	Melissa Lema, Field Representative, (707) 779 - 2214
Gold Ridge Resource Conservation District:	William Hart, (707) 823 - 5244
Report Prepared By:	Becky Mitschele, US EPA Region 9
Report Date:	May 12, 2014

CAFO FACILITY INSPECTION REPORT

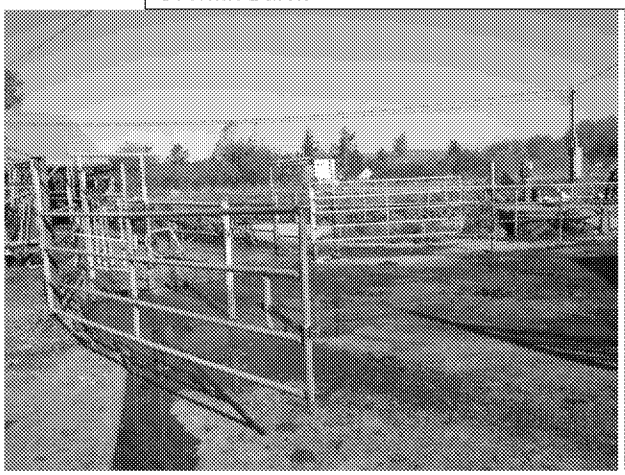
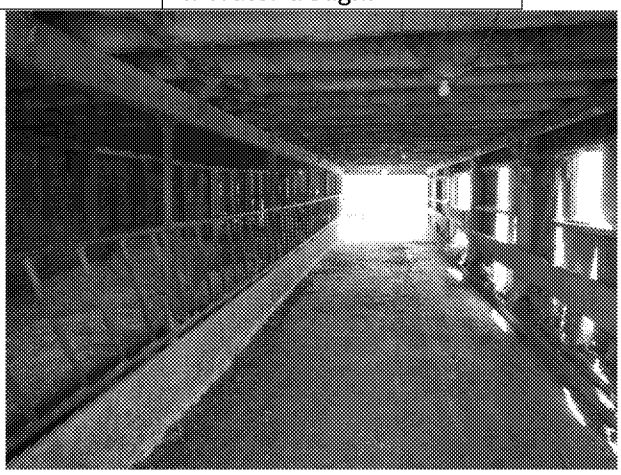
3. Milk Barn.	4. Water trough.

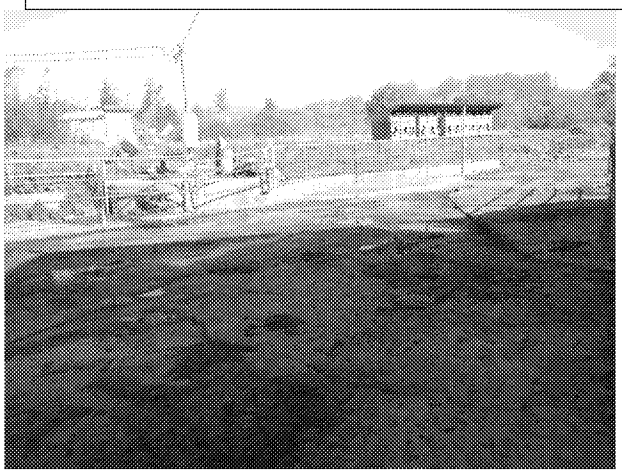
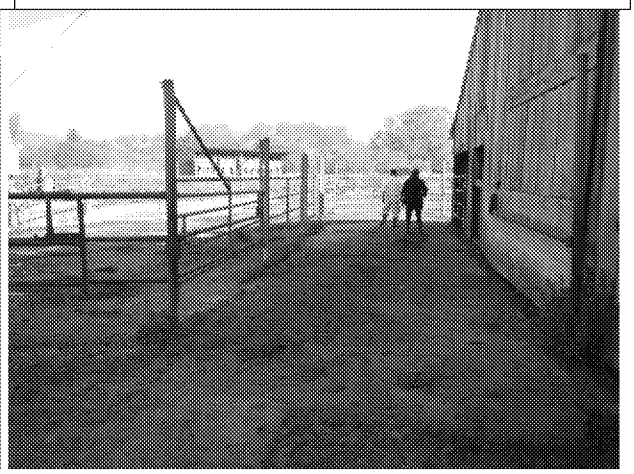
5. Concrete corral and curbs.	6. Barn with scraped lanes.

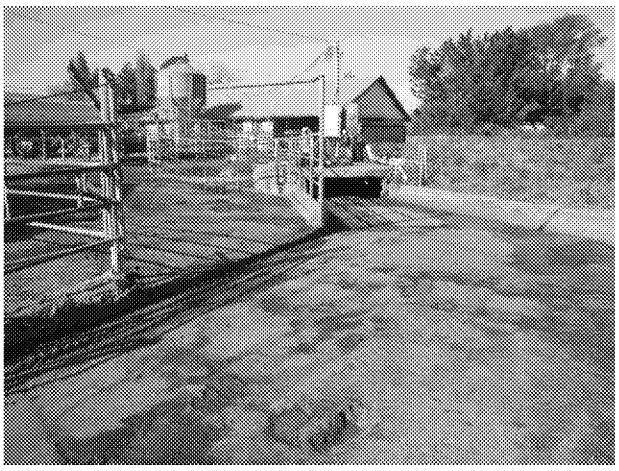
7. Scraped concrete corral with curbs. Note creek riparian zone in background.	8. Concrete lanes and corrals.

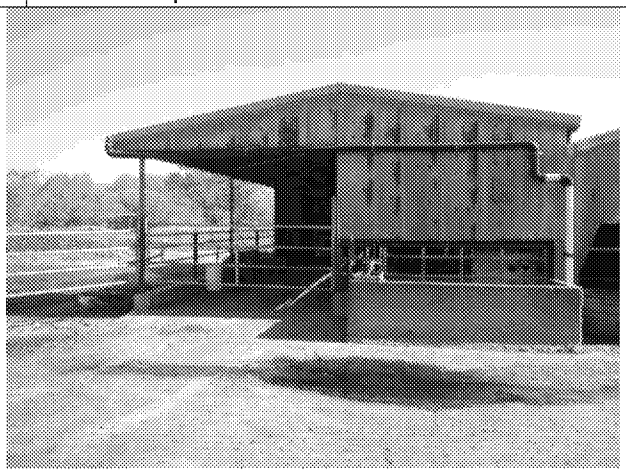
9. Scraped concrete lanes. Note rain gutters on roof.	10. Manure is scraped to pit which is transferred to manure ponds.

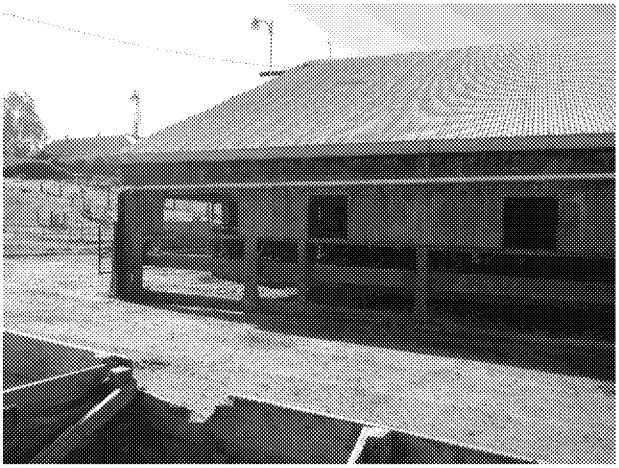
The inspectors also observed ponded water in several areas in the production area: first, at the area near the freestall barn in the dry manure storage area and then at the area near the rain gutter on the freestall barn. (See photo 11, 18, and 19). This area is located within the 100-year floodplain. (See FEMA map). Also, the lower pasture fields were wet (i.e. standing water).

Ponded water at the Site may come into contact with manure and other process wastewater. The facility must ensure that all process wastewater and manure is contained onsite. The area near the freestall barn may need to be sloped so that runoff does not drain to the creek. Gutters may need to be redirected to grassy areas to conserve manure capacity and avoid ponding water.

11. Dry Manure Storage Area.	12. Freestall building with gutters.

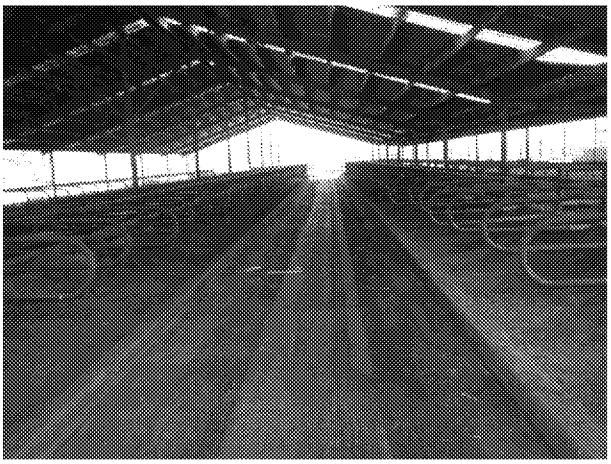
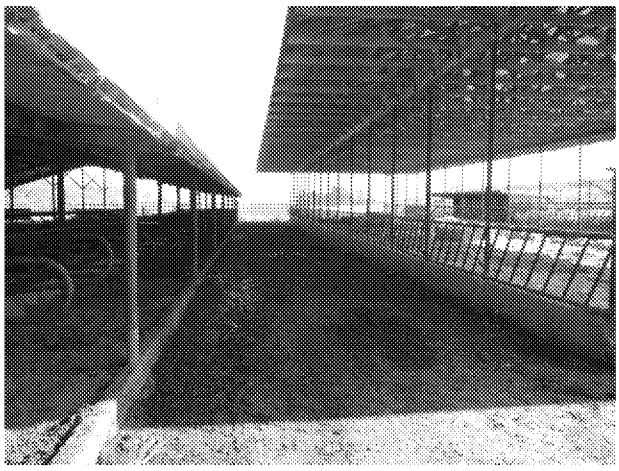
13. East side of Freestall barn with rain gutters.

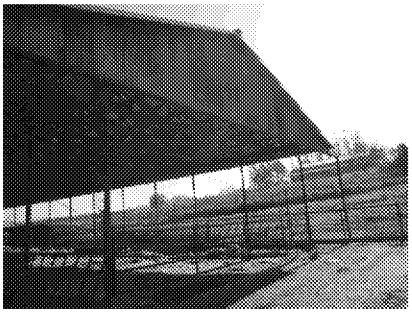
14. Freestall barn with scraped concrete floor.	15. Concrete lane between Freestall barn and new Roofed Feed Area.

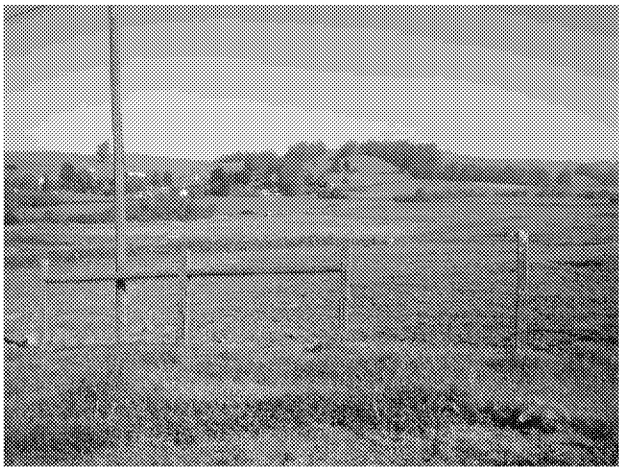
19. Ponding North of Freestall barns.

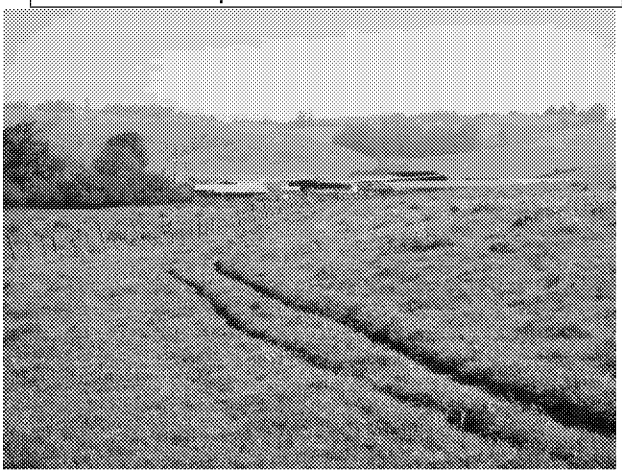
The inspectors observed high weed growth on the berms of ponds 1 and 2 (see photo 23 and 24). Mr. Camozzi says he allows cows to graze the ponds once a year to help with vegetation growth.

The inspectors observed high weed growth on the manure ponds. Weed growing on manure ponds should be trimmed regularly to aid in checking the pond for leaks.

23. Manure Liquids Pond 2.	24. North Berm of Manure Liquids Pond 2.

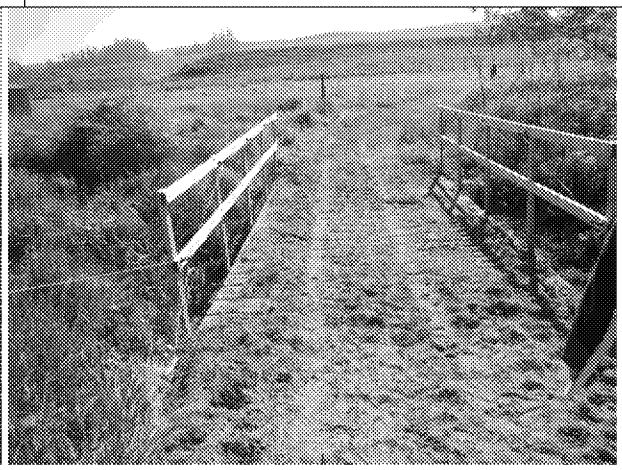
We visited the nearest surface water, unnamed creek (tributary to Estero Americano), immediately adjacent to the perimeter of the Site. The inspectors observed erosion and cow footprints on the creek's banks (see photo 29 and 30).

Mr. Camozzi uses a bridge for the cattle crossing between fields (field 1 and field 2). He removes the bridge around October, prior to the rainy season. (See photo 28). The inspectors noted erosion around the stream banks.

The Site might need additional best management practices near the cattle crossing bridge to ensure that manure and sediment do not enter the creek.

27. Pastures North of Production Area.	28. Bridge cow crossing of creek between pastures, near Domestic Water Supply Well.

29. Creek at bridge.	30. Creek at bridge.
