EPA United States Environmental Protection Agency

Inspection Date(s):	9/29/2015		
Time:	**Entry:** 9:00 am	**Exit:** 10:00am	
Media:	Water		
Regulatory Program(s)	Clean Water Act NPDES /CAFO Dairy		
Company Name:	Bosch Dairy No. 2		
Facility or Site Name:			
Facility/Site Physical Location:	Ex. 6 Personal Privacy (PP)		
Geographic Coordinates:			
Mailing address:			
Facility/Site Contact:	Bernard Bosch	**Title**: Operator	
	Phone: Ex. 6 Personal Privacy (PP)	**Email**:	
Facility/Site Identifier:	NPDES CAG018001 / Order R8-2013-0001, General waste discharge requirements for CAFOs (dairies and related facilities)		
NAICS:	112120 Dairy Cattle and Milk Production		
SIC:	0241 Dairy Farms		
Facility/Site Personnel Participating in Inspection:			
Name	Affiliation	Title	Email
Bernard Bosch		Operator	
EPA Inspector(s):			
John Tinger	EPA	Engineer	Tinger.John@EPA.gov
Federal/State/Tribal/Local Representatives:			
Edward Kashak	WRCB-R8	Engineering Geologist	ekashak@waterboards.ca.gov

SECTION I – INTRODUCTION

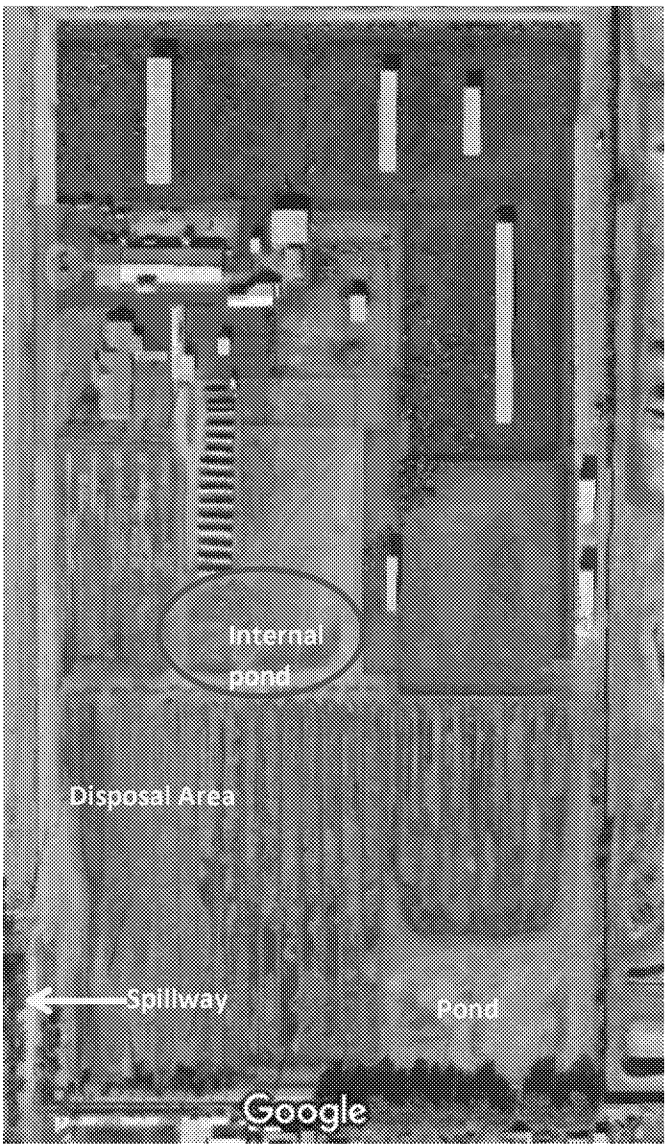
Stormwater generally flows in a southerly direction (see photo 1). Stormwater from the central/eastern portion of the facility first flows to the pond located in the center of the facility, and then may sheet flow to the disposal area and then to the pond in the south eastern portion of the facility.

Photo 1: Facility overview google earth.

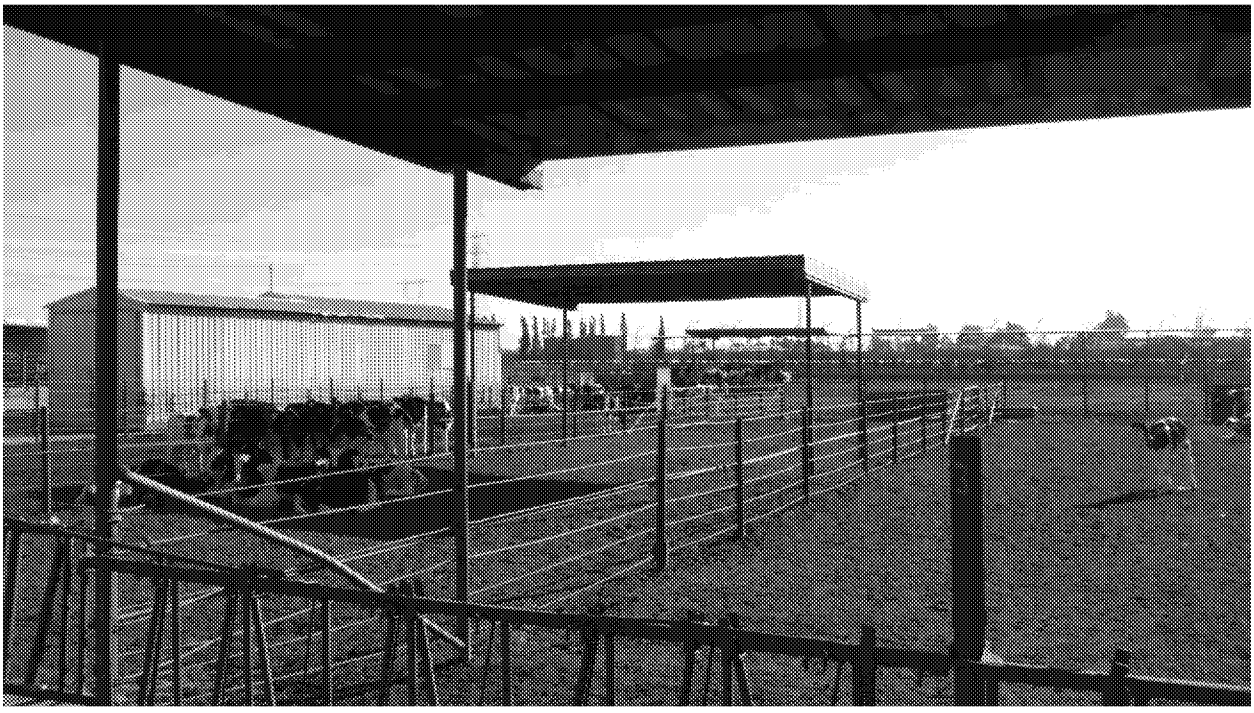
Photo 4: Corrals
