Region 9 Enforcement Division
75 Hawthorne Street
San Francisco, CA 94105

Inspection Date(s):	9/30/2015		
Time:	**Entry:** 8:45	**Exit:** 10:30	
Media:	Water		
Regulatory Program(s)	Clean Water Act NPDES /CAFO Dairy		
Company Name:	Northview Dairy		
Facility or Site Name:			
Facility/Site Physical Location:	Ex. 6 Personal Privacy (PP)		
Geographic Coordinates:			
Mailing address:	Ex. 6 Personal Privacy (PP) Ontario, Ca, 91761		
Facility/Site Contact:	Daryl Koops	**Title**: Operator	
	Phone: Ex. 6 Personal Privacy (PP)	**Email**:	
Facility/Site Identifier:	NPDES CAG018001 / Order R8-2013-0001, General waste discharge requirements for CAFOs (dairies and related facilities)		
NAICS:	112120 Dairy Cattle and Milk Production		
SIC:	0241 Dairy Farms		
Facility/Site Personnel Participating in Inspection:			
Name	Affiliation	Title	Email
Daryl Koops		Operator	
EPA Inspector(s):			
John Tinger	EPA	Engineer	Tinger.John@EPA.gov
Federal/State/Tribal/Local Representatives:			
Edward Kashak	WRCB-R8	Engineering Geologist	ekashak@waterboards.ca.gov

SECTION I – INTRODUCTION

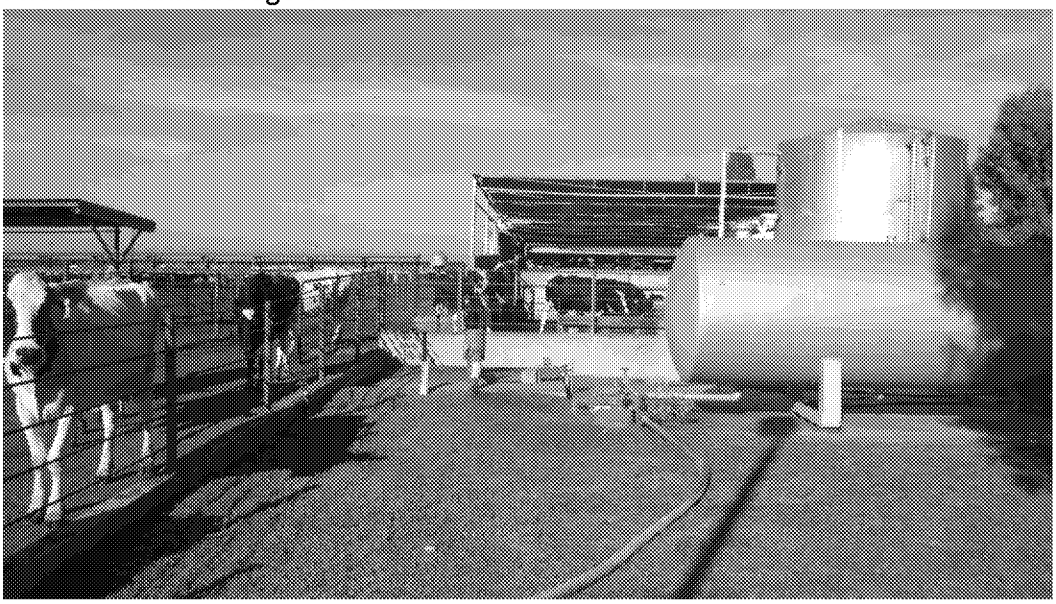
The facility operates a "Flush Alley System". Washwater from the milk barn is transferred to a 20,000 gallon (estimate) storage tank. The washwater from the tank is then used to flush the alleyways to clean manure from the concrete areas of the corrals (see photos 3-5). Alleyways are flushed once per day. The alley washwater flushes to the treatment lagoon (photo 6). At the lagoon, wastewater is pumped from the lagoon through a mechanical screen (photo 7). Solids from the screen are settled in a bin overnight, and water decanted back into the lagoon (photo 8). The solids are stacked in the central area where some additional drying occurs prior to hauling off-site (photo 9).

Photo 2: Tank Storage of washwater

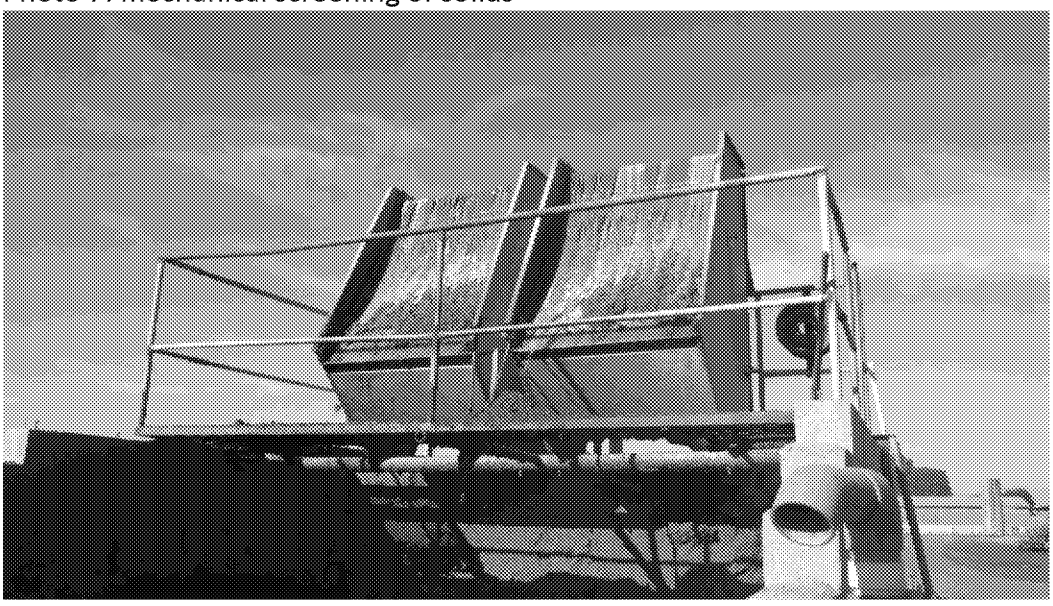
Photo 7: mechanical screening of solids

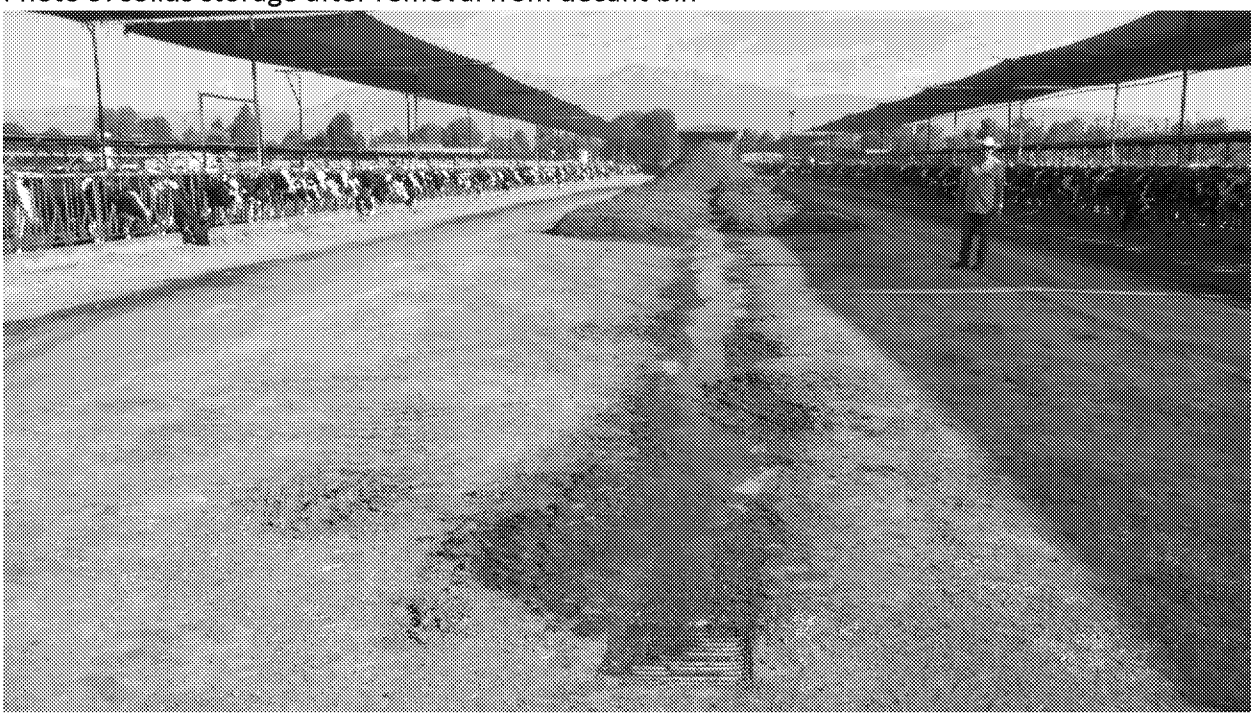
Photo 9: solids storage after removal from decant bin
