Region 9 Enforcement Division
75 Hawthorne Street
San Francisco, CA 94105

ED_005010_00004448-00001

SECTION I – INTRODUCTION

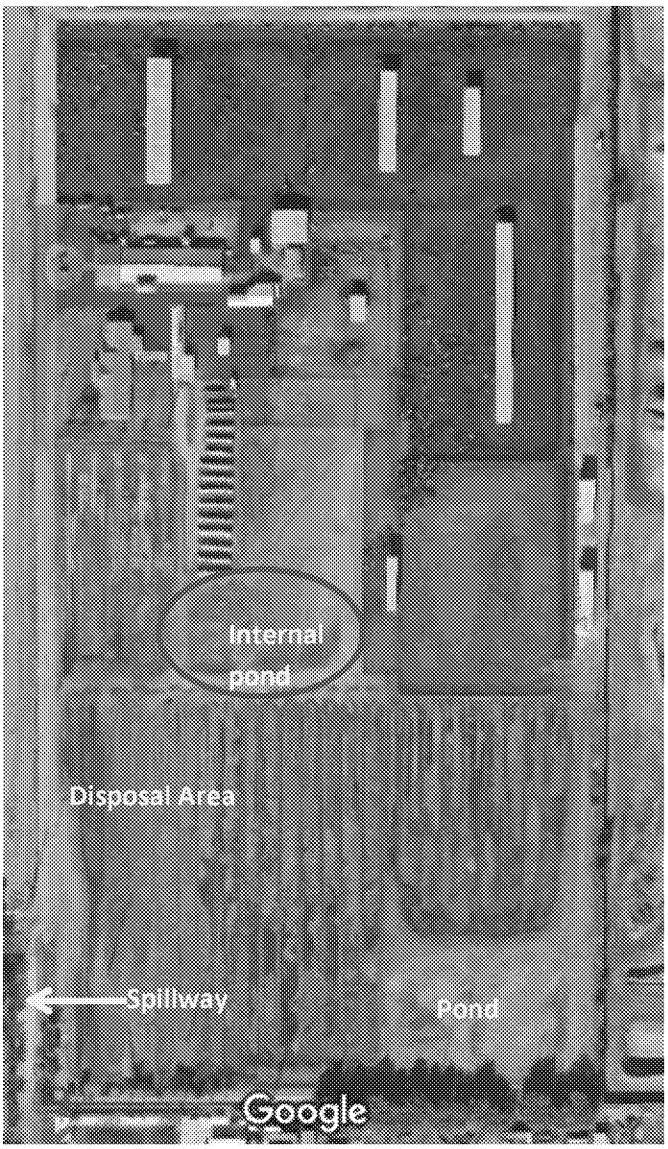
Stormwater generally flows in a southerly direction (see photo 1). Stormwater from the central/eastern portion of the facility first flows to the pond located in the center of the facility, and then may sheet flow to the disposal area and then to the pond in the south eastern portion of the facility.

Photo 1: Facility overview google earth.

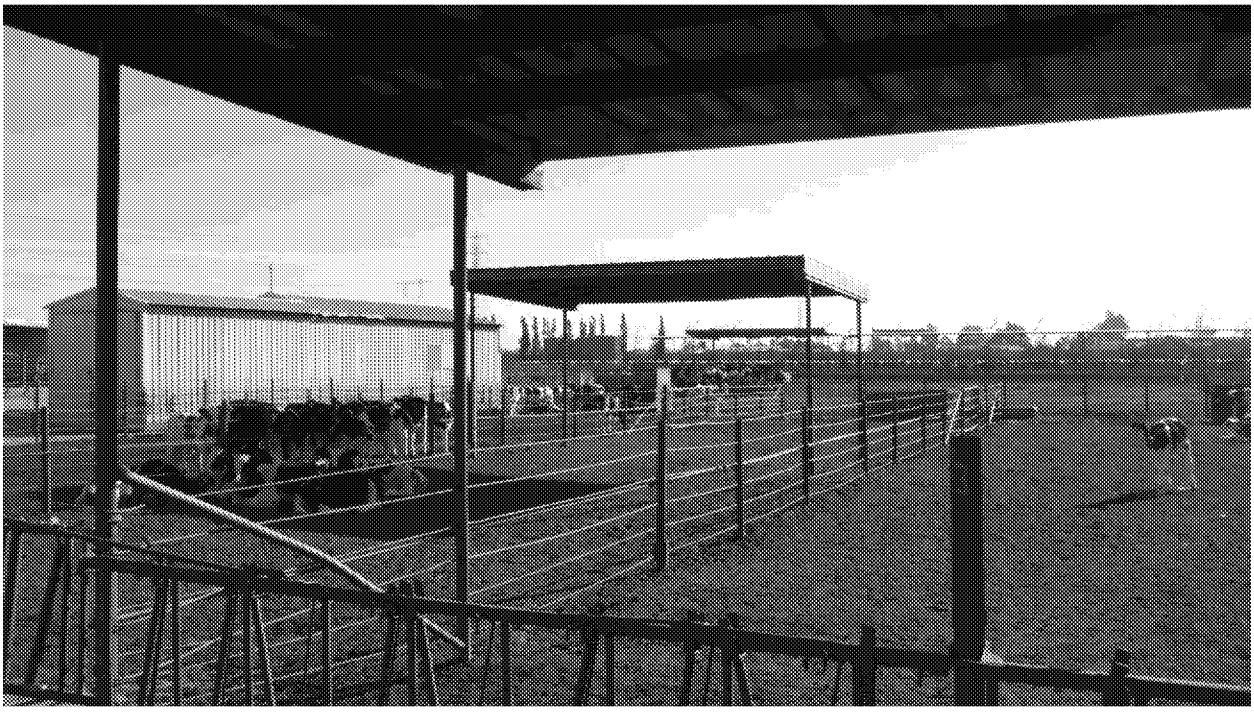
Photo 4: Corrals
