Inspection Date(s):	9/28/15		
Time:	**Entry:** 9:30	**Exit:** 11:45	
Media:	Water		
Regulatory Program(s)	Clean Water Act NPDES /CAFO Dairy		
Company Name:	Falloncrest Farms / John Weststeyn Cattle		
Facility or Site Name:			
Facility/Site Physical Location:	Ex. 6 Personal Privacy (PP)		
Geographic Coordinates:			
Mailing address:	PO Box 2500, Chino, CA, 91708		
Facility/Site Contact:	Ron Pietersma	**Title**: Owner/ Operator	
	Phone: Ex. 6 Personal Privacy (PP)	**Email**:	
	John Weststeyn	Operator	
Facility/Site Identifier:	NPDES CAG018001 / Order R8-2013-0001, General waste discharge requirements for CAFOs (dairies and related facilities)		
NAICS:	112120 Dairy Cattle and Milk Production		
SIC:	0241 Dairy Farms		
Facility/Site Personnel Participating in Inspection:			
Name	Affiliation	Title	Email
John Weststeyn	John Weststeyn Cattle	Operator	
EPA Inspector(s):			
John Tinger	EPA	Engineer	Tinger.John@EPA.gov

SANTA ANA REGIONAL WATER QUALITY CONTROL BOARD
INSPECTION REPORT

Appendix 2 – Photograph Log

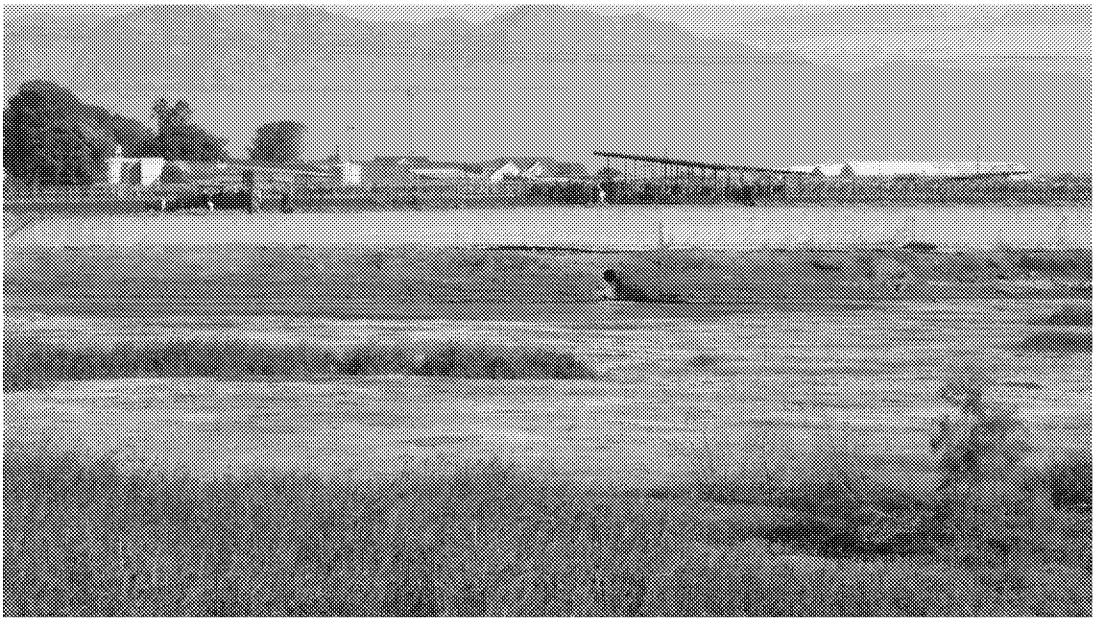
Ponds appeared to contain excess accumulated sediment and excess vegetation (see photos 2, 3, 4). At the time of the inspection, the operator stated the facility began removing solids from the northeastern corner of the north pond about 6 weeks prior to inspection. The area of solids removal was observed in a small portion of the northern pond (see photo 4). The remaining solids in the area appeared to be fairly wet. The operated stated removal of solids was currently suspended due to wet conditions in the basin which prevents a loader from working. The operator stated that they expect to have solids removal completed within about a month, provided the weather remains dry. The solids have been moved to the former calf ranch area to dry before hauling off site.

Photo 3: Northern edge of northern pond. Pond actively receiving washwater. View looking north. Excessive solids and vegetation in pond.

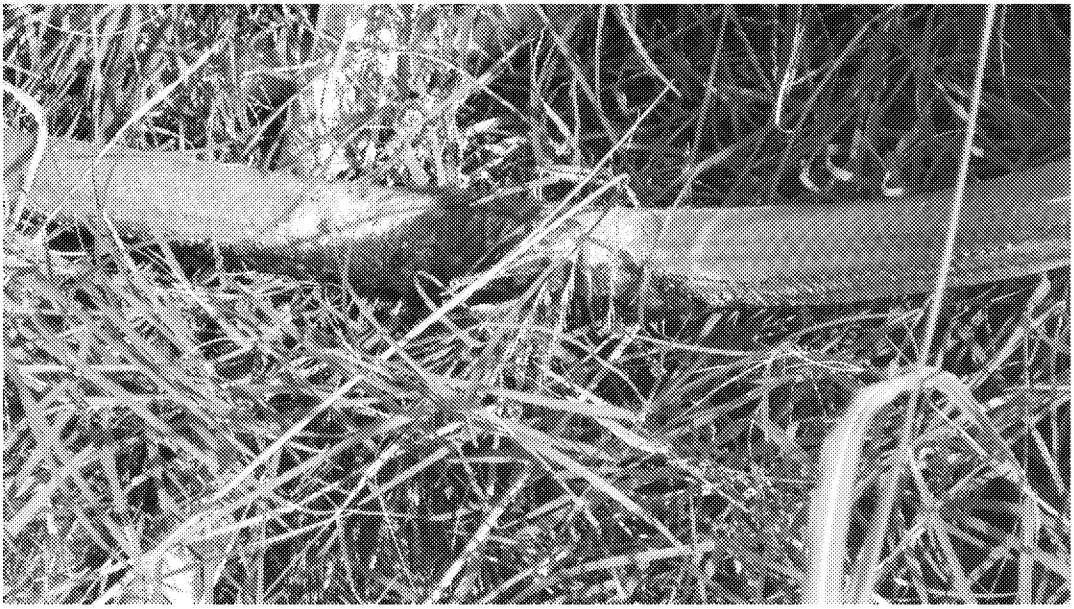
A broken water line was observed draining into the wastewater lagoon (see photos 8-9). Algae growth was observed both on the waterline hose and on the pavement downstream of the leak, indicating the presence of the leak for an extended amount of time.

Photo 8: Broken water hose discharging to southern pond.

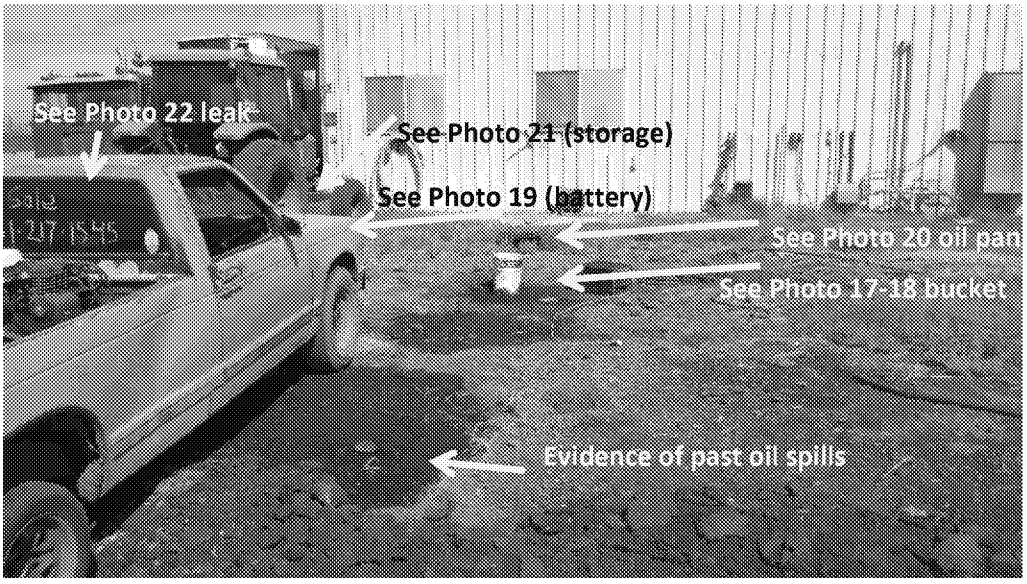
Open containers of used oil were observed at several locations with potential to discharge to the stormdrain (see photos 11, 12, 16, 17, 18). At least one bucket had a label of "hydraulic oil". Evidence of oil stained soil and oil stained pavement was observed at several locations throughout the area (see photos 12, 15, 16).

Photo 16: Maintenance area. Southwest corner of maintenance shed. Oil stained soil, improper used oil storage, and improper material storage.

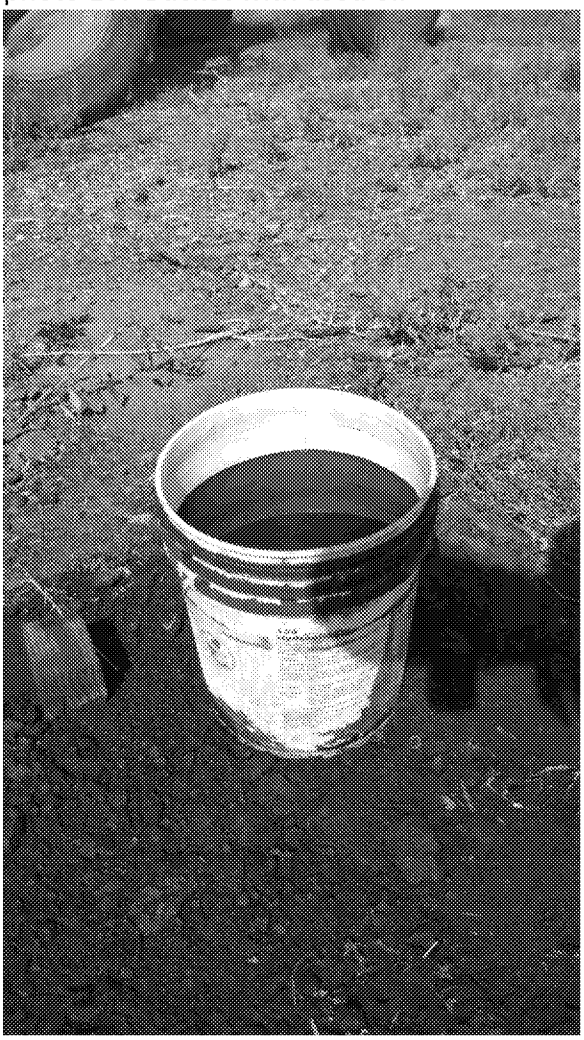
Photo 17 : Maintenance area : detail of photo 16: Bucket with used oil

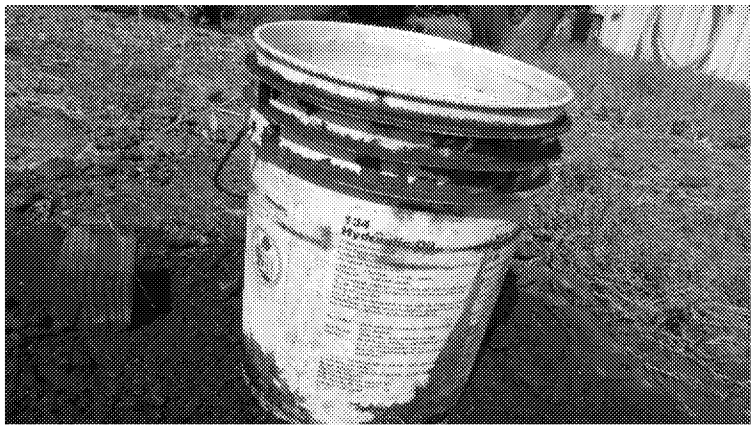
Photo 18: Detail : bucket labeled "Hydraulic oil"

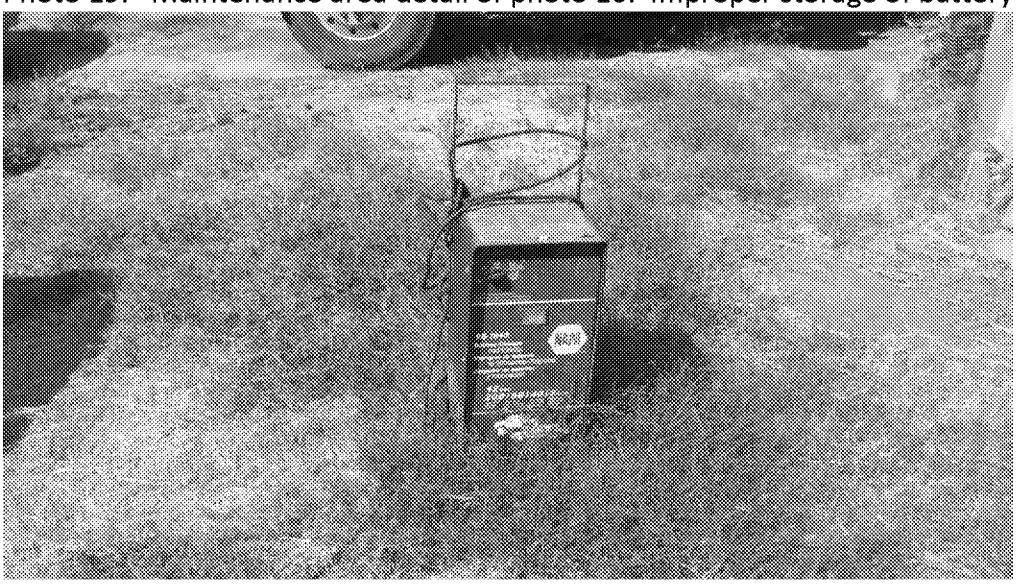
A battery was observed stored outside with potential to leak to stormdrain (photo 19).

Photo 19: Maintenance area detail of photo 16: Improper storage of battery

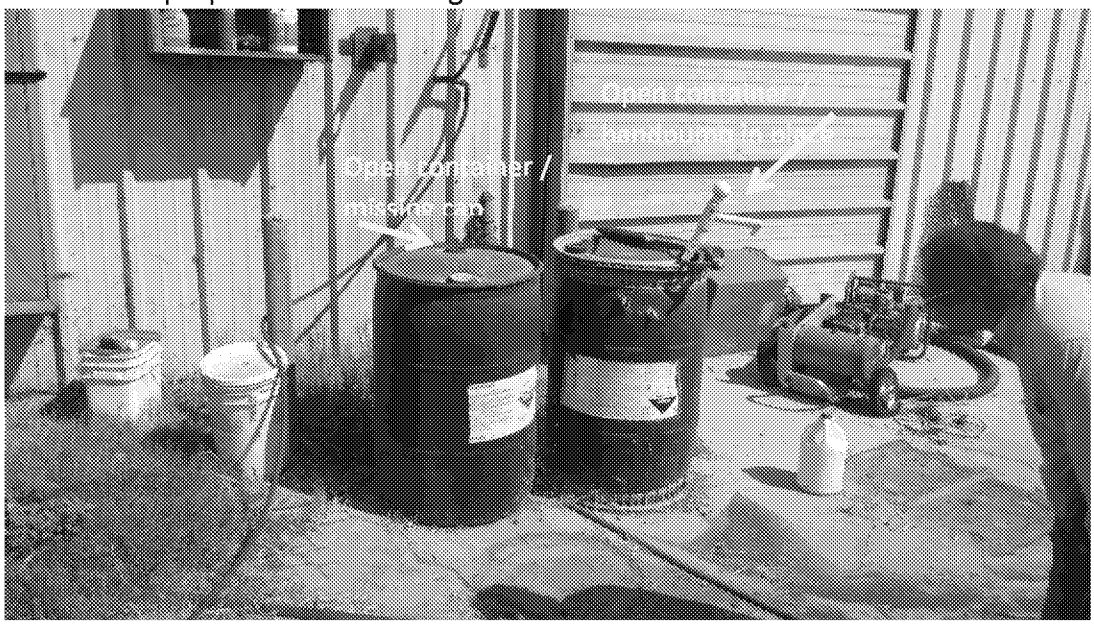
Two 55 gallons barrels were observed without secondary containment with potential to discharge to the stormwater drain. The barrels were both approximately ½ full. One barrel was open due to a missing cap and was labeled "formaldehyde". The second barrel was open due to an installed pump system, and, while the label was partially unreadable, it appeared to be "sodium hypochlorite" brand name "HASACHLOR".

Photo 23: improper chemical storage.

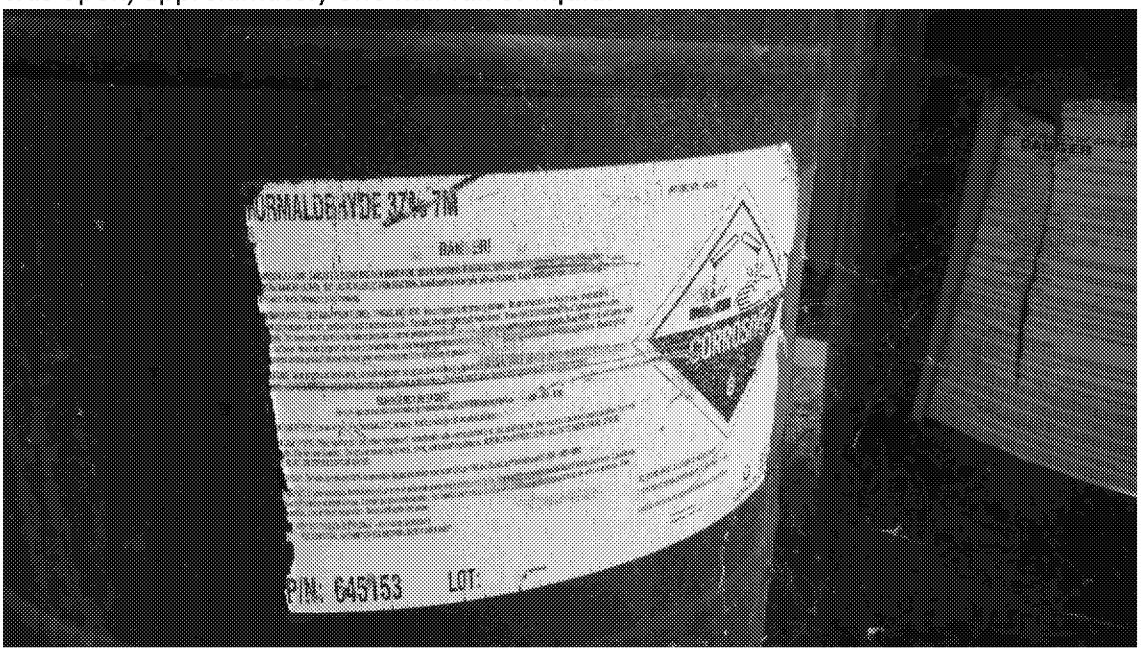
Photo 24: Detail of photo 23: Improper chemical storage, detail label "formaldehyde". Barrel was open, approximately one half full of liquid.

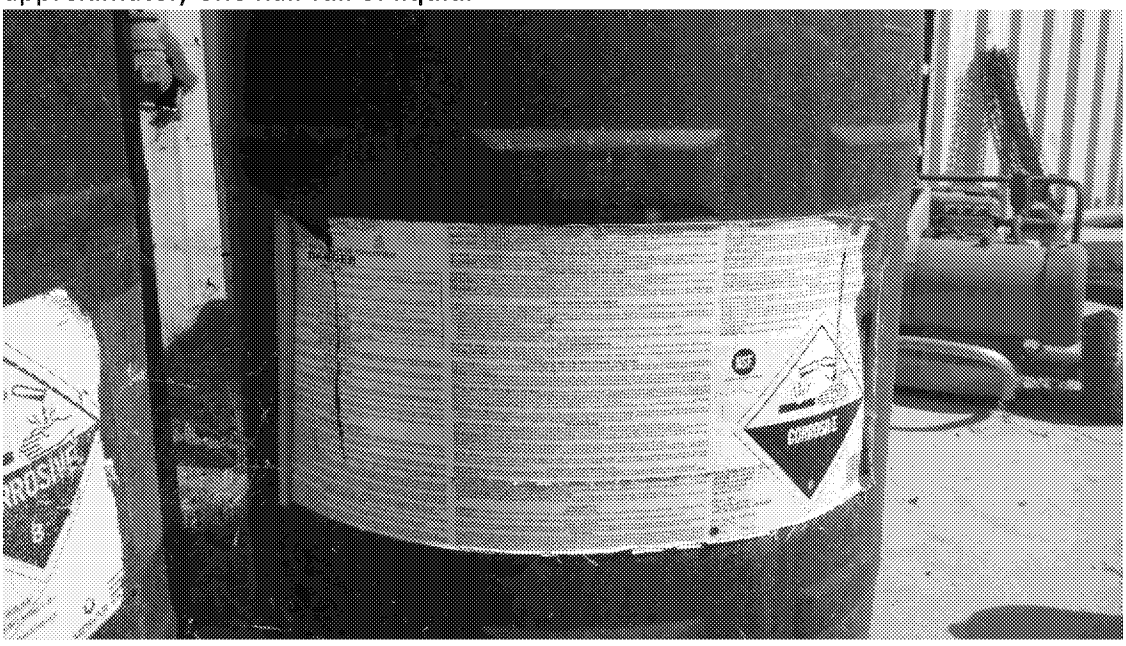
Photo 25: Detail of photo 23: improper chemical storage, detail of label. Label is partially unreadable, but appears to be "sodium hypochlorite" brand name "HASACHLOR". Barrel was approximately one half full of liquid.

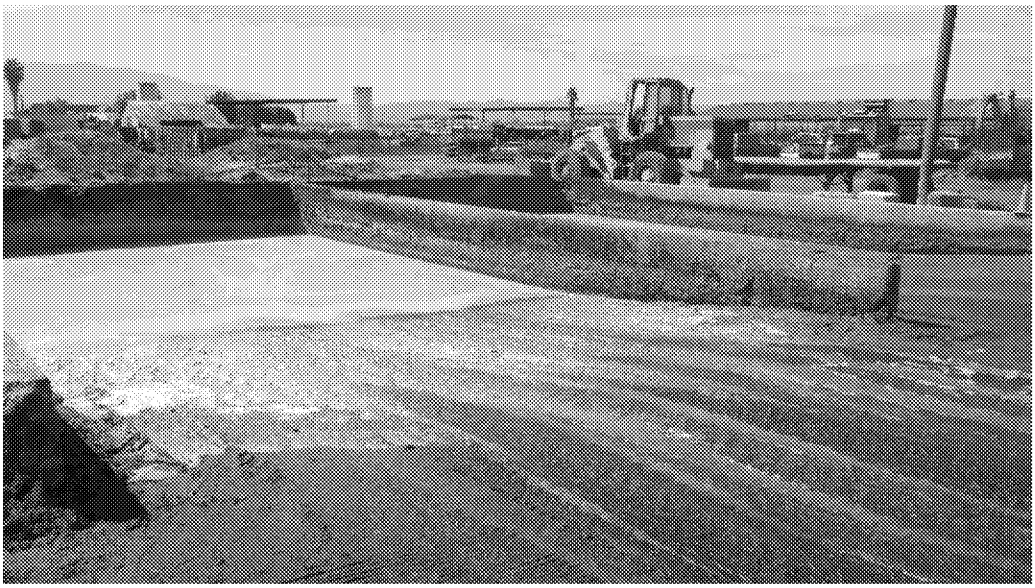
Photo 28: area of mixing feed.

The area at the south end of the maintenance area is used for mixing feed in several concrete basins, including feedstock which may include old ice cream and other milk products (photo 28). The area around the feed area and pavement was stained with material that had the potential to discharge to the stormdrain. (photo 27, 28).
The material was dark black but did not have a sheen and was determined to be feed material tracked out from the mixing tanks and was not oil. At the closeout meeting, the operator noted that curdled milk product can have the black appearance of oil.
