Region 9 Enforcement Division
75 Hawthorne Street
San Francisco, CA 94105

Inspection Date(s):	9/29/2015		
Time:	**Entry:** 10:00 am	**Exit:** 12:00pm	
Media:	Water		
Regulatory Program(s)	Clean Water Act NPDES /CAFO Dairy		
Company Name:	Legend Dairy Farms #2		
Facility or Site Name:			
Facility/Site Physical Location:	Ex. 6 Personal Privacy (PP)		
Geographic Coordinates:			
Mailing address:	P.O. Box 2500, Chino, CA, 91708		
Facility/Site Contact:	Ron Peitersma	**Title**: Operator	
	Phone: Ex. 6 Personal Privacy (PP)	**Email**:	
Facility/Site Identifier:	NPDES CAG018001 / Order R8-2013-0001, General waste discharge requirements for CAFOs (dairies and related facilities)		
NAICS:	112120 Dairy Cattle and Milk Production		
SIC:	0241 Dairy Farms		
Facility/Site Personnel Participating in Inspection:			
Name	Affiliation	Title	Email
Ron Peitersma	Legend Dairy	Operator	
EPA Inspector(s):			
John Tinger	EPA	Engineer	Tinger.John@EPA.gov
Federal/State/Tribal/Local Representatives:			
Edward Kashak	WRCB-R8	Engineering Geologist	ekashak@waterboards.ca.gov

SECTION I – INTRODUCTION

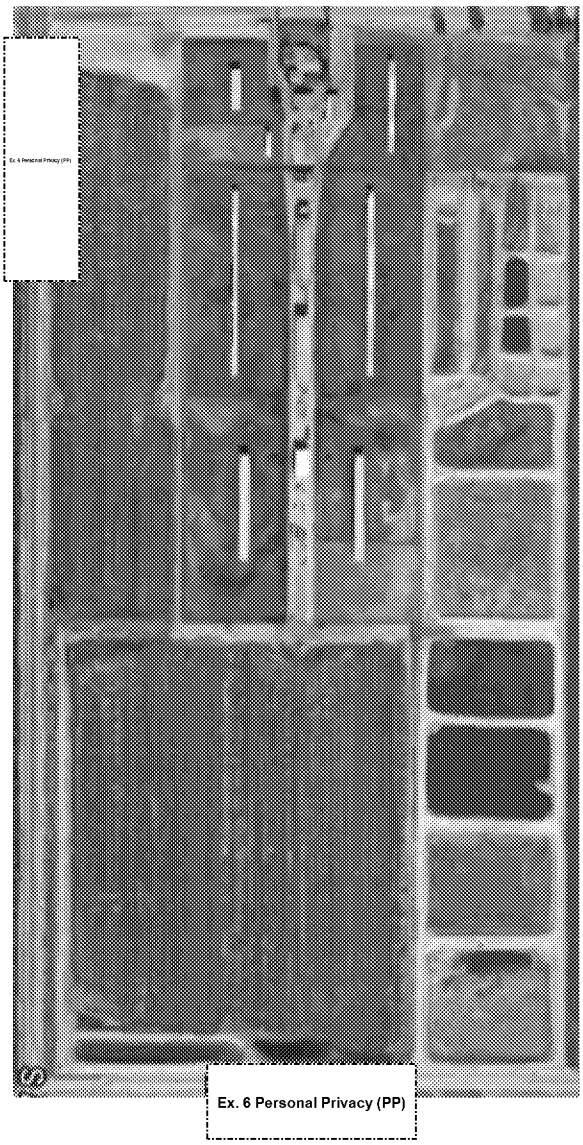
Photo 1: facility overview

The facility has 16 ponds located on the eastern side of the dairy. (see photo 1) Washwater from the milk barn areas gravity flows to the northern ponds (photo 6), and washwater either gravity flows or is pumped to the ponds in series towards the spillway located at the southern end of the facility.

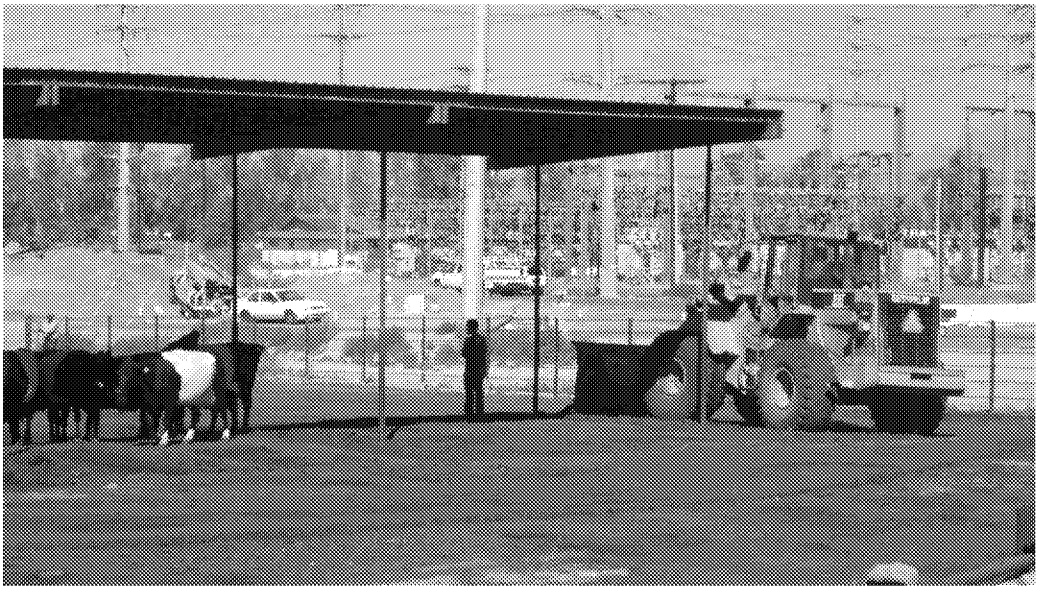
DISCUSSION OF FACILITY HOUSEKEEPING:
No issues noted. Corrals were being scraped and stockpiles of manure were being removed at time of inspection (see photo 1-2. Operator stated corrals would be continuously scrapped until the rainy season to remove manure. Manure did not appear to have been present for more than 180 days.

Photo 2: Corrals being scraped and manure being hauled off

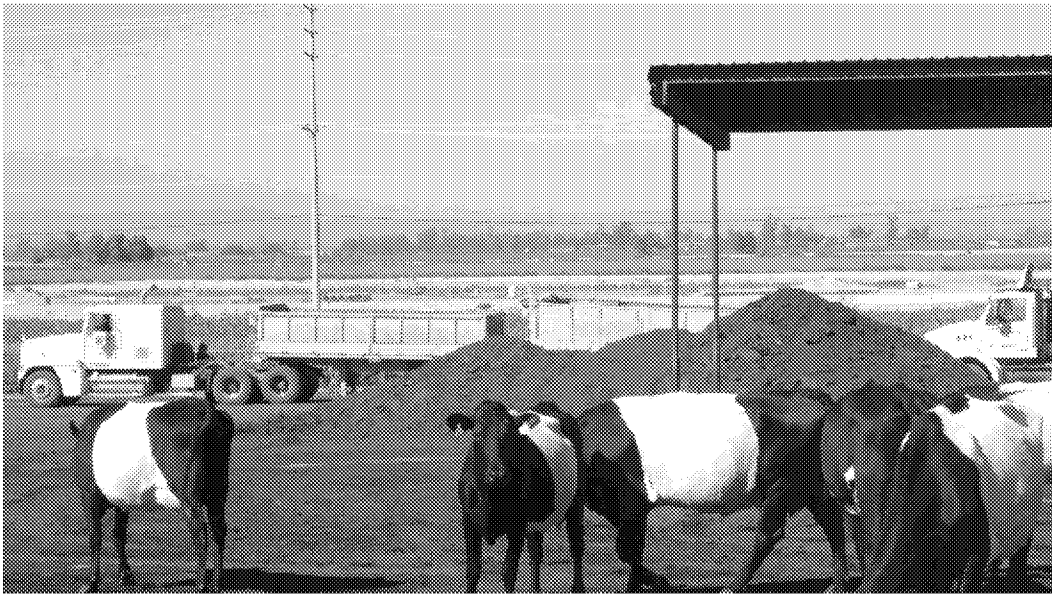
Photo 3: Corrals being scraped and manure being hauled off

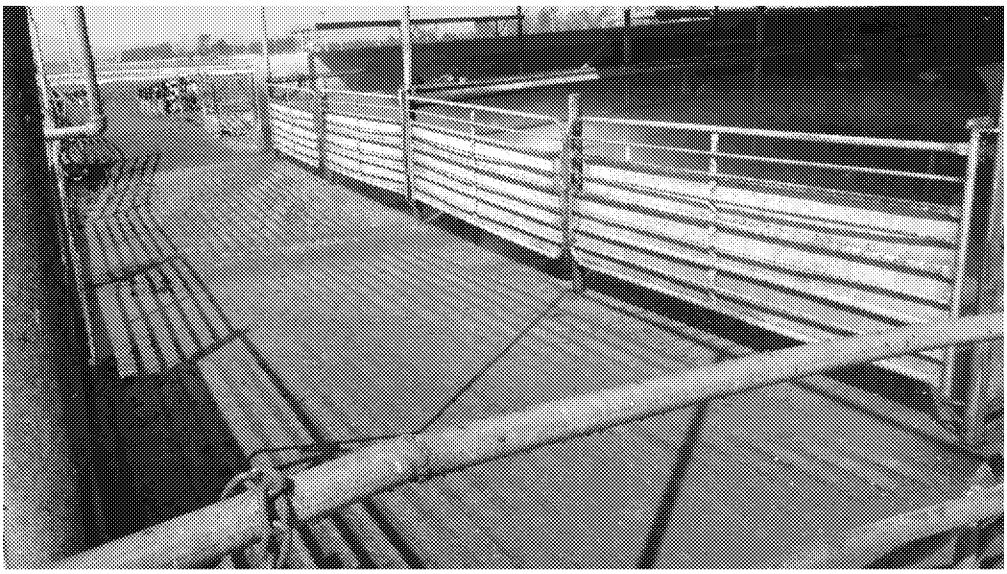
No evidence of significant rodent damage, erosion, or excess vegetation along berms was observed. Ponds generally clear of vegetation. Several ponds appeared to have excess amount of sediment buildup.

Photo 6: washwater flowing into pond. Build-up of accumulated sediments.

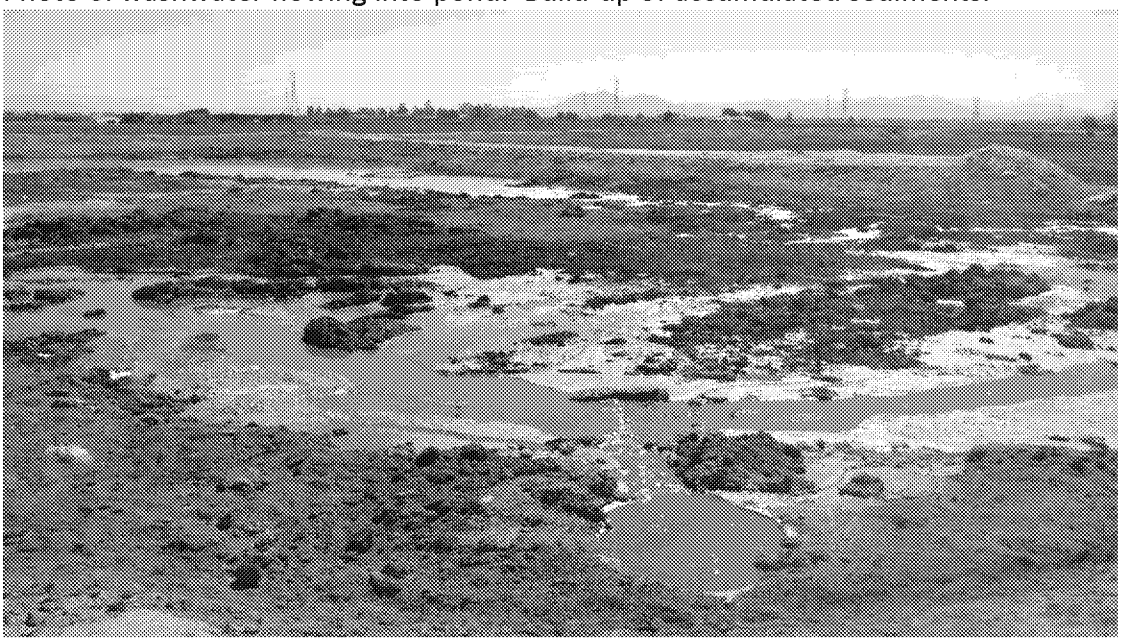
- Several ponds appeared to have excess solids with accumulation more than 2 feet deep. However, the pond network appeared to have sufficient storage capacity based on EWMP design, which includes a total of 16 ponds, many in series, and most of which did not have excess solids. The operator indicated the ponds will likely be scheduled for cleaning next year.
