Inspection Date(s):	9/28/15		
Time:	**Entry:** 9:30	**Exit:** 11:45	
Media:	Water		
Regulatory Program(s)	Clean Water Act NPDES /CAFO Dairy		
Company Name:	Falloncrest Farms / John Weststeyn Cattle		
Facility or Site Name:			
Facility/Site Physical Location:	Ex. 6 Personal Privacy (PP)		
Geographic Coordinates:			
Mailing address:	PO Box 2500, Chino, CA, 91708		
Facility/Site Contact:	Ron Pietersma	**Title**: Owner/ Operator	
	Phone: Ex. 6 Personal Privacy (PP)	**Email**:	
	John Weststeyn	Operator	
Facility/Site Identifier:	NPDES CAG018001 / Order R8-2013-0001, General waste discharge requirements for CAFOs (dairies and related facilities)		
NAICS:	112120 Dairy Cattle and Milk Production		
SIC:	0241 Dairy Farms		
Facility/Site Personnel Participating in Inspection:			
Name	Affiliation	Title	Email
John Weststeyn	John Weststeyn Cattle	Operator	
EPA Inspector(s):			
John Tinger	EPA	Engineer	Tinger.John@EPA.gov

SANTA ANA REGIONAL WATER QUALITY CONTROL BOARD
INSPECTION REPORT

Appendix 2 – Photograph Log

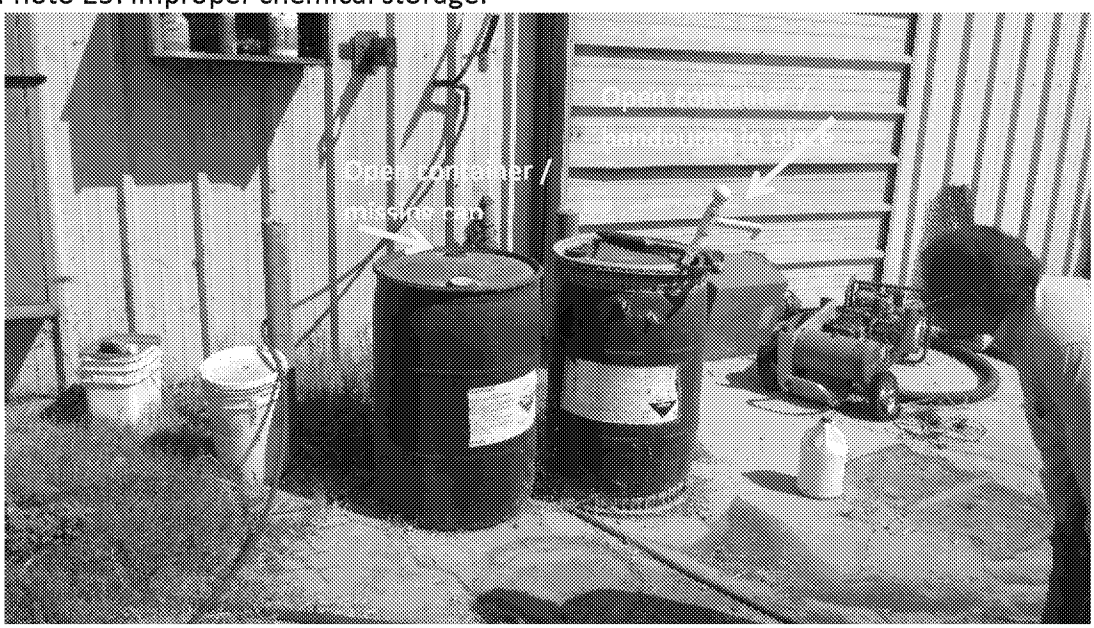
Two 55 gallons barrels were observed without secondary containment with potential to discharge to the stormwater drain. The barrels were both approximately ½ full. One barrel was open due to a missing cap and was labeled "formaldehyde". The second barrel was open due to an installed pump system, and, while the label was partially unreadable, it appeared to be "sodium hypochlorite" brand name "HASACHLOR".

Photo 23: improper chemical storage.
