Region 9 Enforcement Division
75 Hawthorne Street
San Francisco, CA 94105

Inspection Date(s):	9/30/2015		
Time:	**Entry:** 8:45	**Exit:** 10:30	
Media:	Water		
Regulatory Program(s)	Clean Water Act NPDES /CAFO Dairy		
Company Name:	Northview Dairy		
Facility or Site Name:			
Facility/Site Physical Location:	Ex. 6 Personal Privacy (PP)		
Geographic Coordinates:			
Mailing address:			
Facility/Site Contact:	Daryl Koops	**Title**: Operator	
	Phone: Ex. 6 Personal Privacy (PP)	**Email**:	
Facility/Site Identifier:	NPDES CAG018001 / Order R8-2013-0001, General waste discharge requirements for CAFOs (dairies and related facilities)		
NAICS:	112120 Dairy Cattle and Milk Production		
SIC:	0241 Dairy Farms

SECTION I – INTRODUCTION

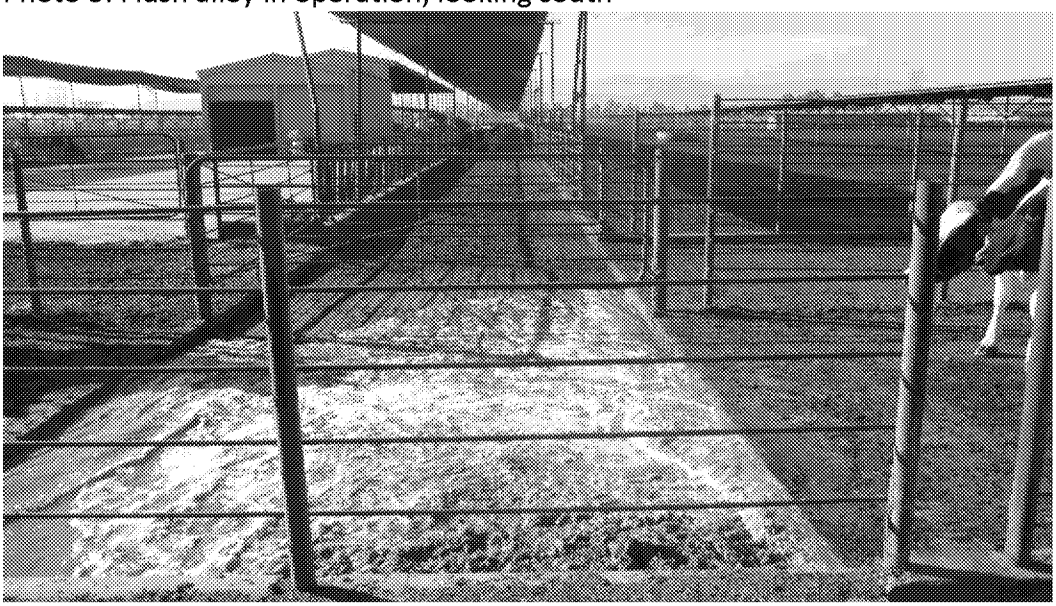
The facility operates a "Flush Alley System". Washwater from the milk barn is transferred to a 20,000 gallon (estimate) storage tank. The washwater from the tank is then used to flush the alleyways to clean manure from the concrete areas of the corrals (see photos 3-5). Alleyways are flushed once per day. The alley washwater flushes to the treatment lagoon (photo 6). At the lagoon, wastewater is pumped from the lagoon through a mechanical screen (photo 7). Solids from the screen are settled in a bin overnight, and water decanted back into the lagoon (photo 8). The solids are stacked in the central area where some additional drying occurs prior to hauling off-site (photo 9).

Photo 3: Flush alley in operation, looking south

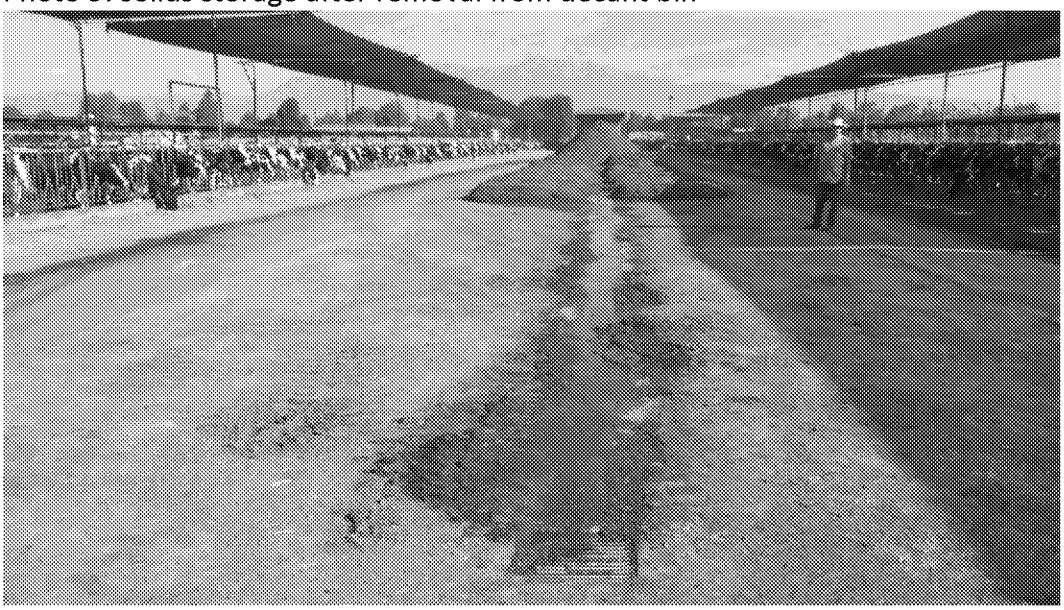
Photo 9: solids storage after removal from decant bin

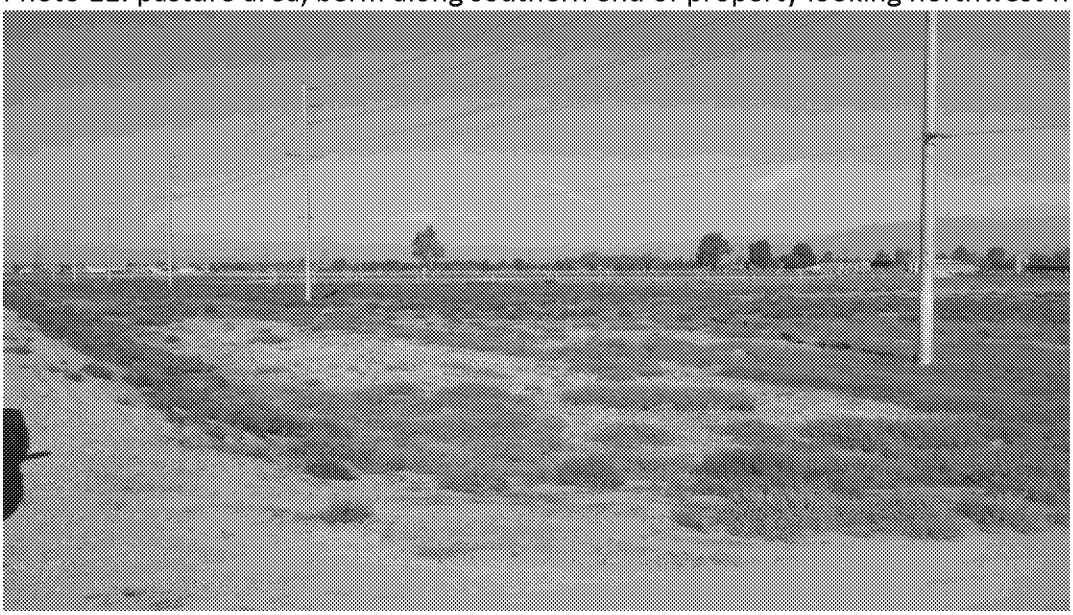
Photo 11: pasture area, berm along southern end of property looking northwest from spillway.
