Region 9 Enforcement Division
75 Hawthorne Street
San Francisco, CA 94105

Inspection Date(s):	9/30/15		
Time:	**Entry:** 1:00pm	**Exit:** 2:15pm	
Media:	Water		
Regulatory Program(s)	Clean Water Act NPDES /CAFO Dairy		
Company Name:	TIVA Dairy		
Facility or Site Name:			
Facility/Site Physical Location:	Ex. 6 Personal Privacy (PP)		
Geographic Coordinates:			
Mailing address:			
Facility/Site Contact:	Dickie Vander Meulen	**Title**: Owner/Operator	
	Phone: Ex. 6 Personal Privacy (PP)	**Email**:	
Facility/Site Identifier:	NPDES CAG018001 / Order R8-2013-0001, General waste discharge requirements for CAFOs (dairies and related facilities)		
NAICS:	112120 Dairy Cattle and Milk Production		
SIC:	0241 Dairy Farms		
Facility/Site Personnel Participating in Inspection:			
Name	Affiliation	Title	Email
Dickie Vander Meulen	TIVA Dairy	Operator	
EPA Inspector(s):			
John Tinger	EPA	Engineer	Tinger.John@EPA.gov
Federal/State/Tribal/Local Representatives:			
Edward Kashak	WRCB-R8	Engineering Geologist	ekashak@waterboards.ca.gov

SECTION I – INTRODUCTION

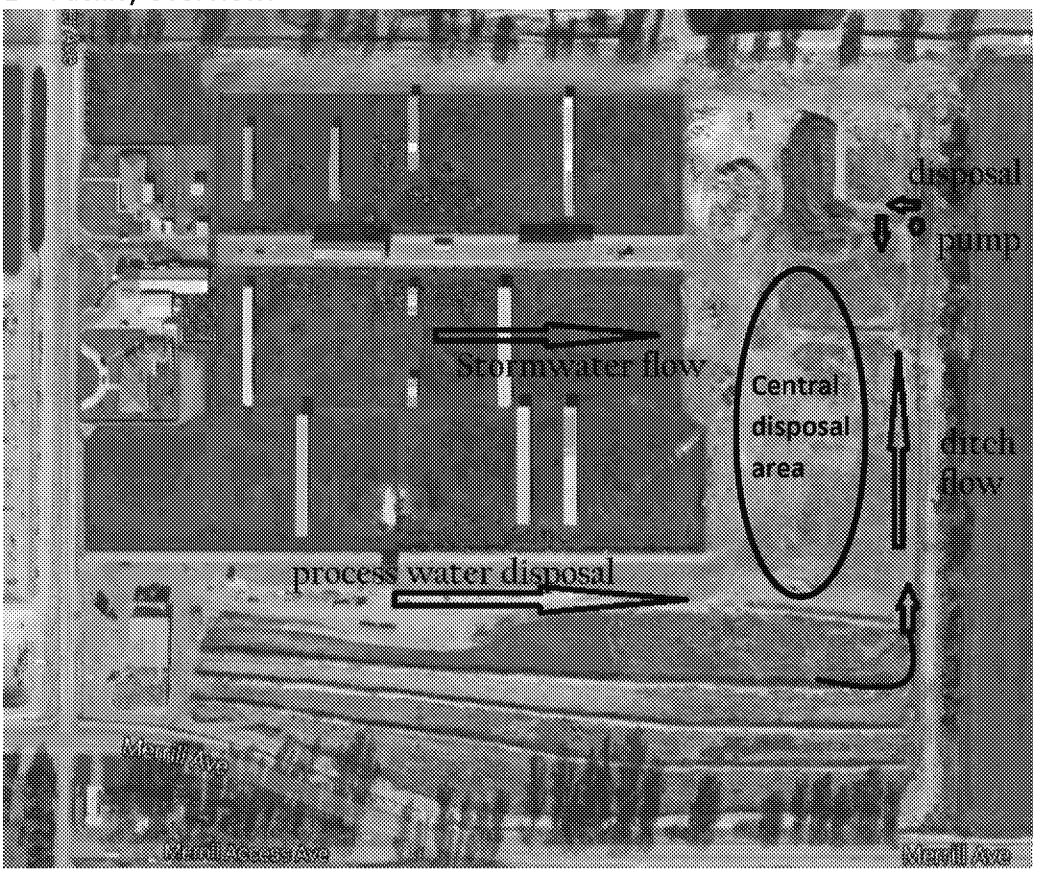
1 – Facility overview.

Washwater from the milking barn area gravity drains through underground pipes to the southern portion of the dairy where it is directed to one of 4 standpipes for discharge to the disposal area. The disposal area consists of 4 bermed areas which drain towards the eastern end of the facility. (see photo 1). The operator manually directs the wastewater to one of the 4 standpipes. At the time of the inspection, wastewater was actively flowing into the 2nd northernmost bermed area (photo 3). The operator stated wastewater has been directed to this bermed area for approximately 2 weeks. Previously, the northernmost bermed area had received wastewater (photo 4). At the time of the inspection, the solids in the northermost area had been drying for approximately 2 weeks, and the operator stated he anticipates removing the solids within the month when the solids are sufficiently dry to accommodate equipment.

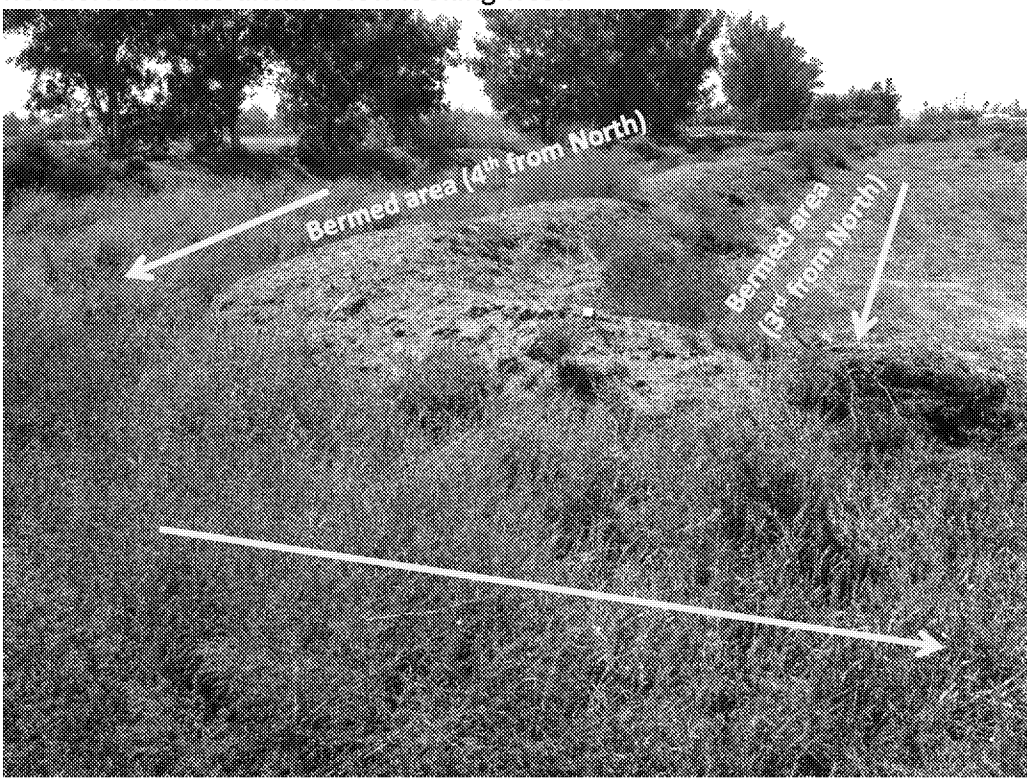
At the eastern end of the bermed areas, the berms are several feet lower to create a spillway into a ditch running alongside the eastern boundary (photo 8). The ditch was observed to contain heavy vegetation cover, especially in the southeast corner. The ditch directs wastewater northward back towards the center of the facility. At the end of the ditch, the operator has installed a pump (photo 10). When the ditch is full, the operator pumps wastewater to the northernmost disposal area where it infiltrates (photo 11). Excess wastewater from this pasture area may overflow to the center disposal area (photo 12).

Photo 7: Southeastern edge of facility. Bermed areas turn corner and flow is directed northerward into ditch. View looking west.

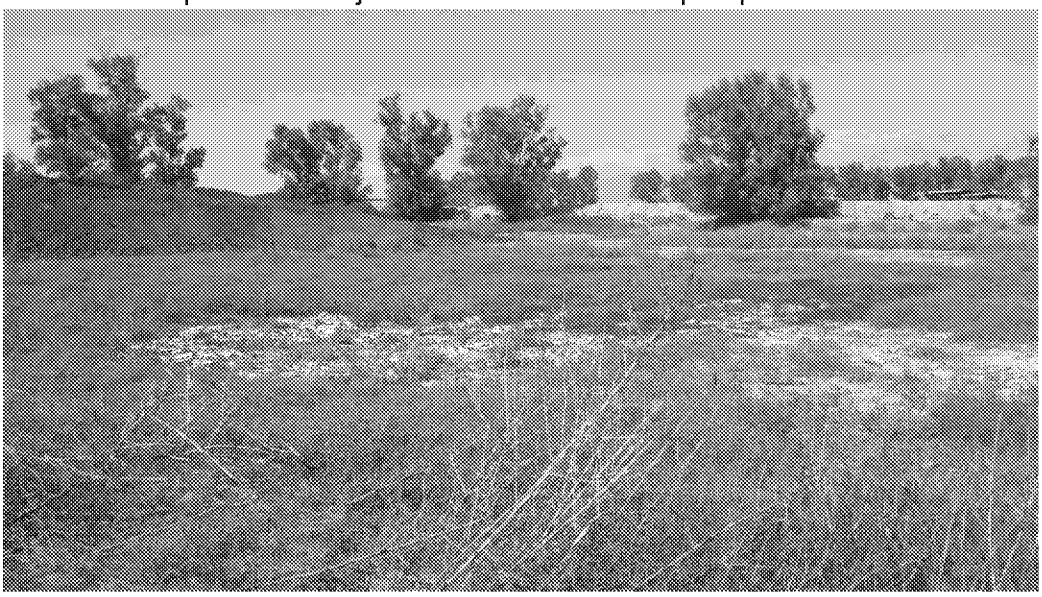
Stormwater generally flows from the corrals towards the center and easterly direction to the disposal areas (photo 12). The soils in the disposal area were observed to be sandy and very porous. The operator noted the high percolation rates in this area, and stating that 2' of water will drain overnight. The operator rips the disposal area as needed to encourage infiltration in this area. The operator recently bought a new disc ripper to facilitate ripping the area.

Photo 12: disposal area in center of eastern section of facility. This area receives stormwater flow from corrals, and receives any overflow from the disposal area in photo 11. The area is disked to promote infiltration. View looking northwest.
