Armstrong Chicken Farms Clean Water Act inspection (__ of 88 photos)
All photos taken by Kristine Karlson, EPA, on March 26, 2014.

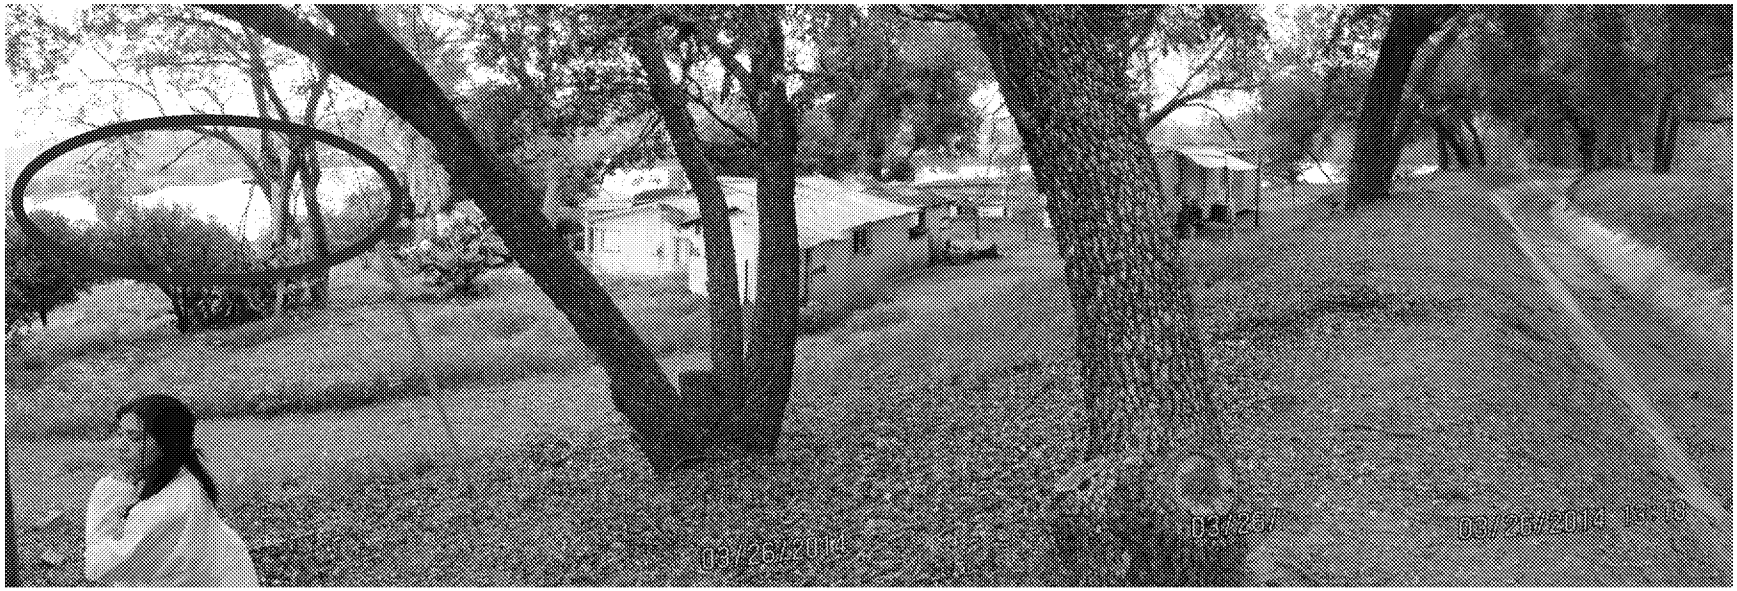
Photo 7 – View of canal running alongside and above the Armstrong Egg Farms facility. The canal is located uphill from the facility and does not appear to be able to receive flows from it. Circle marks hen houses downhill and to the west.
