Armstrong Chicken Farms Clean Water Act inspection (41 of 88 photos total)
All photos taken by Kristine Karlson, EPA, on March 26, 2014.

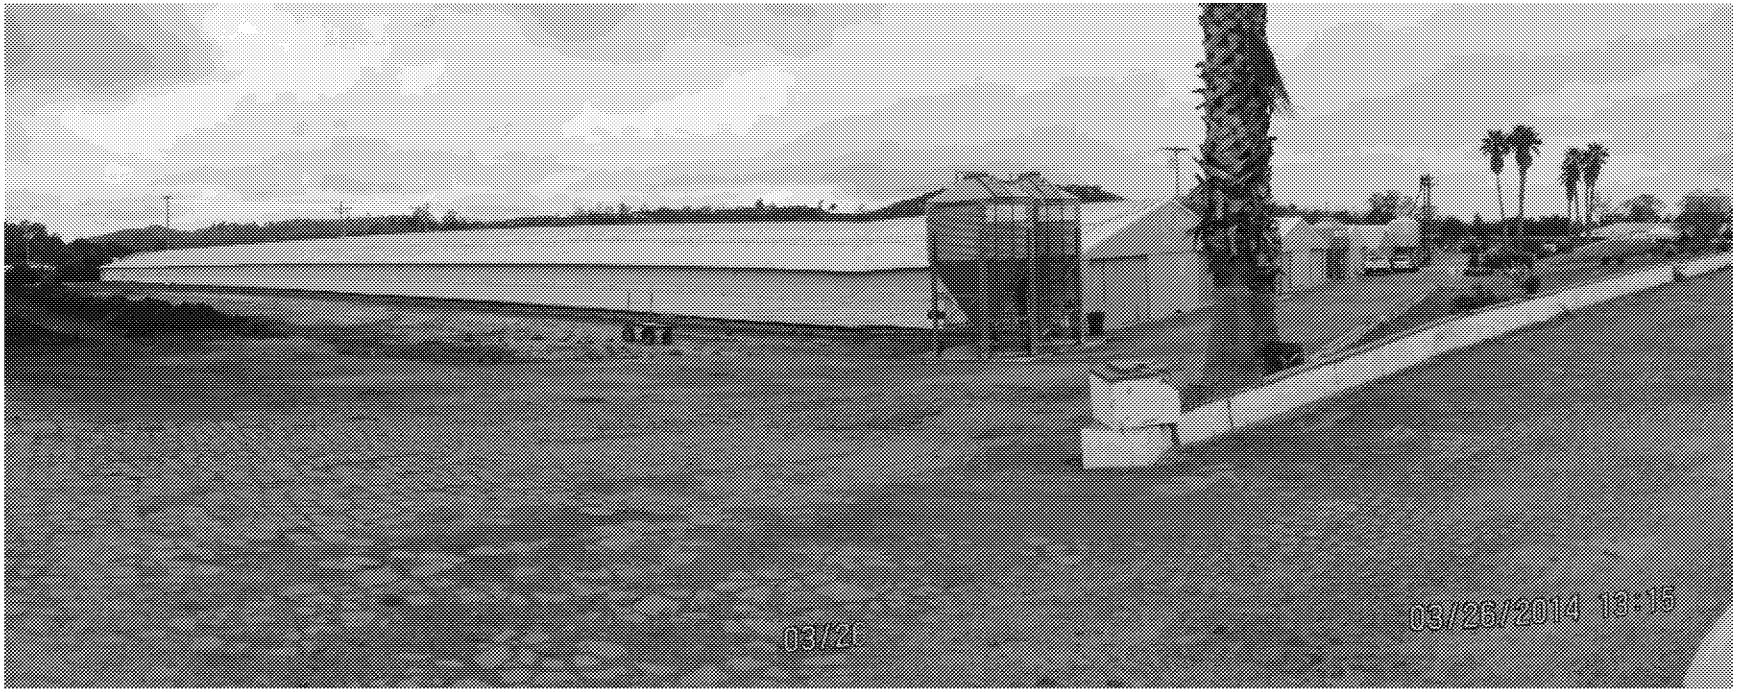
Photo 6 – View of hen houses to the north of the manure piles. View is to the northwest. There is an area between the manure piles and the hen house immediately to the north that is unpaved. This image represents two photographs stitched together.

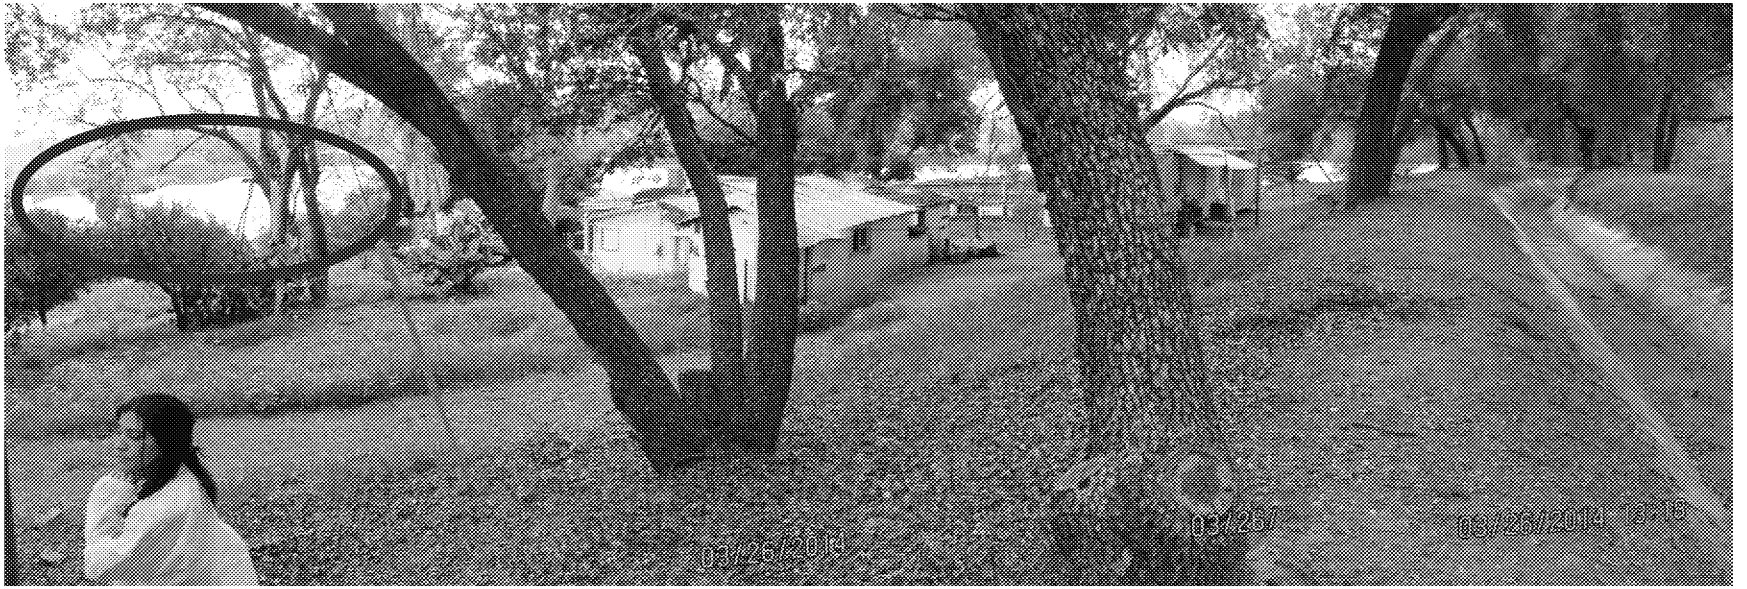
Photo 7 – View of canal running alongside and above the Armstrong Egg Farms facility. The canal is located uphill from the facility and does not appear to be able to receive flows from it. Circle marks hen houses downhill and to the west.

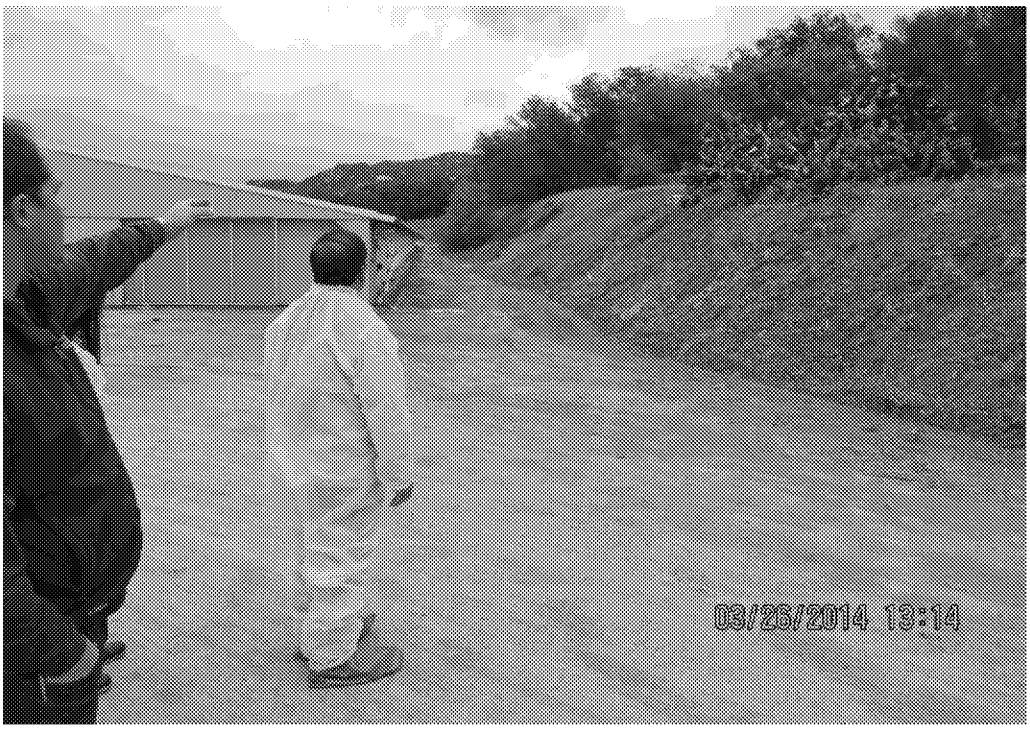
Photo 8 – View of the easternmost hen house adjacent to the canal in the previous photo. The earthen berm supports the western side of the canal. The bed of the canal lies above the level of the ground below.

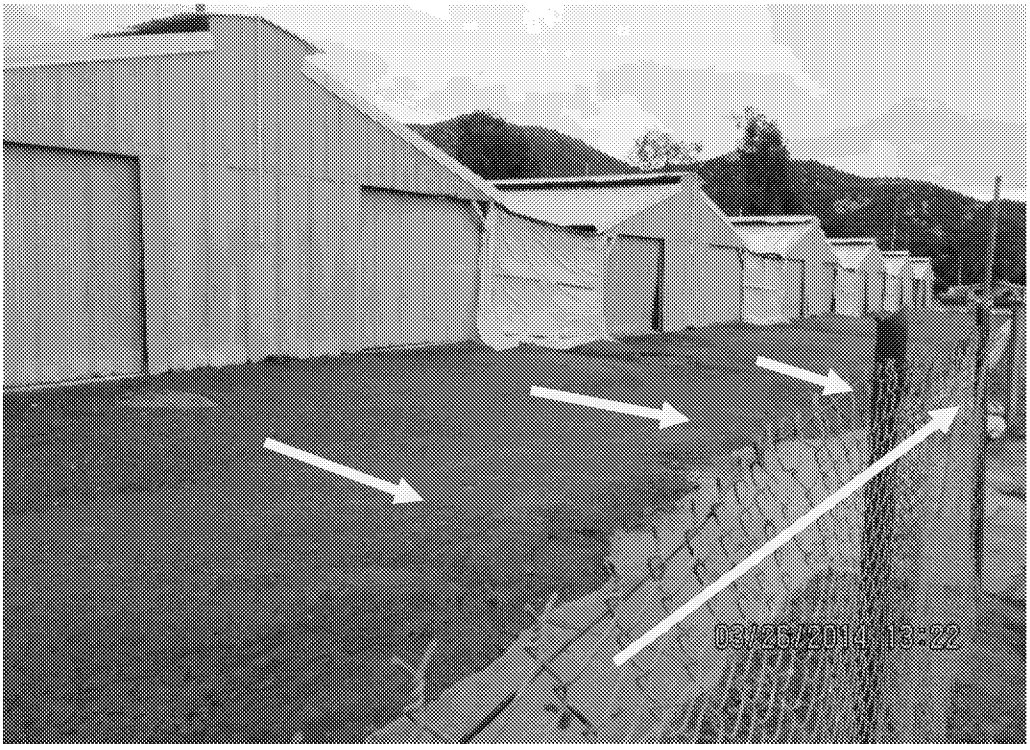
Photo 9 – Hen houses lined up in the southern portion of the facility. Arrows mark the likely direction of any stormwater flows, based on our observations of the topography and the operator's statements. Flow is downhill to the north, then west toward the roadway.

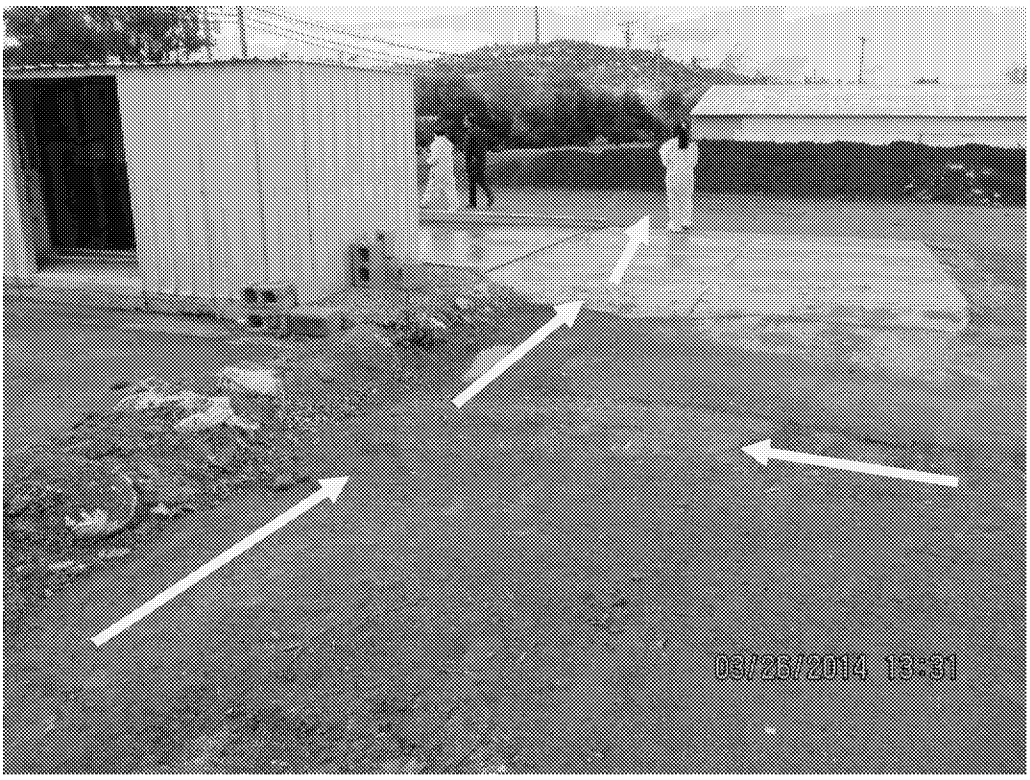
Photo 14 – View toward the northwest of the same earthen berm. It directs any flows from the hen houses in the south end of the facility across the pavement and toward the manure piles (see arrows).

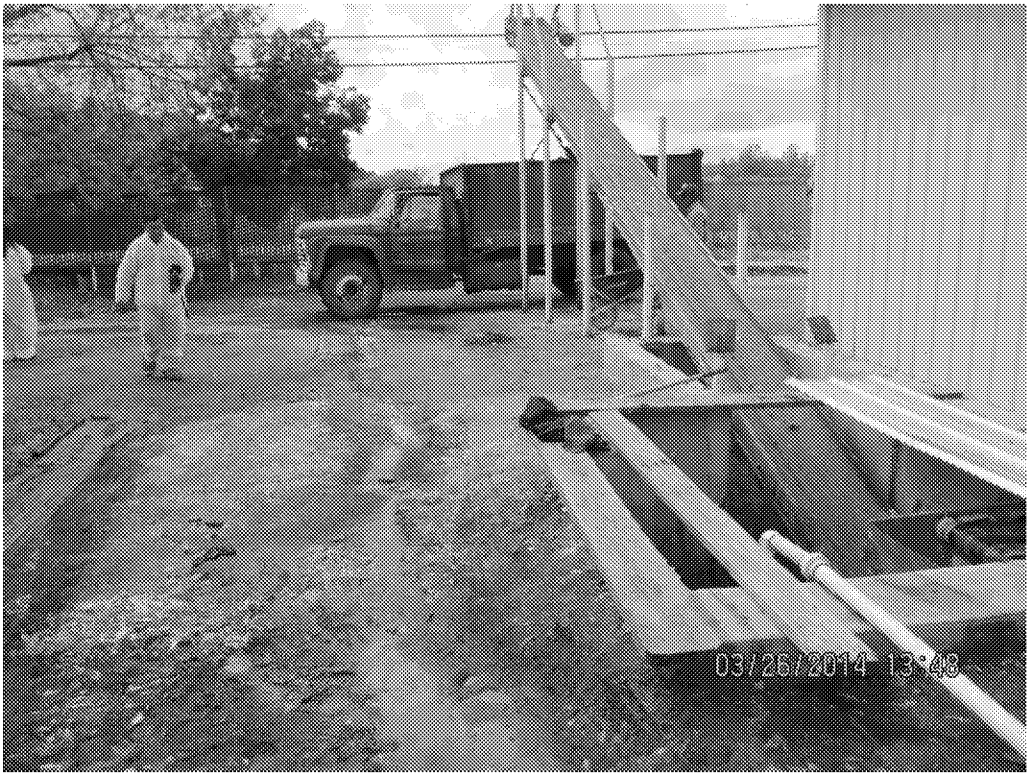
Photo 23 – View of conveyor belt unloading manure into the red truck in Photo 22. Manure is spilled on the pavement.

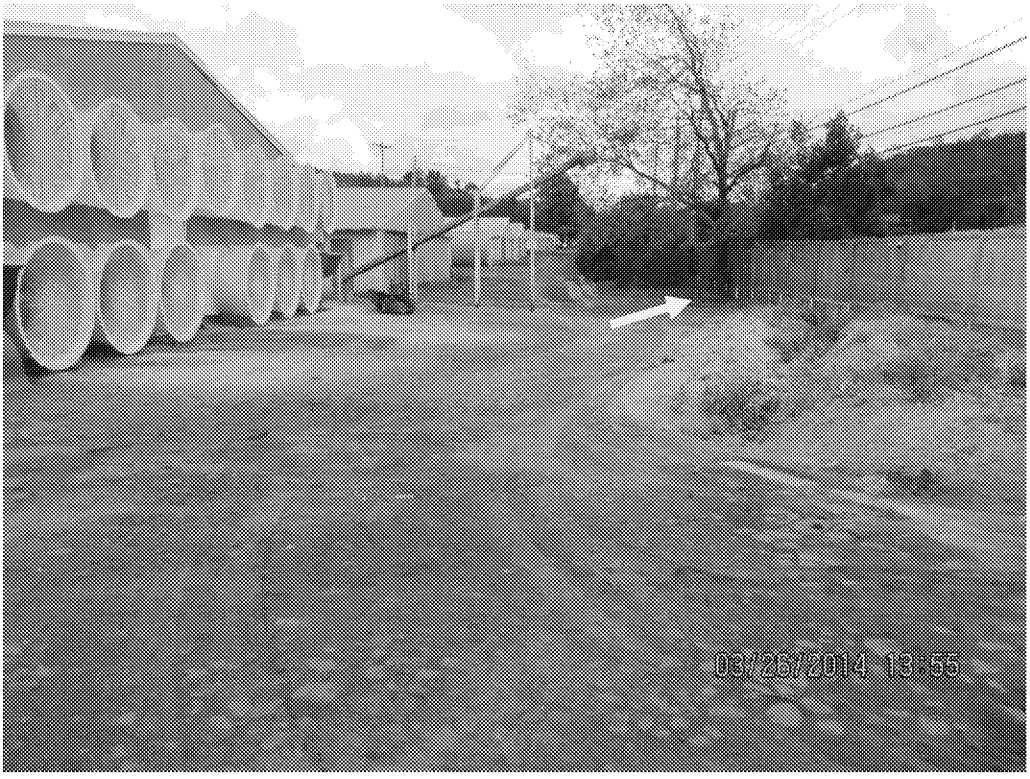
Photo 28 – Blowers airing out the largest hen house, at the NW corner of the facility. The light coloring on the ground is a coating of fine feathers. Discharge point is marked with an arrow.
