Memorandum

From: Steve Willis
To: Wayne Miller
Date: June 3, 2018
Subject: June 1, 2018 Site visit to observe PFAS Investigation activities at Former Williams Air Force Base.

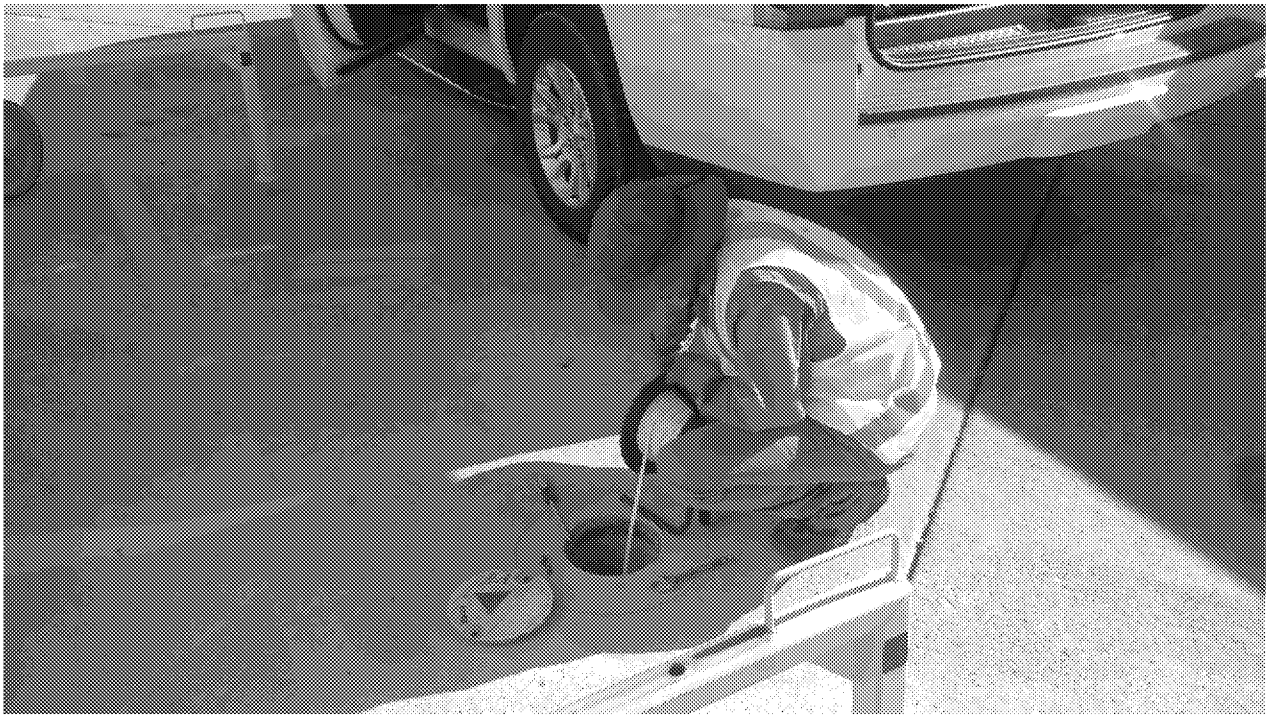
Photo 4. Collecting a Hydrasleeve groundwater sample from well WILPMW005.

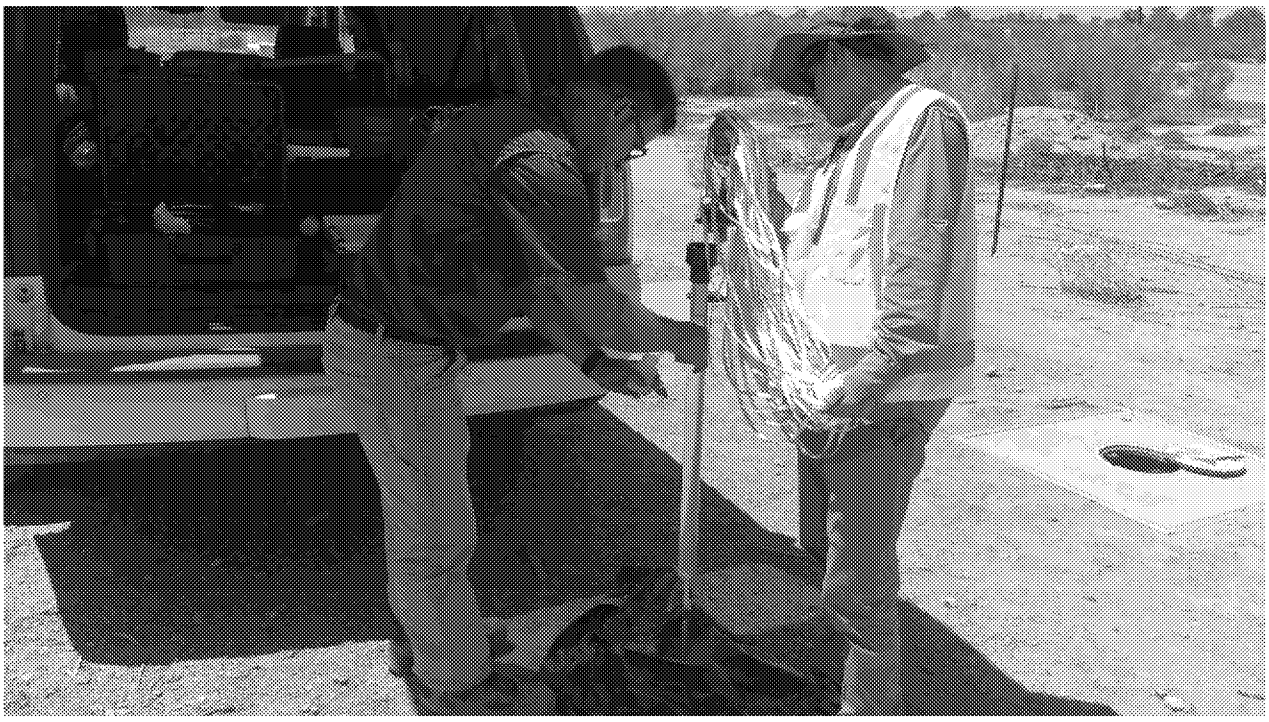
Photo 14. Collecting a Hydrasleeve groundwater sample from well LF01-W35S.
