ALABAMA HAZARDOUS WASTES MANAGEMENT AND MINIMIZATION ACT (AHWMMA)

Compliance Evaluation Inspection (CEI) Report

Eagle Battery, Inc.
4015 Mobile Highway
Montgomery, Montgomery County, Alabama 36108

March 22, 2016

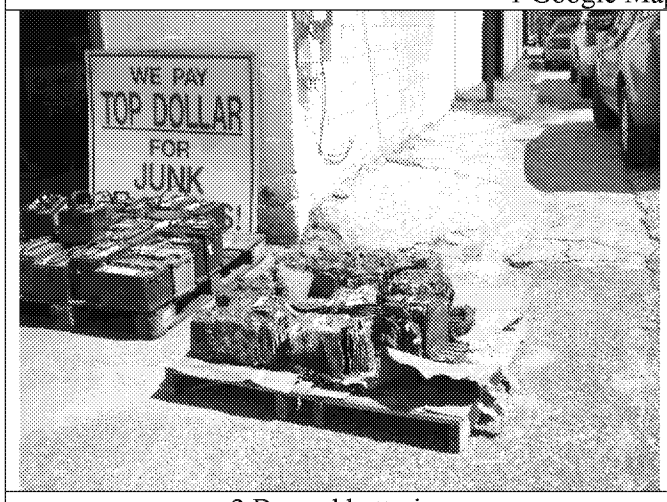
1 Google Maps view of site

On March 22, 2016, Ms. Whiting and I (hereinafter "we" or "us") arrived at the site at 1:00 p.m. and immediately saw two pallets of batteries sitting outside the shop; one pallet held batteries that had been burned to the point that no casings remained. See Photograph #2. We proceeded inside, where we met Mr. Mathews. We introduced ourselves and explained the purpose of our visit, then proceeded to Mr. Mathews' office, where we held the opening meeting and he provided background information about the site and an overview of its operations. See Photograph #1 for an overview of the facility.

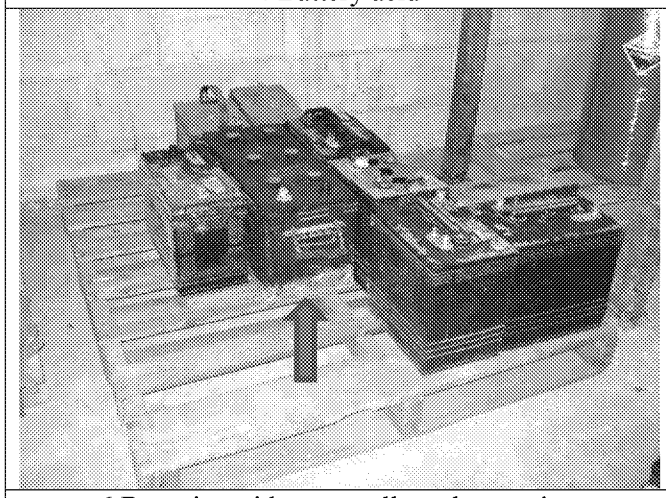
In the parts storage area, we saw seven six-foot long spent fluorescent lamps standing against one wall. Mr. Mathews said he wasn't sure how long they had been there or what he should do with them. The lamps were surrounded by miscellaneous discarded materials, so we could not access them to ensure they were still intact. Batteries, acid, and other parts are stored on shelves and pallets along an adjacent wall. We saw four 25-gallon plastic drums of battery acid, including two that had been secured to a wooden pallet using plastic shrink wrap. These

3 Spent fluorescent lamps
