ALABAMA HAZARDOUS WASTES MANAGEMENT AND MINIMIZATION ACT (AHWMMA)
Compliance Evaluation Inspection (CEI) Report

Zilkha Biomass Selma LLC
1256 County Road 78
Selma, Dallas County, Alabama 36703

February 25, 2016

ATTACHMENT – ZILKHA BIOMASS SELMA LLC PHOTO LOG

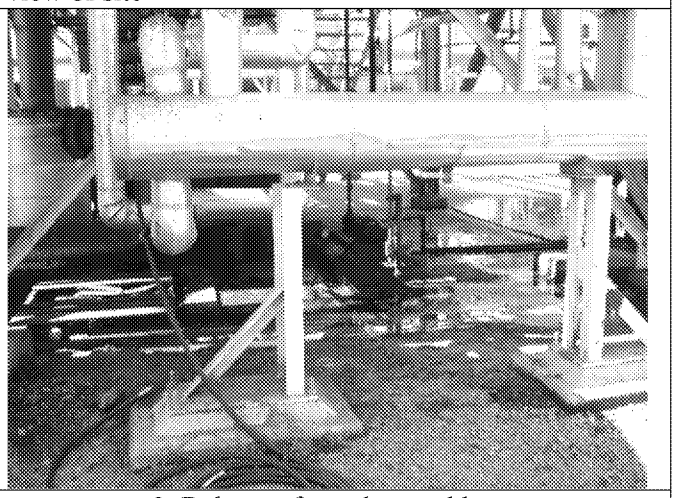
While no chemicals are used in the thermal treatment unit according to ZBS' literature, the scrubber uses sodium hypochlorite (referred to as "caustic" by facility employees). A tank adjacent to the scrubber was used by Dixie Pellets to hold the caustic; since it is severely corroded, ZBS personnel transferred the product into several totes for continued use. Mr. Shields told us that the tank was slated to be removed at some point in the future. During operation, there appears to be a steady release of brownish liquid from the scrubber and the concrete pad below that unit was severely degraded, although we could not determine if that was from the on-going release or due to a prior release of caustic from the corroded tank. Mr. Shields stated that ZBS had not made a hazardous waste determination on the released liquid. He was able to tell us that the WESP generates a nonhazardous sludge that is essentially wet sawdust and dirt. See Photograph #2 through Photograph #7.

2. Thermal Treatment Unit and Scrubber
