ALABAMA HAZARDOUS WASTES MANAGEMENT AND MINIMIZATION ACT (AHWMMA) COMPLIANCE EVALUATION INSPECTION (CEI) REPORT

Aerospace Coatings International, LLC (ACI)
370 Knight Drive
Oxford (Talladega County), AL 36203

June 25, 2019

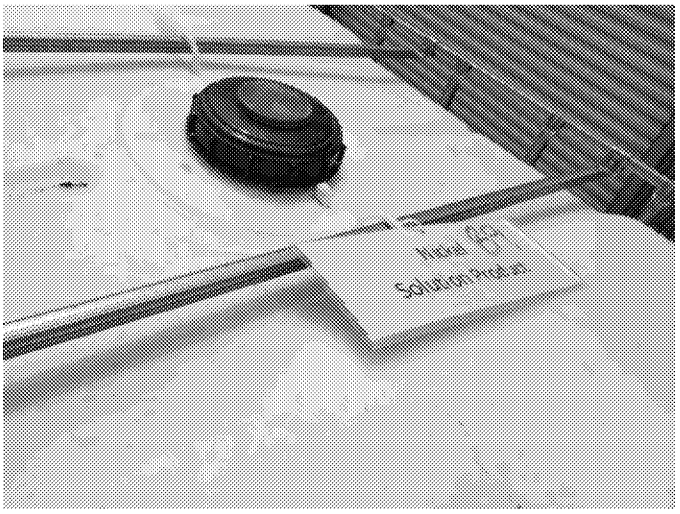
Photograph #1: containers of hazardous waste staged outside the CAA

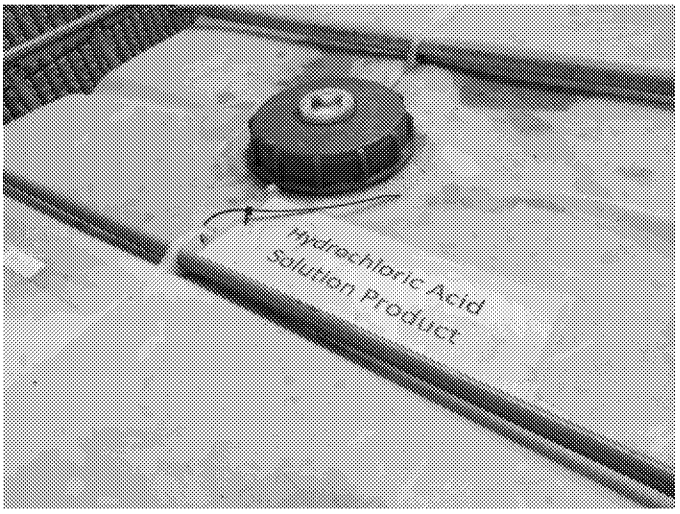
- Two 330-gallon plastic totes of used nickel plating solution that were closed and labeled with the words "Nickel Solution Product" (see Photograph # 3 and Photograph #4);
- One 330-gallon plastic tote of used Zyglo ™ solution that was closed and labeled with the words "Used Zyglo Product" (see Photograph #5); and
- One 250-gallon plastic tote of used hydrochloric acid solution that was closed and labeled with the words "Hydrochloric Acid Solution Product" (see Photograph #6).

Photograph #3: container of used chemicals (not waste) staged outside the CAA

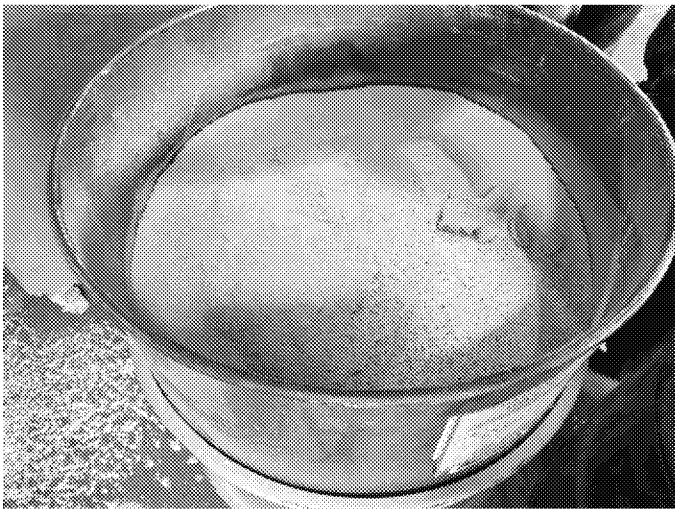
Photograph #7: open satellite accumulation container staged outside the multi-purpose plating line

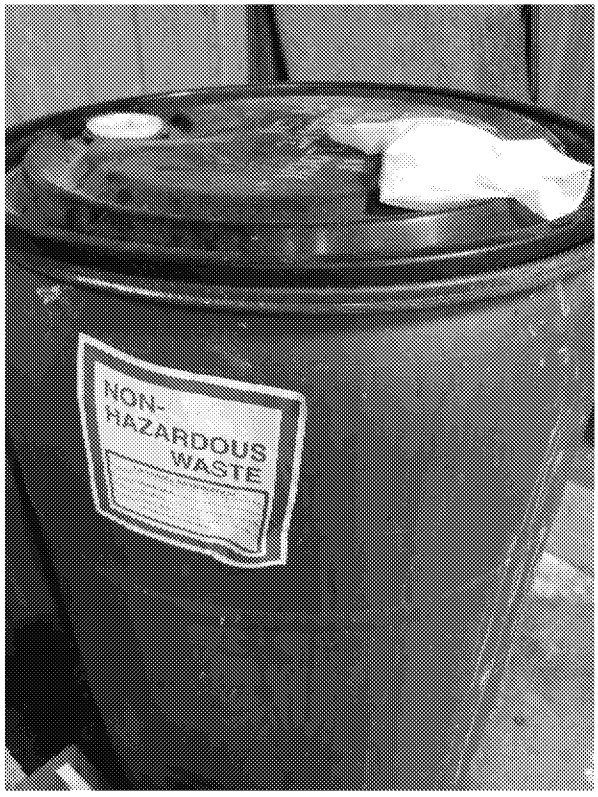
Photograph #10: container of non-hazardous waste in the multi-purpose plating line

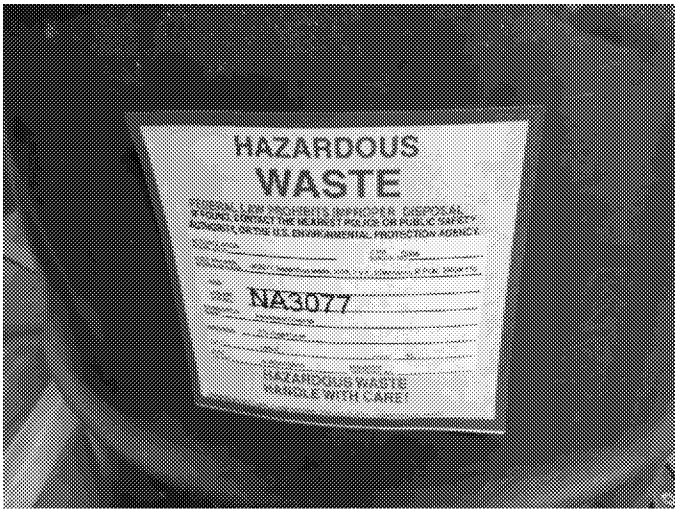
Photograph #14: satellite accumulation container in the plating preparation area

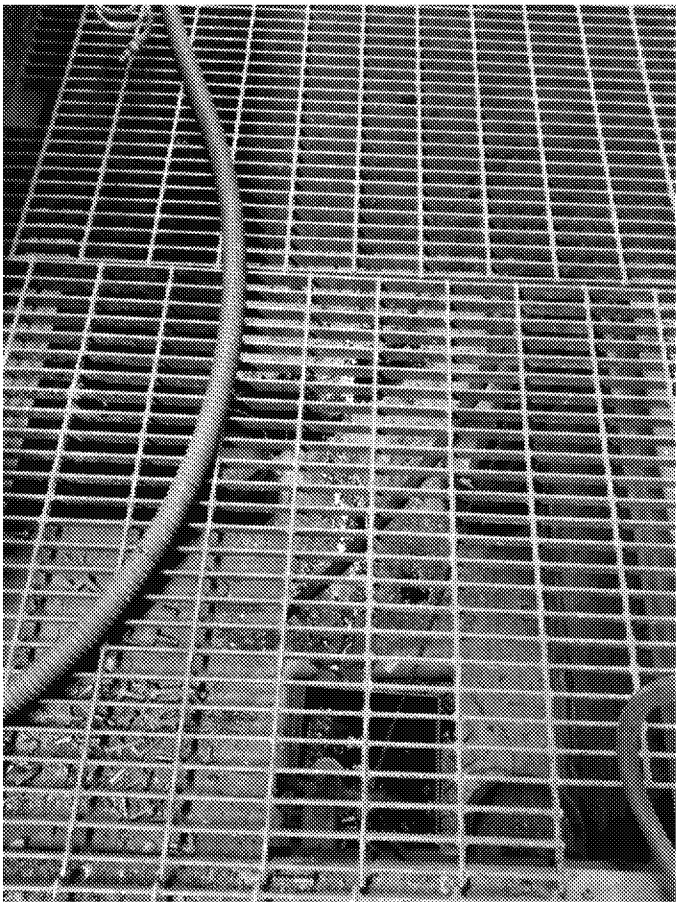
Photograph #15: sump in the floor underneath the chrome plating line (contained liquid at the time of the inspection)

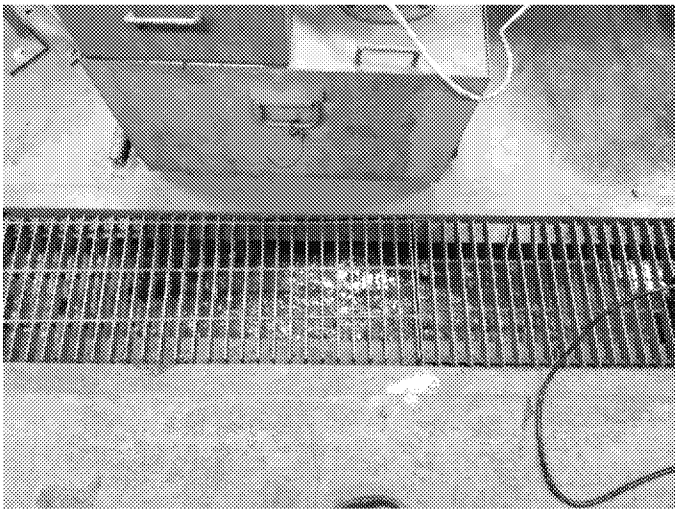
Photograph #23: trough in the floor of the OD shop (contained liquid at the time of the inspection)

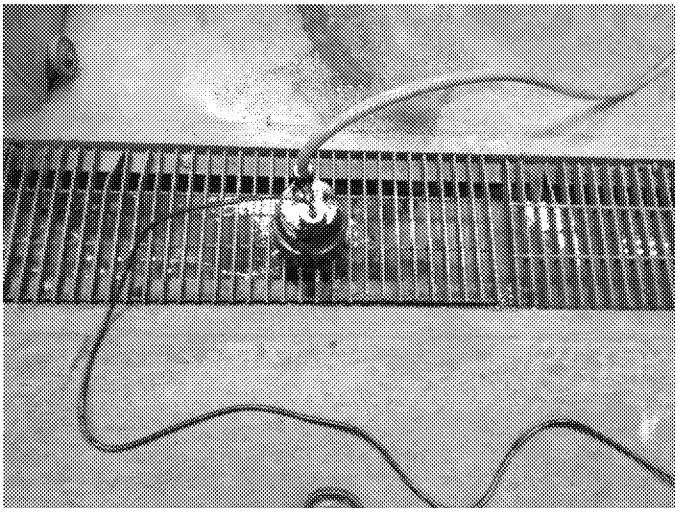
Photograph #24: trough in the floor of the OD shop (liquid being pumped into a 330-gallon tote)

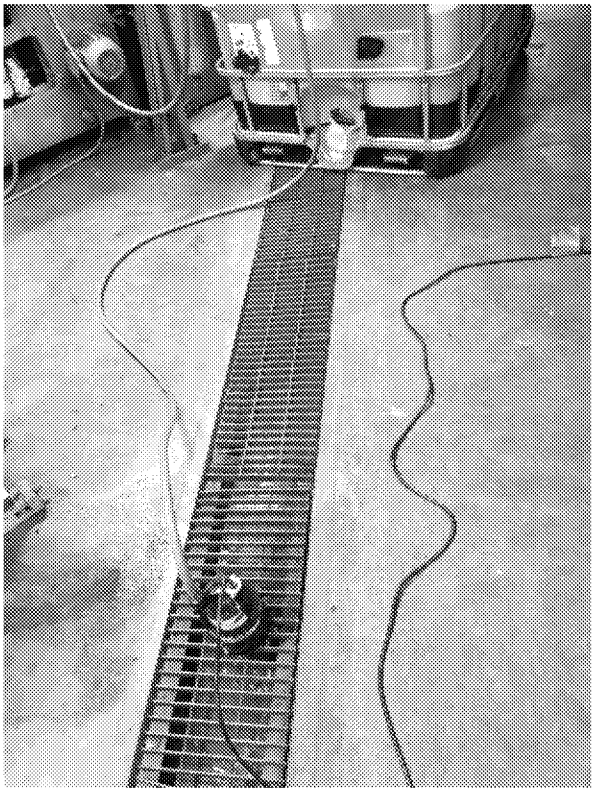
Photograph #25: trough in the floor of the OD shop (liquid being pumped into a 330-gallon tote)

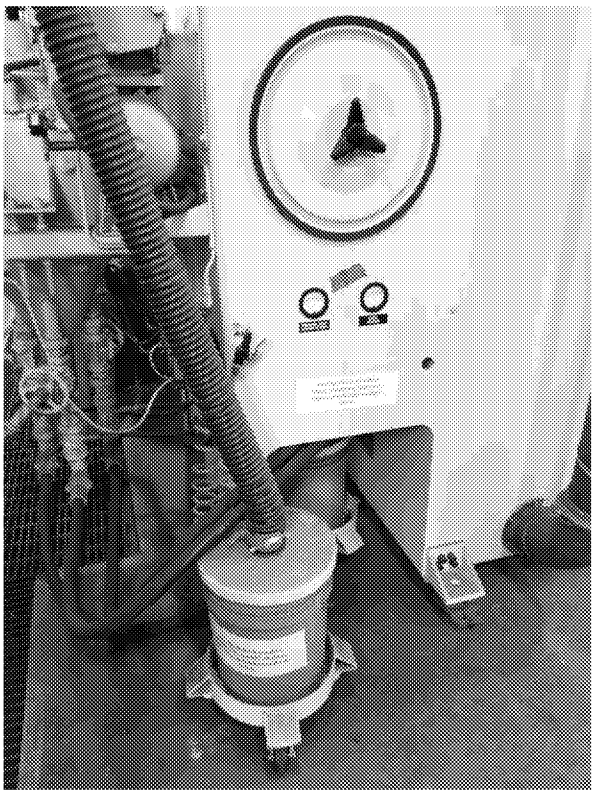
Photograph #27: satellite accumulation container in the OD shop (waste on side of drum)

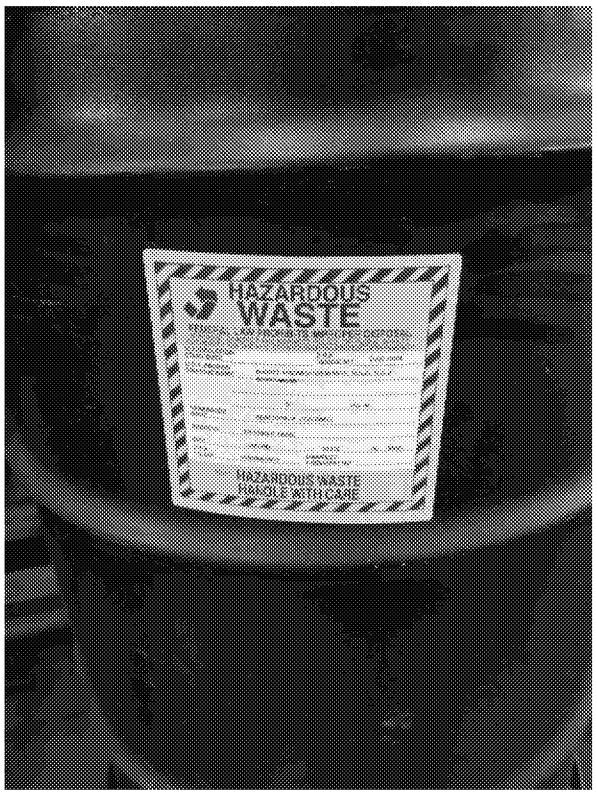
Photograph #31: satellite accumulation container in the OD shop

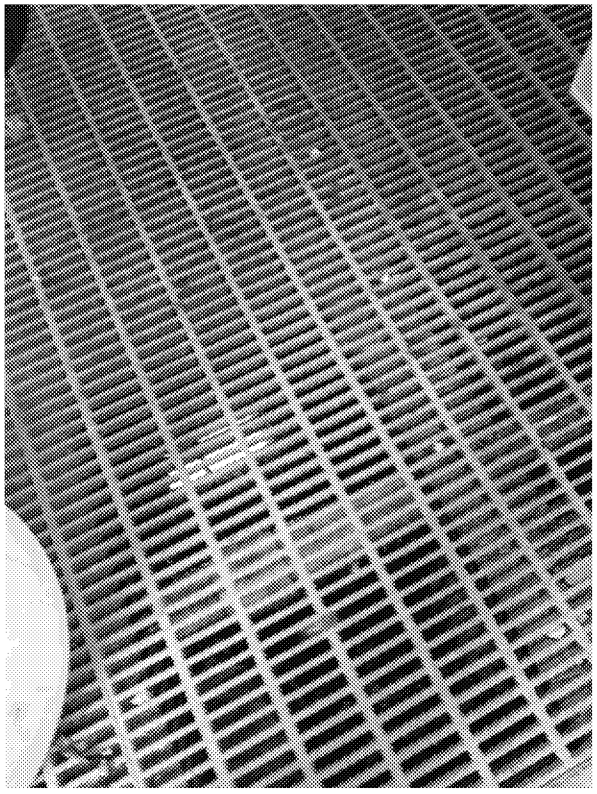
Photograph #32: pit in the floor underneath the stripper shop (contained liquid at the time of the inspection)

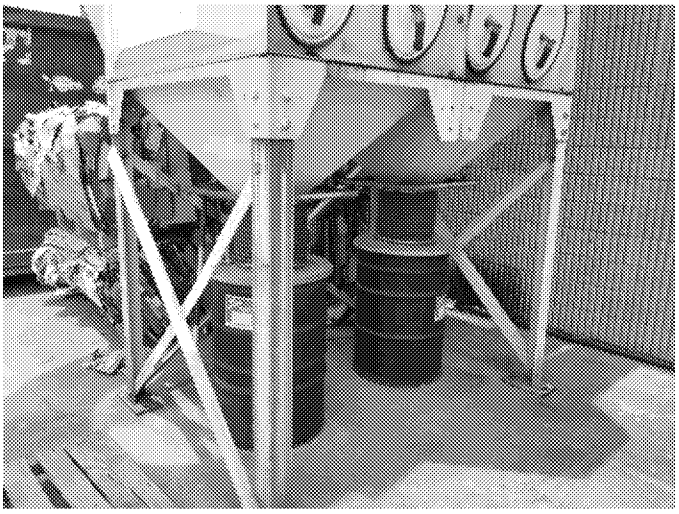
Photograph #35: containers of non-hazardous waste attached to a dust collector

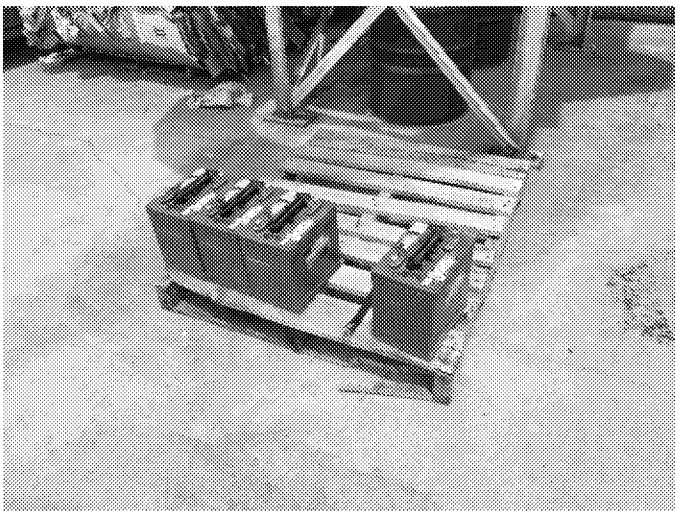
Mr. Landingham next accompanied us on a tour of the concrete lot outside of the main building. Four dust collectors connected to the facility's air pollution control system were located on the south side of the building. Each of these dust collectors was attached to an open-top metal 55-gallon drum. Each drum was closed and labeled with the words "Non-Hazardous Waste" (see Photograph #33 through Photograph #35). According to Mr. Landingham, one of the dust collectors is connected to the Plasma ™ coating area and collects overspray of powdered metal coating. According to Mr. Landingham, the facility does not have a separate waste profile for the contents of the dust collector connected to the Plasma ™ coating area even though its contents are expected to be different from those of the other dust collectors. Four intact lead-acid batteries were staged on a wooden pallet near the cyclones (see Photograph #36). Mr. Landingham told us that they were new / unused batteries (not waste).

Photograph #36: new batteries staged outside the main building

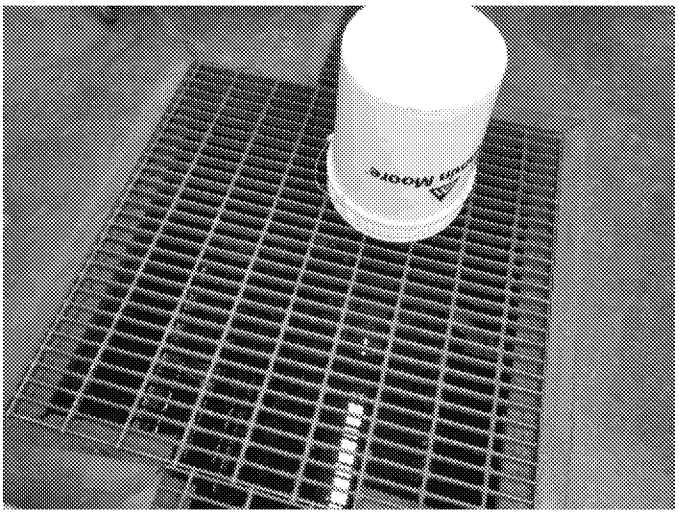
Photograph #37: trough in the floor of the ID shop (contained liquid at the time of the inspection)

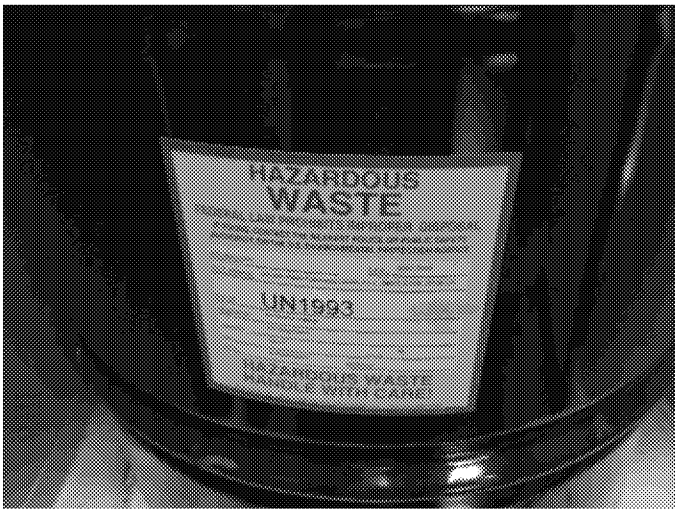
Photograph #44: open satellite accumulation container staged outside of the Plasma ™ coating area

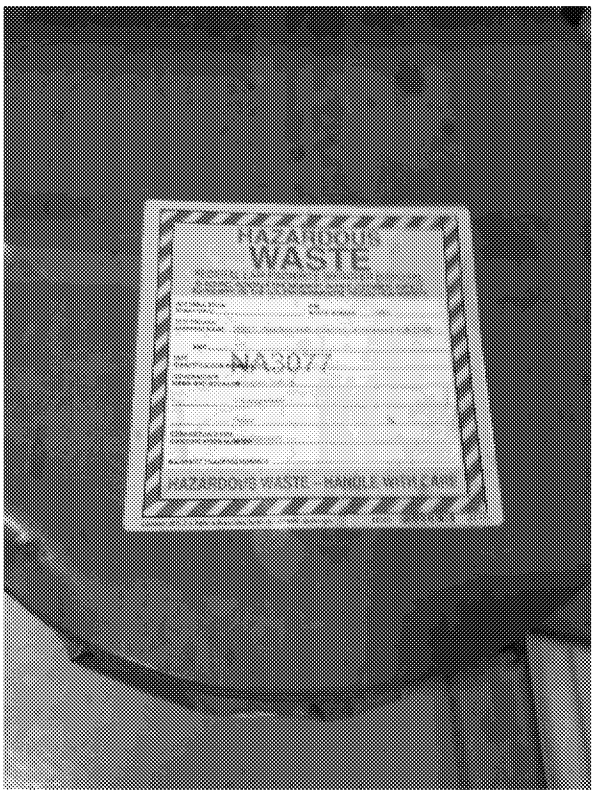
Photograph #46: satellite accumulation container in the LG building preparation area

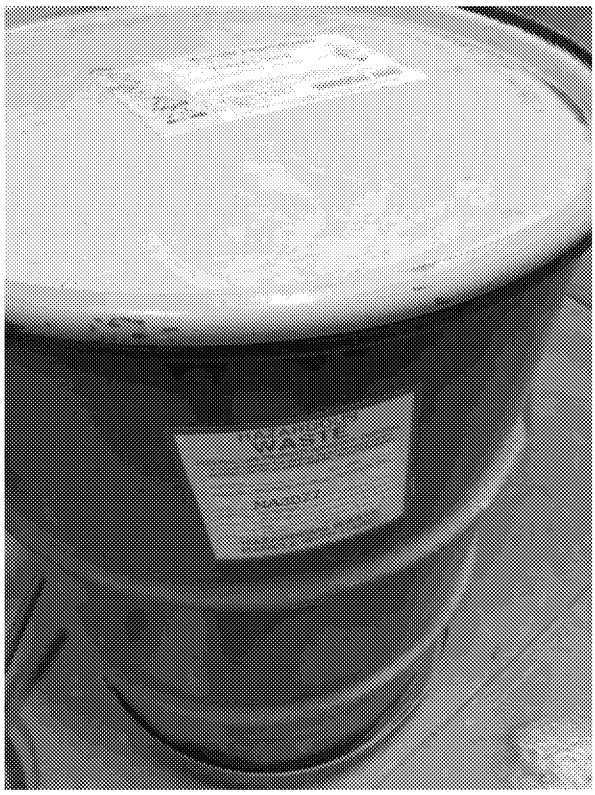
Photograph #48: open satellite accumulation container in the LG building preparation area

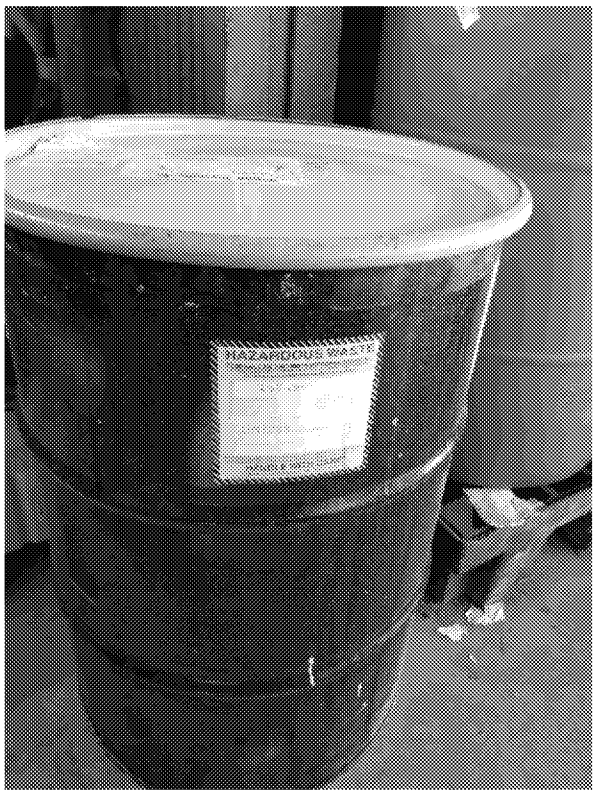
- One open-top metal 55-gallon drum of solid paint-related waste that was closed, labeled with the words "Hazardous Waste", marked with the applicable waste codes (D001 and D035), and marked with an accumulation start date of "6-24-2019" (see Photograph #52);
- One closed-top metal 55-gallon drum of used oil that was staged on a plastic spill control pallet, closed, and labeled with the words "Used Oil" (see Photograph #53); and
- One open-top plastic 55-gallon drum of used oil that was staged on a plastic spill control pallet, closed, and labeled with the words "Used Oil / Coolant Cimcool" (see Photograph #54).

Photograph #52: container of hazardous waste in the CAA

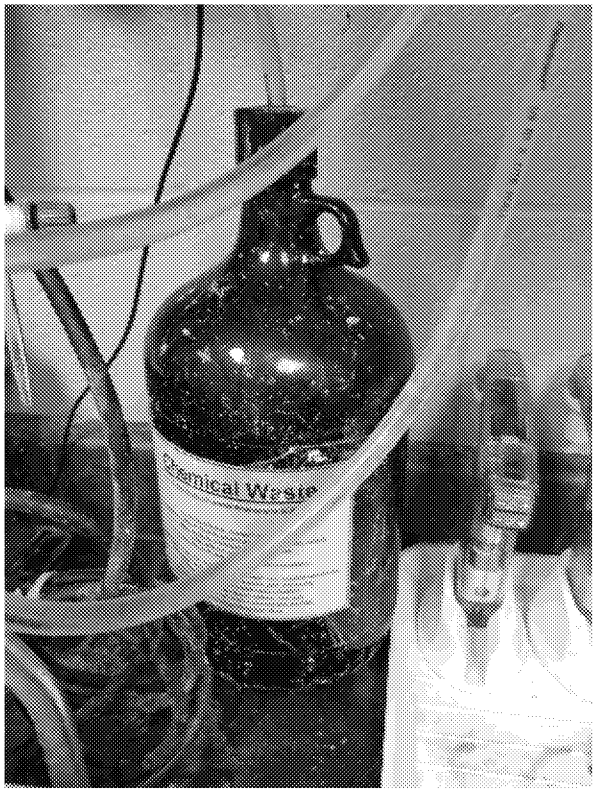
Photograph #57: improperly labeled satellite accumulation container in the QA/QC laboratory
